The City of East Peoria Storm Water Management Plan

December-2022

Patrick N. Meyer & Associates, Inc.

Findings

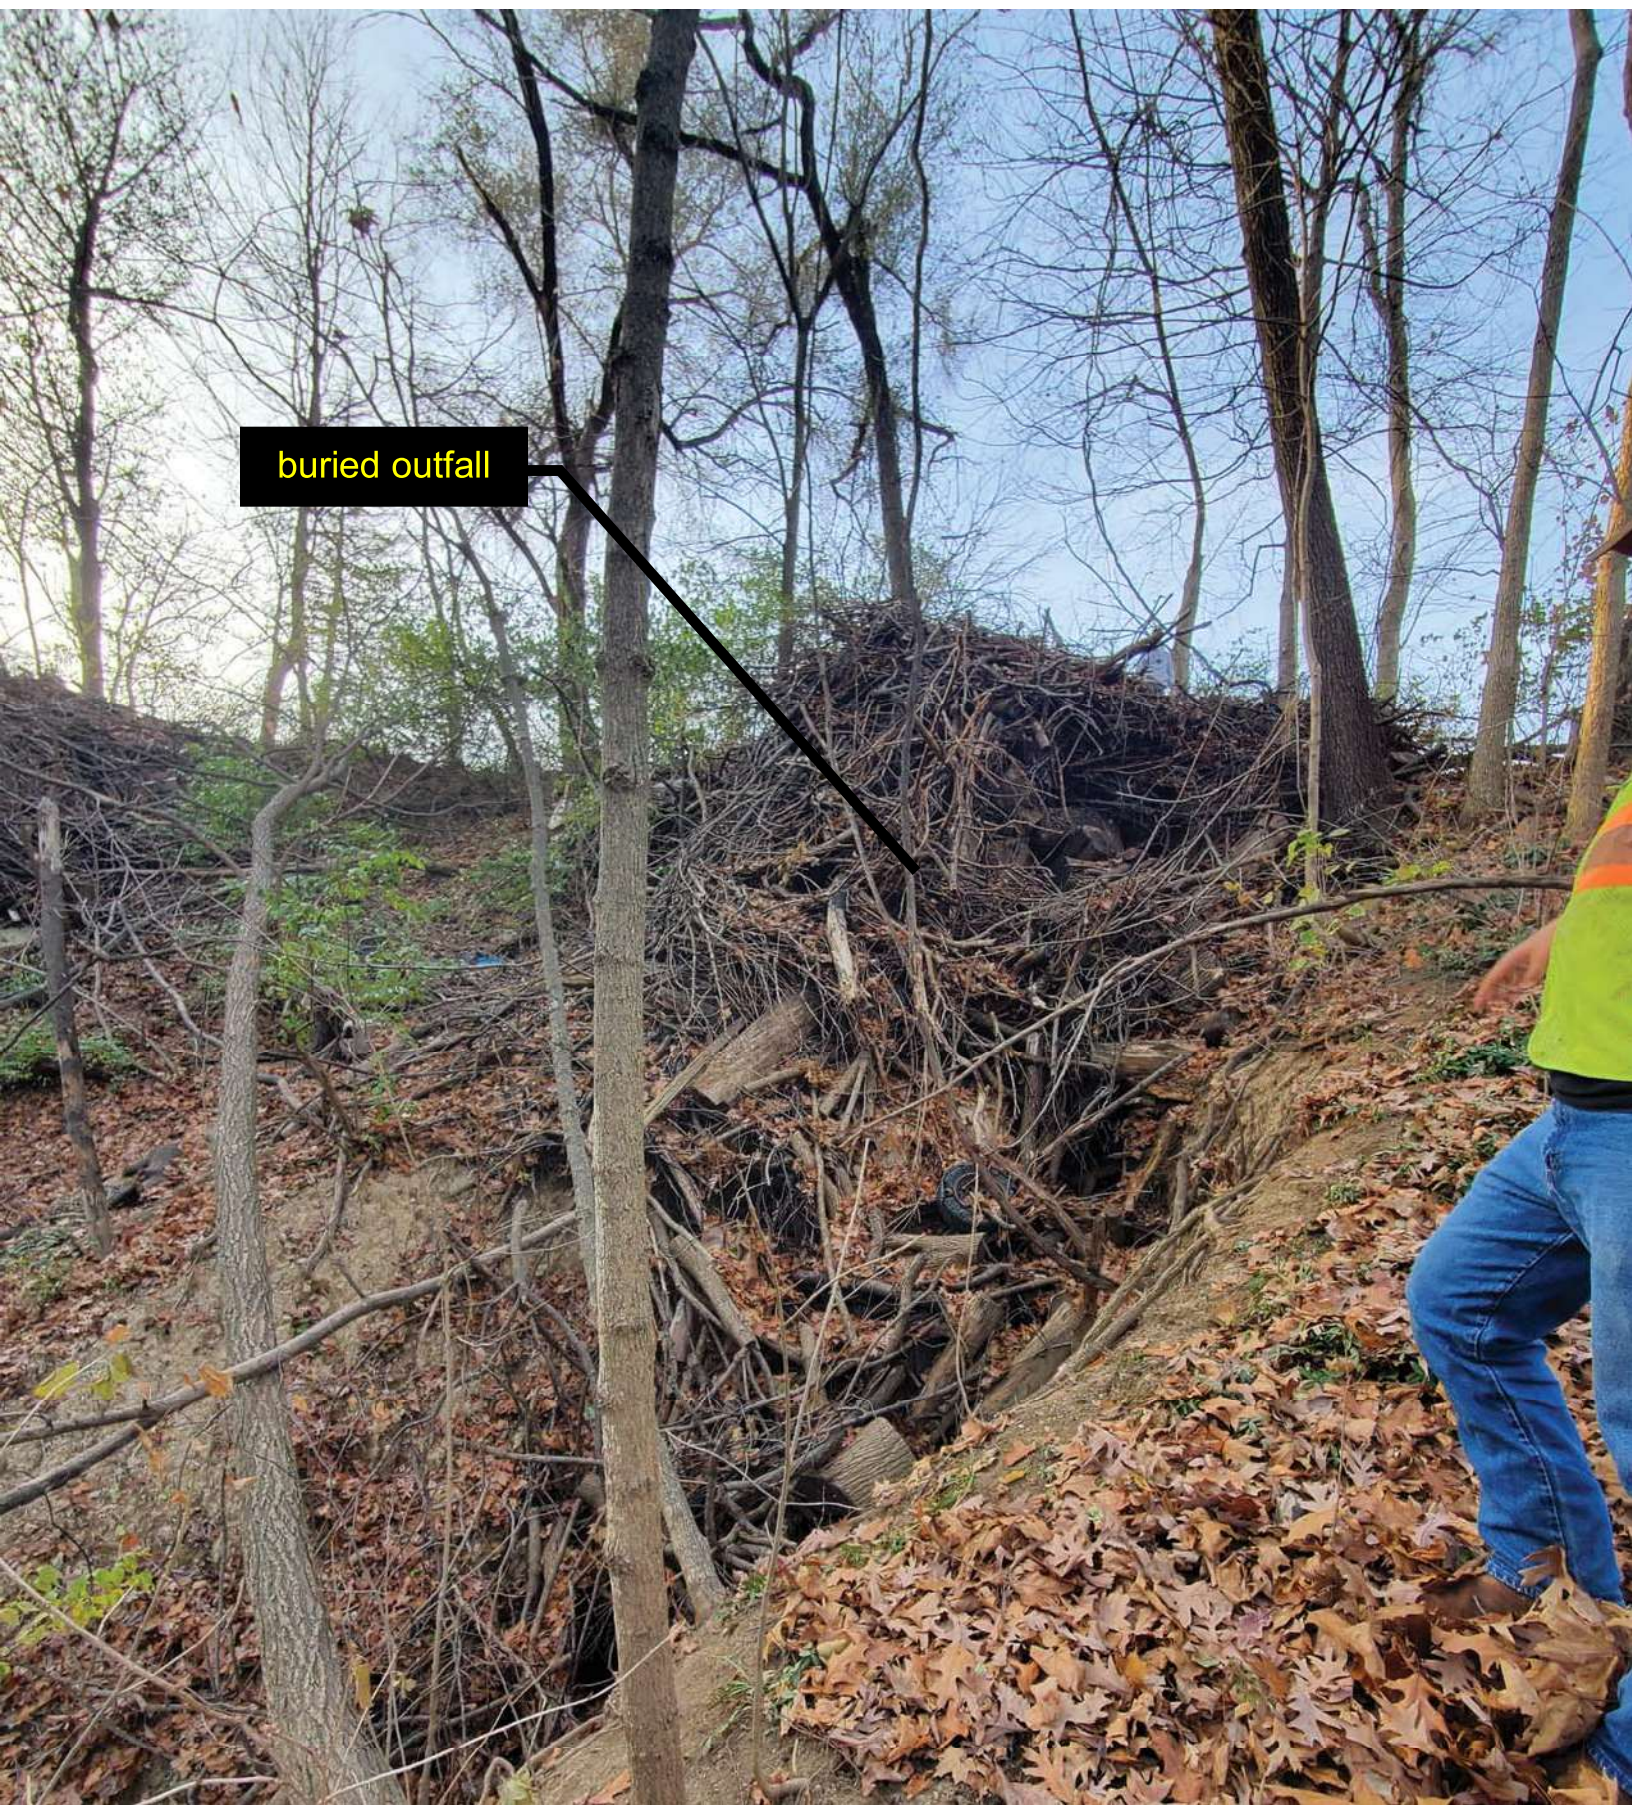
buried outfall

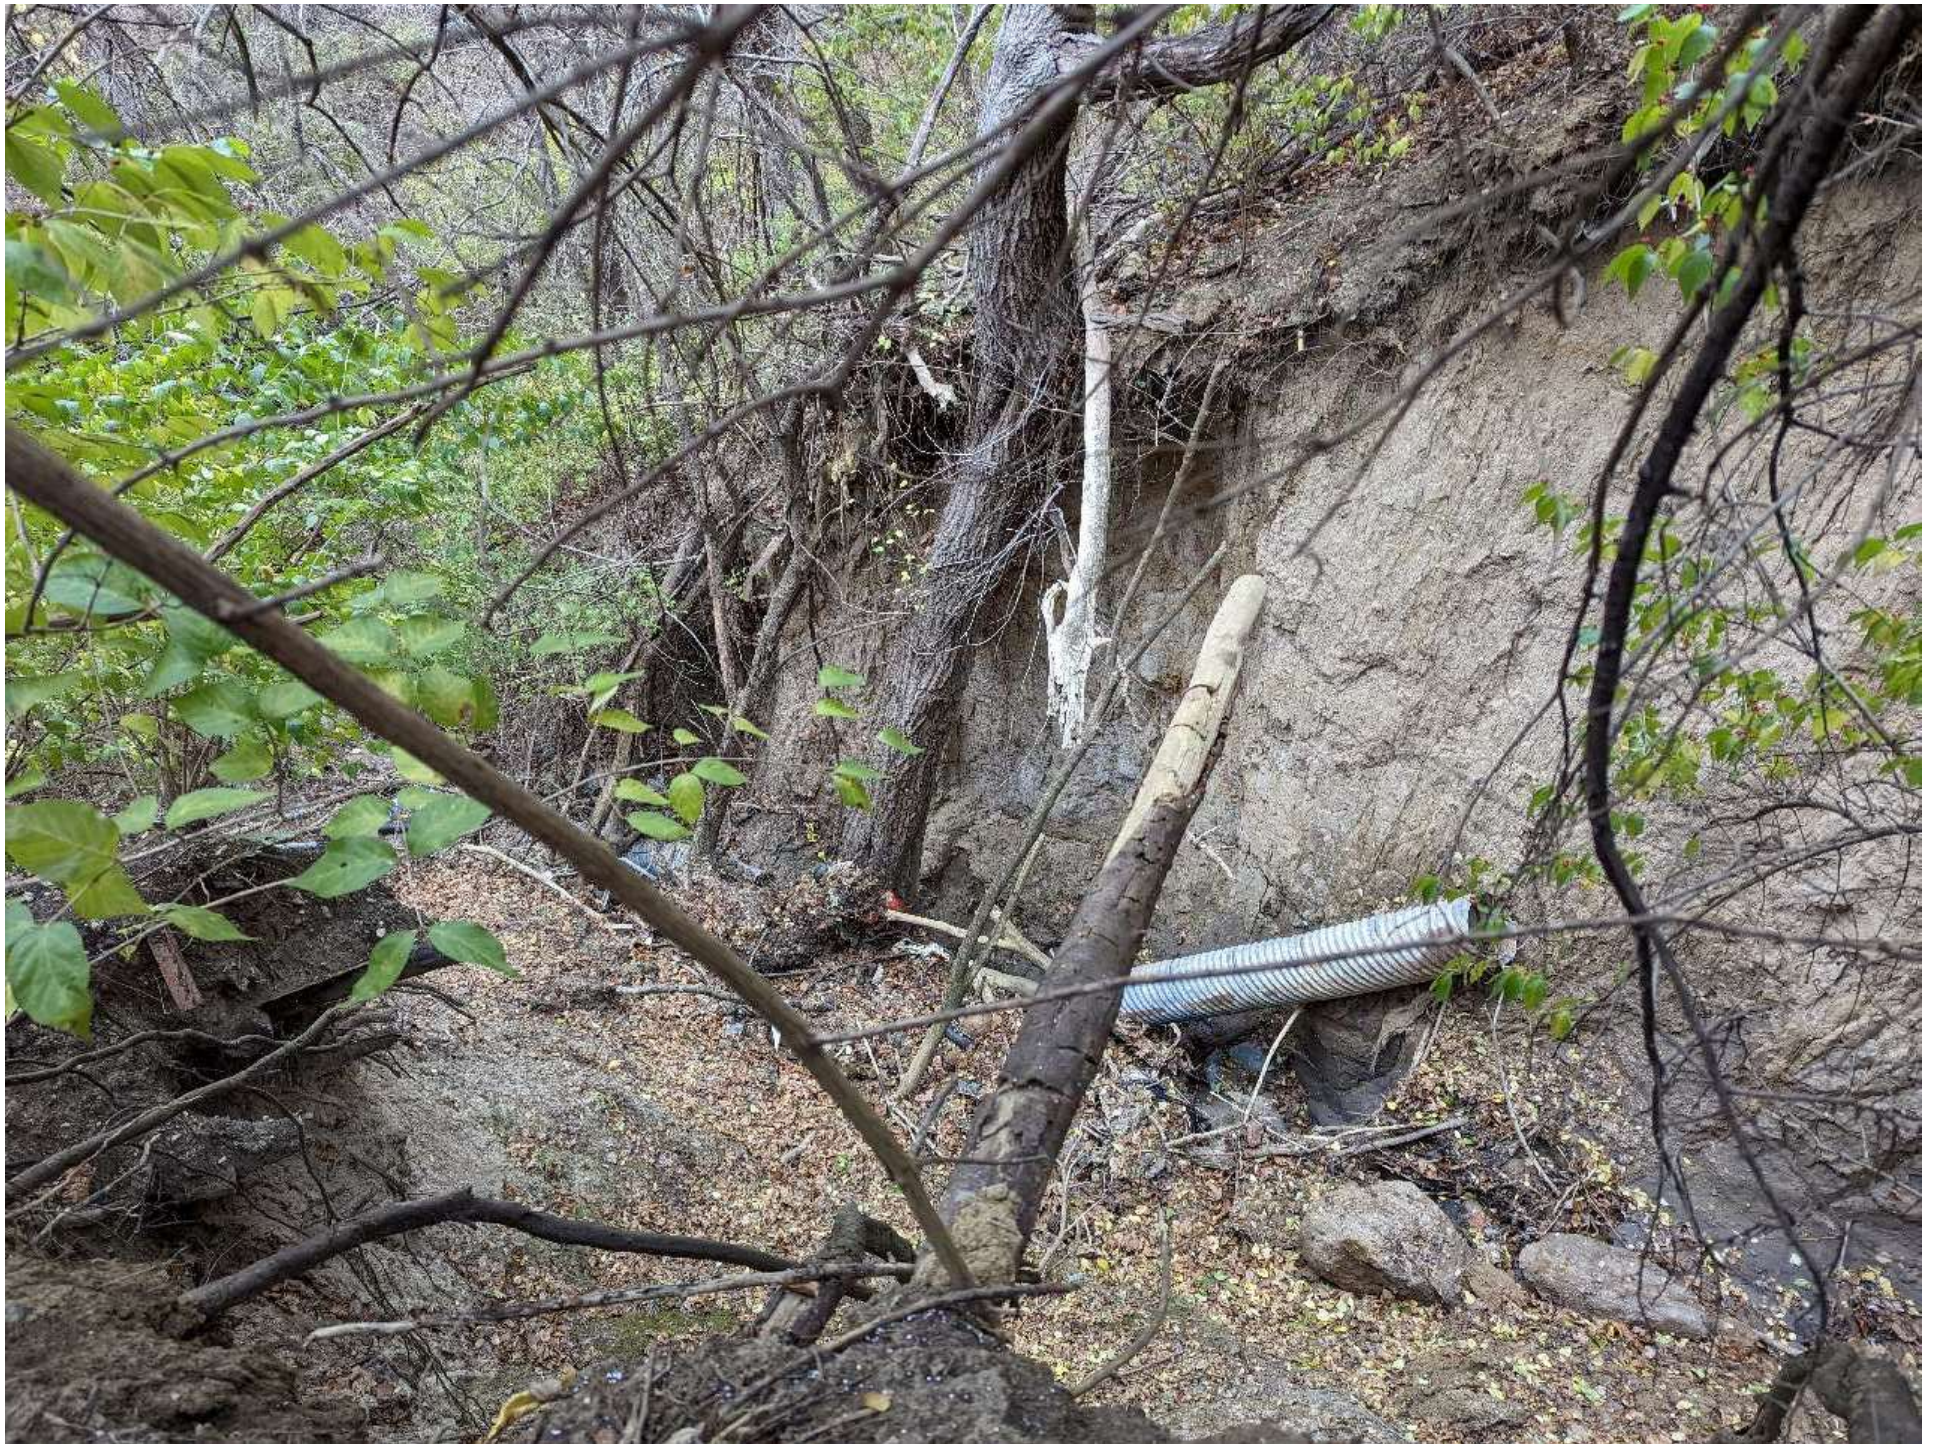
Object ID 232-Off of Harvey Ct

OBJECTID	Material Type	Diameter (inches)	Pipe Condition	Erosion Condition	Depth of Erosion (ft)	Cost	Location	VI - Other Comments?	Notes
232	Corrugated	15	Very Poor	1 - Severe Erosion (>5ft)	30 ft	\$ 200,000	Off of Harvey	The pipe has extremely SEVERE erosion occurring, up to 30 ft	Pipe sections are coming apart and is in proximity of building
10	Corrugated	18	Very Poor	1 - Severe Erosion (>5ft)	20ft plus	\$ 200,000	Off of Centennial Hill	The pipe has bad rust and is broken near the bottom of the pipe... Also, the end section fell off	There is extreme erosion on the hillside behind the pipe, creeping towards the road... Also, not completely sure on the pipe size, somewhere close to a 18" pipe
92	Corrugated	24	Very Poor	1 - Severe Erosion (>5ft)	14-15 ft	\$ 75,000	Off of Illini	Severe erosion up to 14-15 ft and little to no standing water	The pipe itself is in good shape but parts of the pipe have come off due to erosion

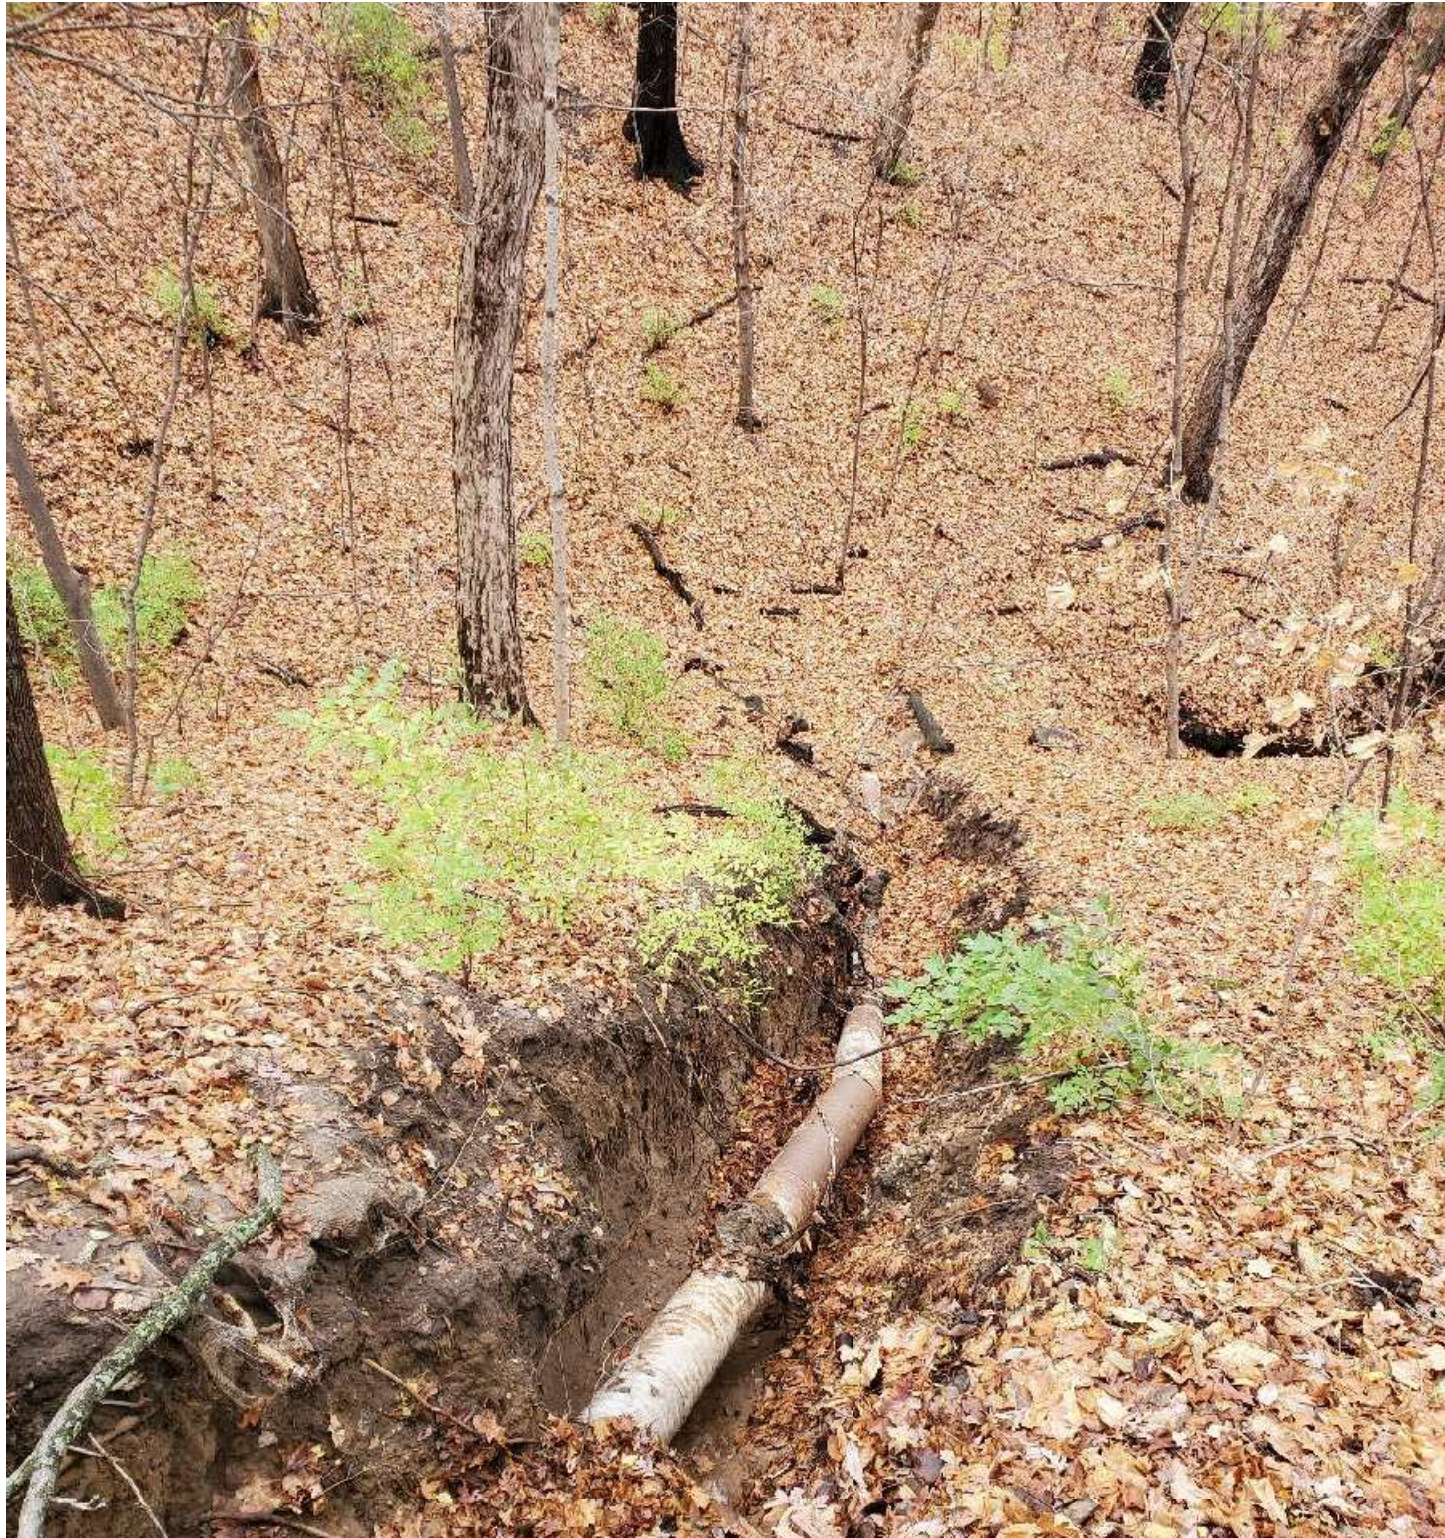
Object ID 194-Off Terrace Ln

194	Corrugated	18	Poor	1 - Severe Erosion (>5ft)	15 ft	\$ 75,000	Off of Terrace Ln	This outfall has SEVERE erosion	The pipe is rusting
260	Steel	13	Poor	1 - Severe Erosion (>5ft)	15 ft	\$ 75,000	Off of Maria	Televised!	The pipe is rusted
214	Corrugated	15	Very Poor	1 - Severe Erosion (>5ft)	10-12 ft	\$ 75,000	Off of Springfield Rd	The pipe has severe erosion up to 10-12 ft	The pipe is rusting bad causing severe erosion
263	Corrugated	12	Fair	1 - Severe Erosion (>5ft)	12	\$ 75,000	Off of Maria	There is major erosion at the outfall due to break in pipe	Pipes been broken in places and is eroding
94	Corrugated	18	Very Poor	1 - Severe Erosion (>5ft)	9-10	\$ 150,000	Off of Illini	9-10 feet of erosion, no standing water	Belly of pipe is completely rusted out and is completely falling apart as it's coming off the hillside.
166	Corrugated	24	Poor	1 - Severe Erosion (>5ft)	10 ft	\$ 150,000	Off of Oakwood	Bad erosion around the outfall	The pipe bottom is rusted

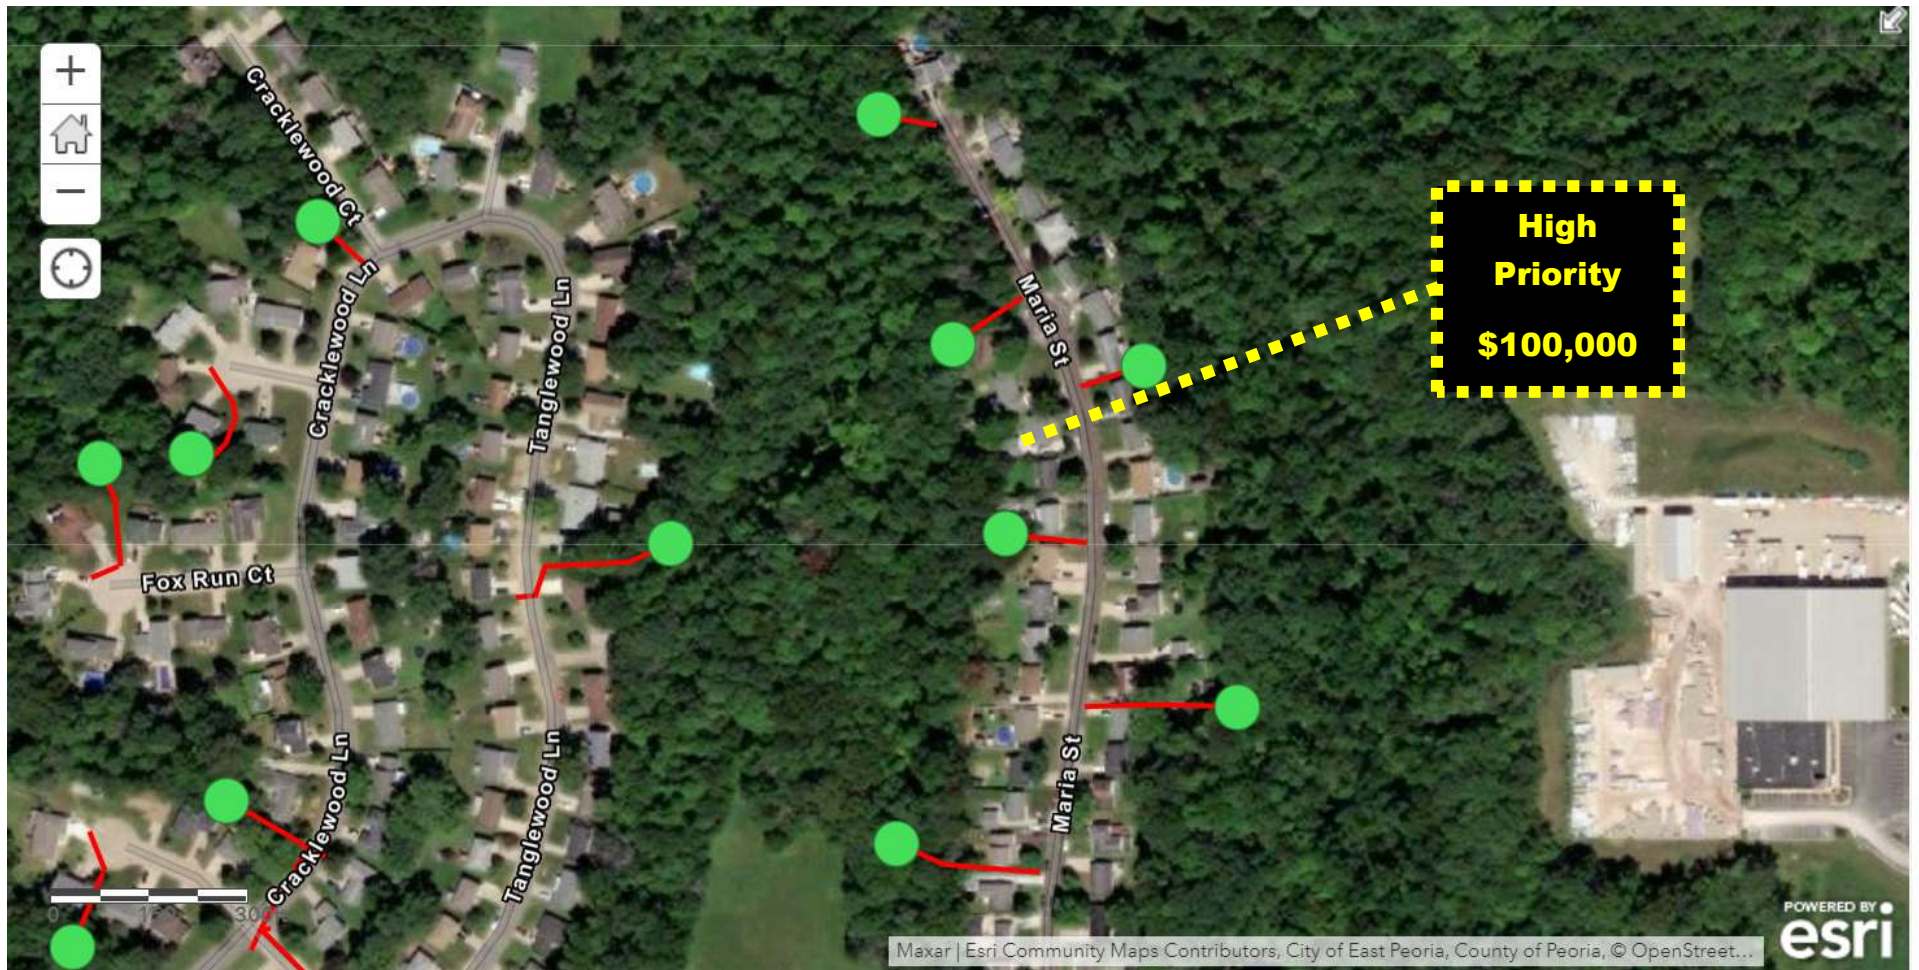
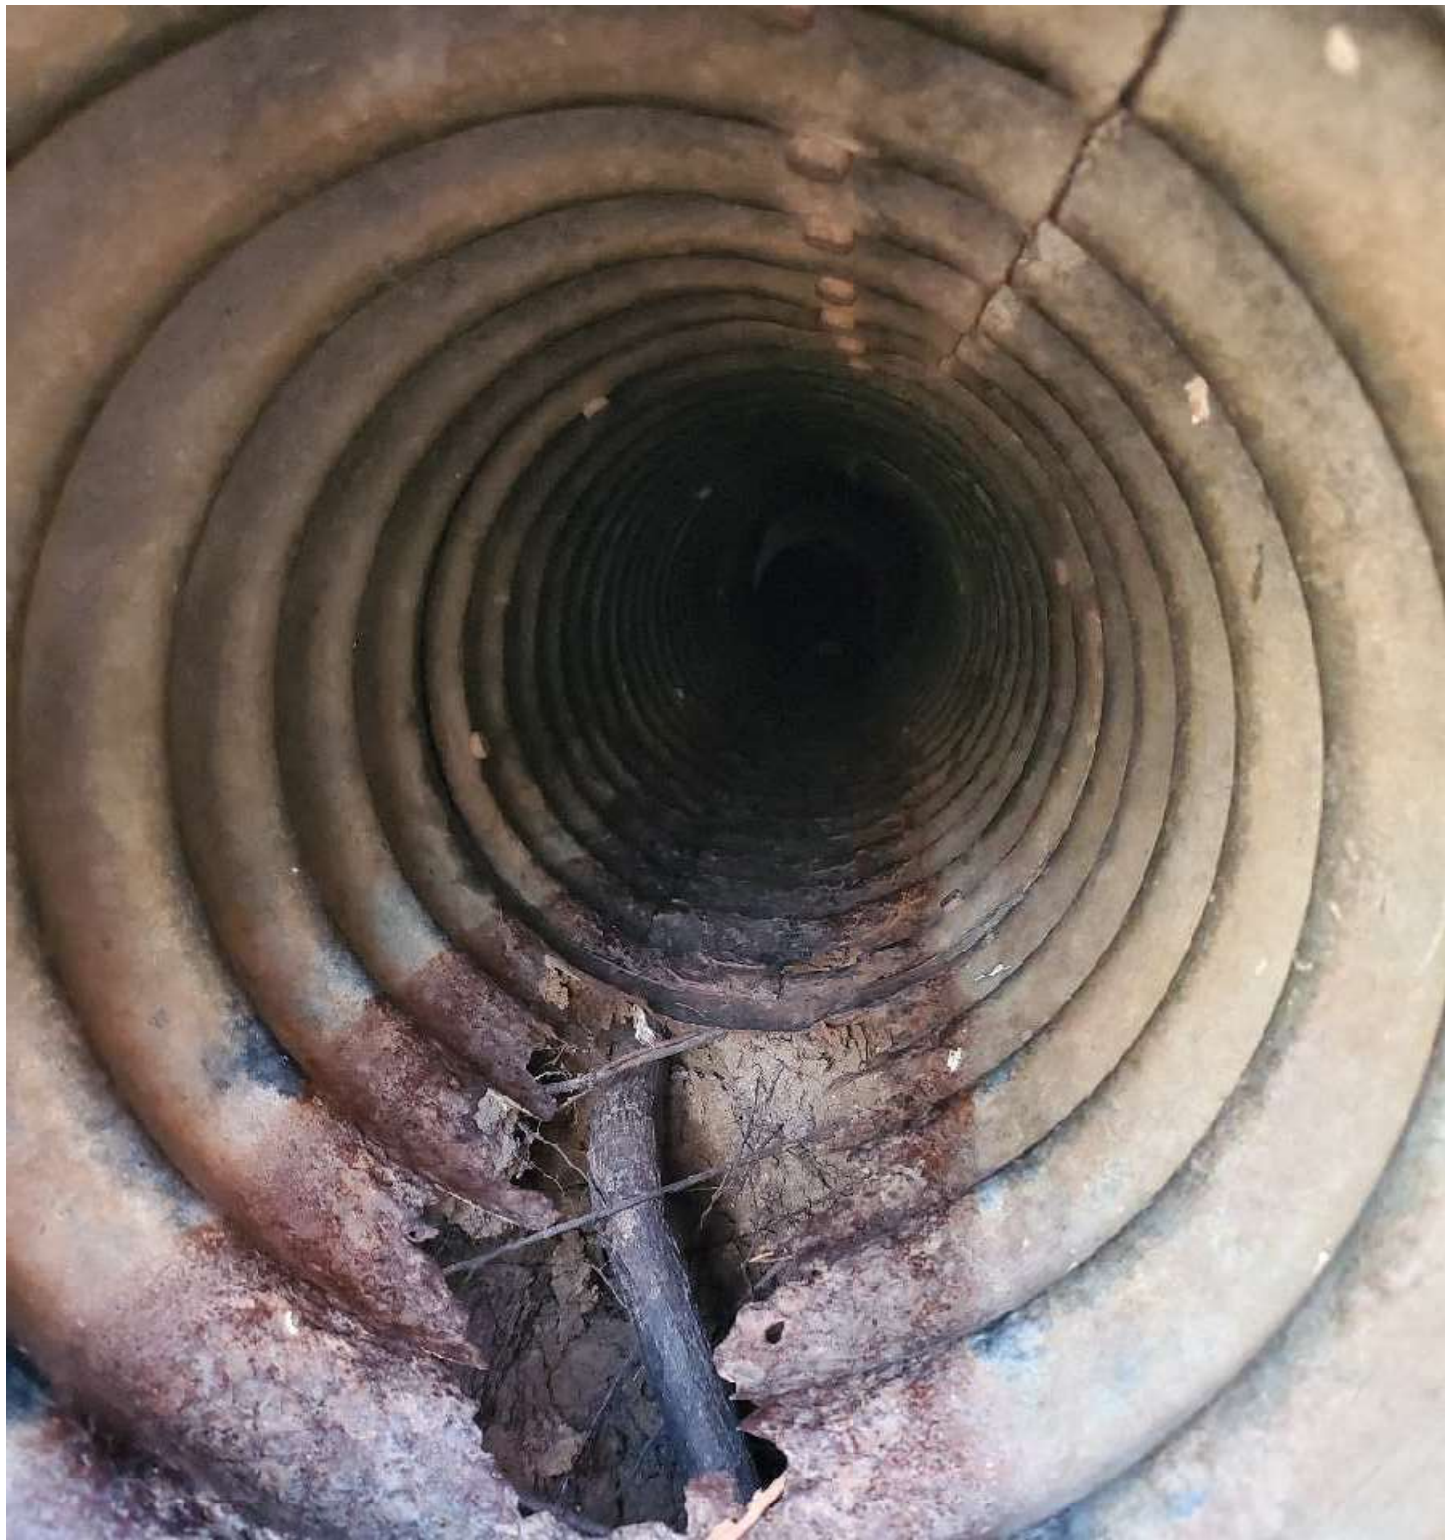
Object ID 261-Off of Maria St

261	Corrugated	10	Poor	1 - Severe Erosion (>5ft)	10 ft	\$ 100,000	Off of Maria	Severe erosion occurring outside the outfall pipe	Rusty with holes, may be broken off in the pipe
