# **The City of East Peoria Storm Water Management Plan**

December-2022

**Patrick N. Meyer & Associates, Inc.**

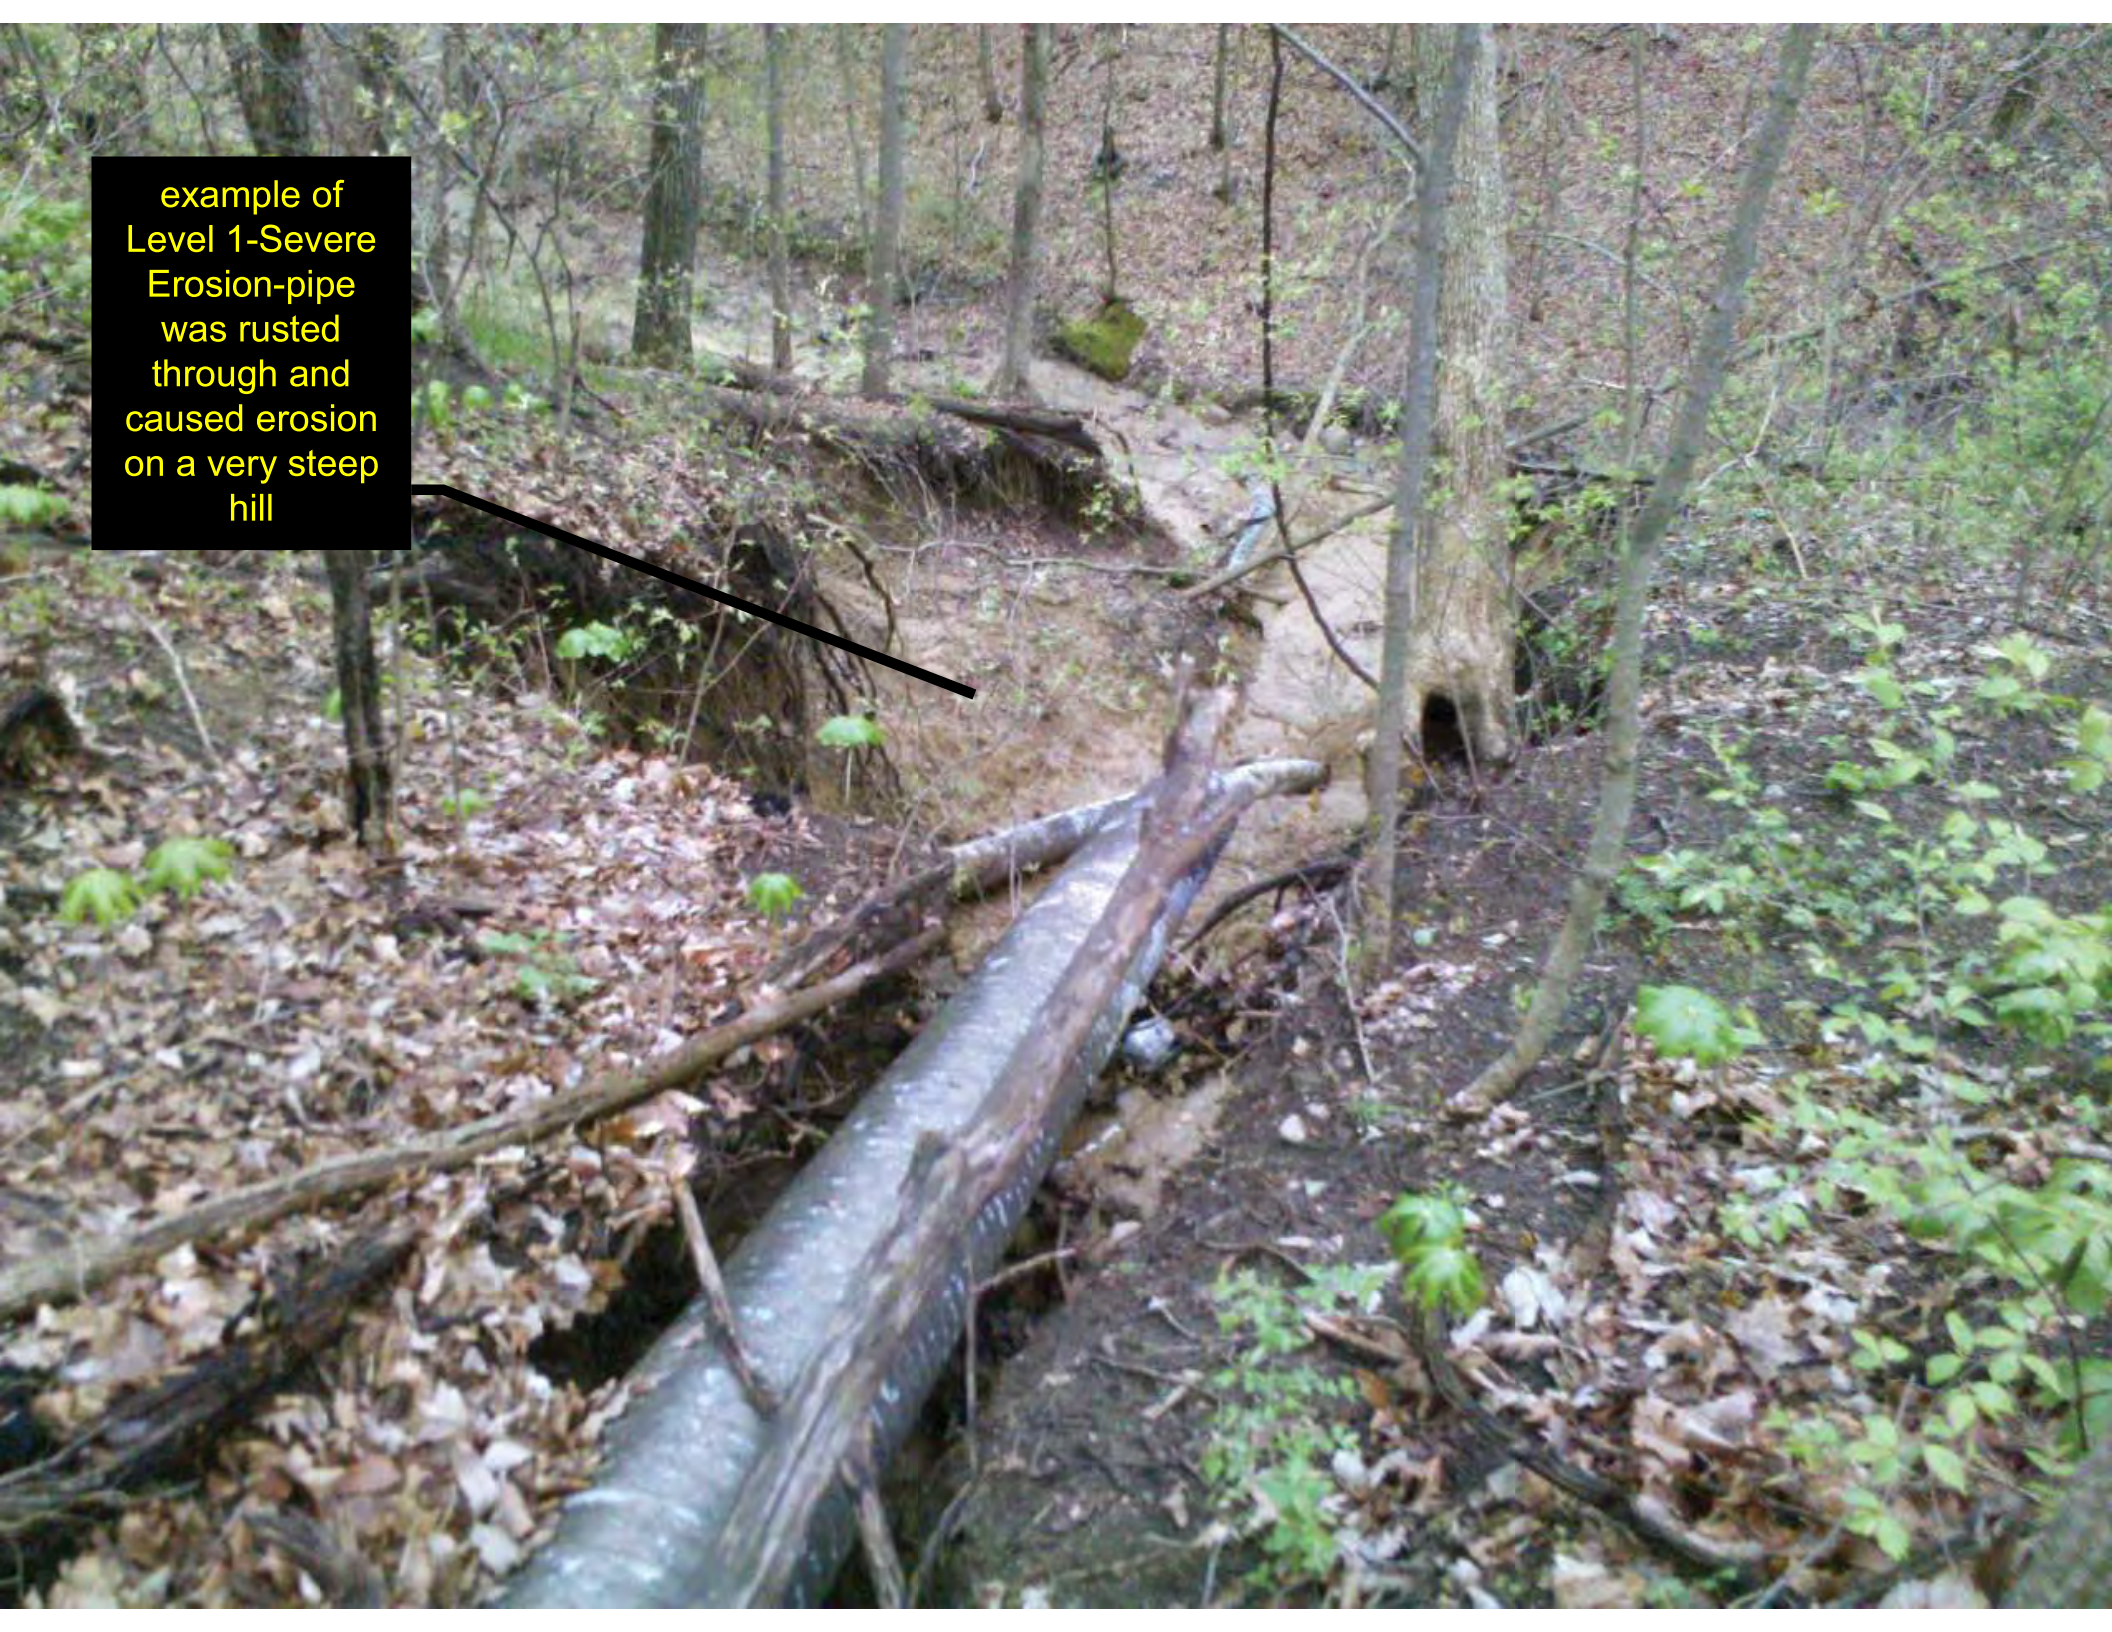
example of  
Level 1-Severe  
Erosion-pipe  
was rusted  
through and  
caused erosion  
on a very steep  
hill

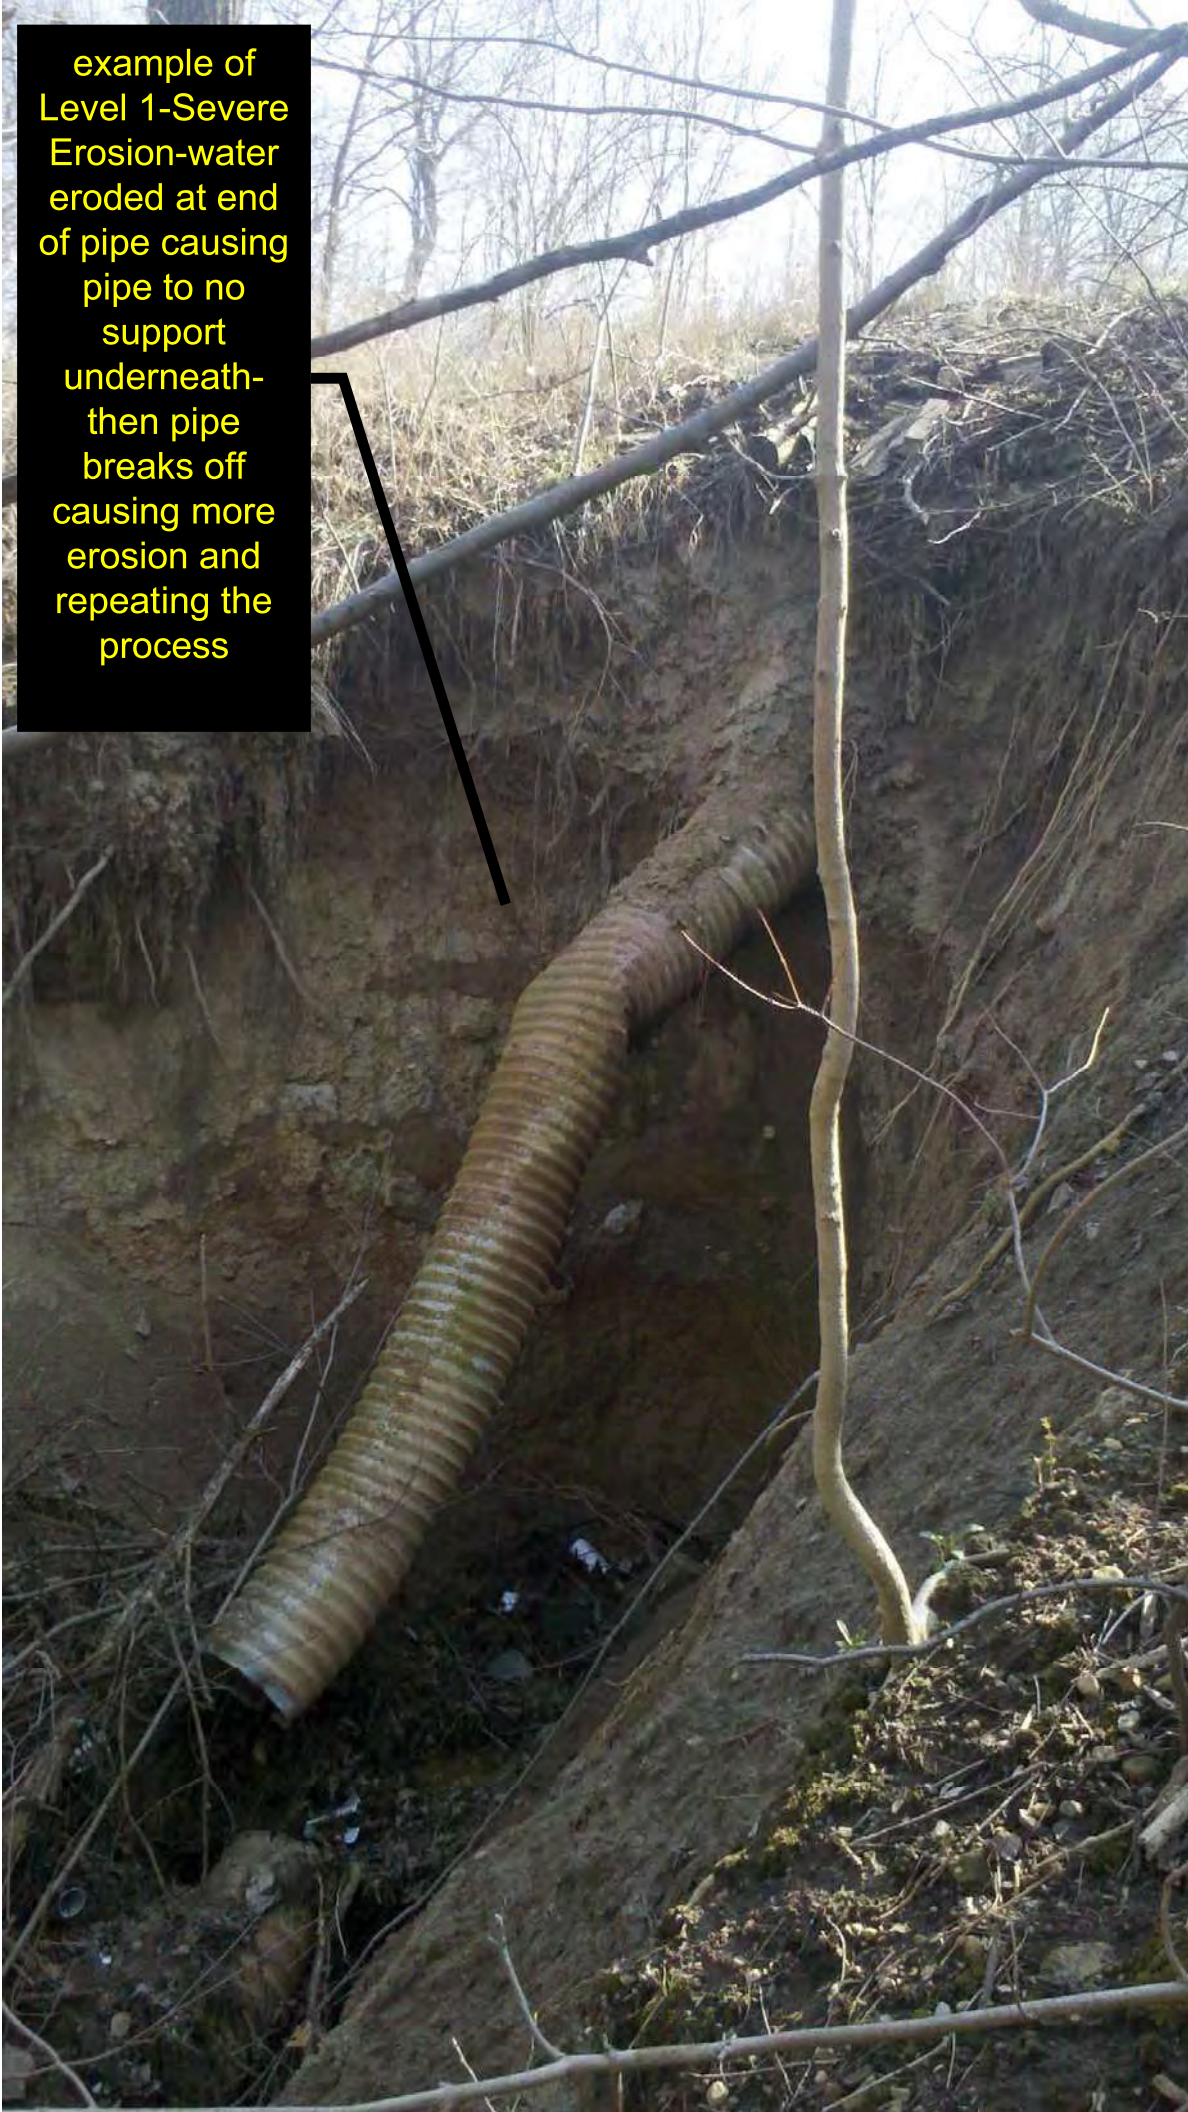
example of  
Level 1-Severe  
Erosion-water  
eroded at end  
of pipe causing  
pipe to no  
support  
underneath-  
then pipe  
breaks off  
causing more  
erosion and  
repeating the  
process

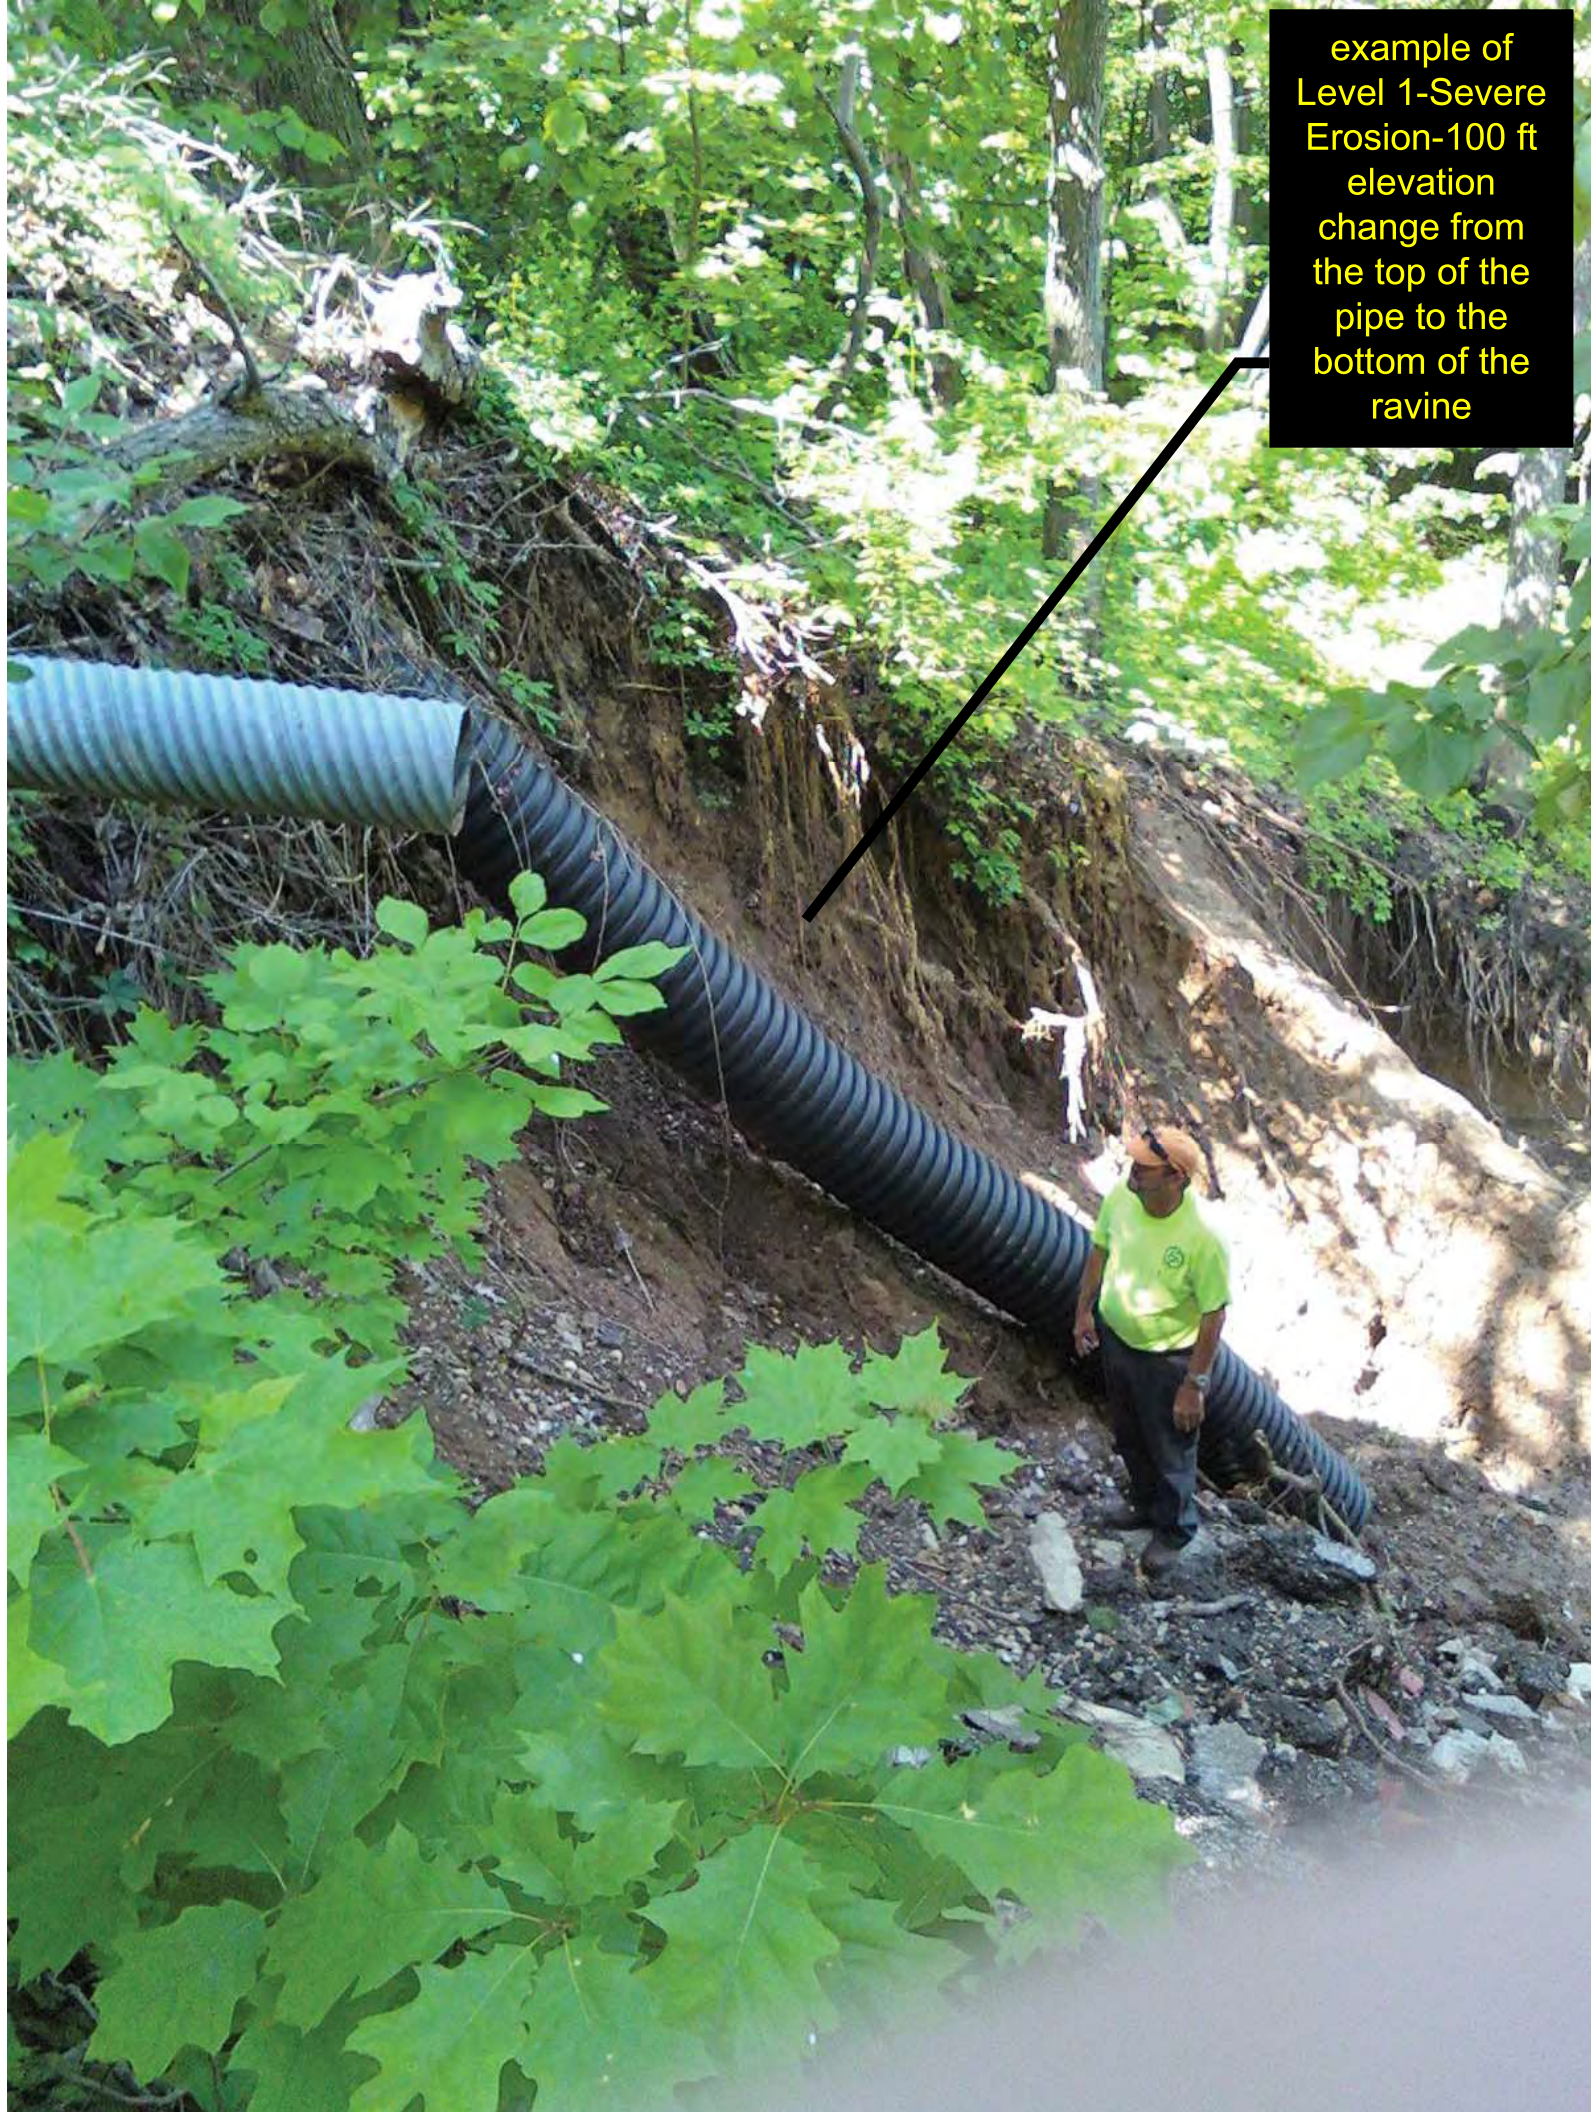
example of  
Level 1-Severe  
Erosion-100 ft  
elevation  
change from  
the top of the  
pipe to the  
bottom of the  
ravine

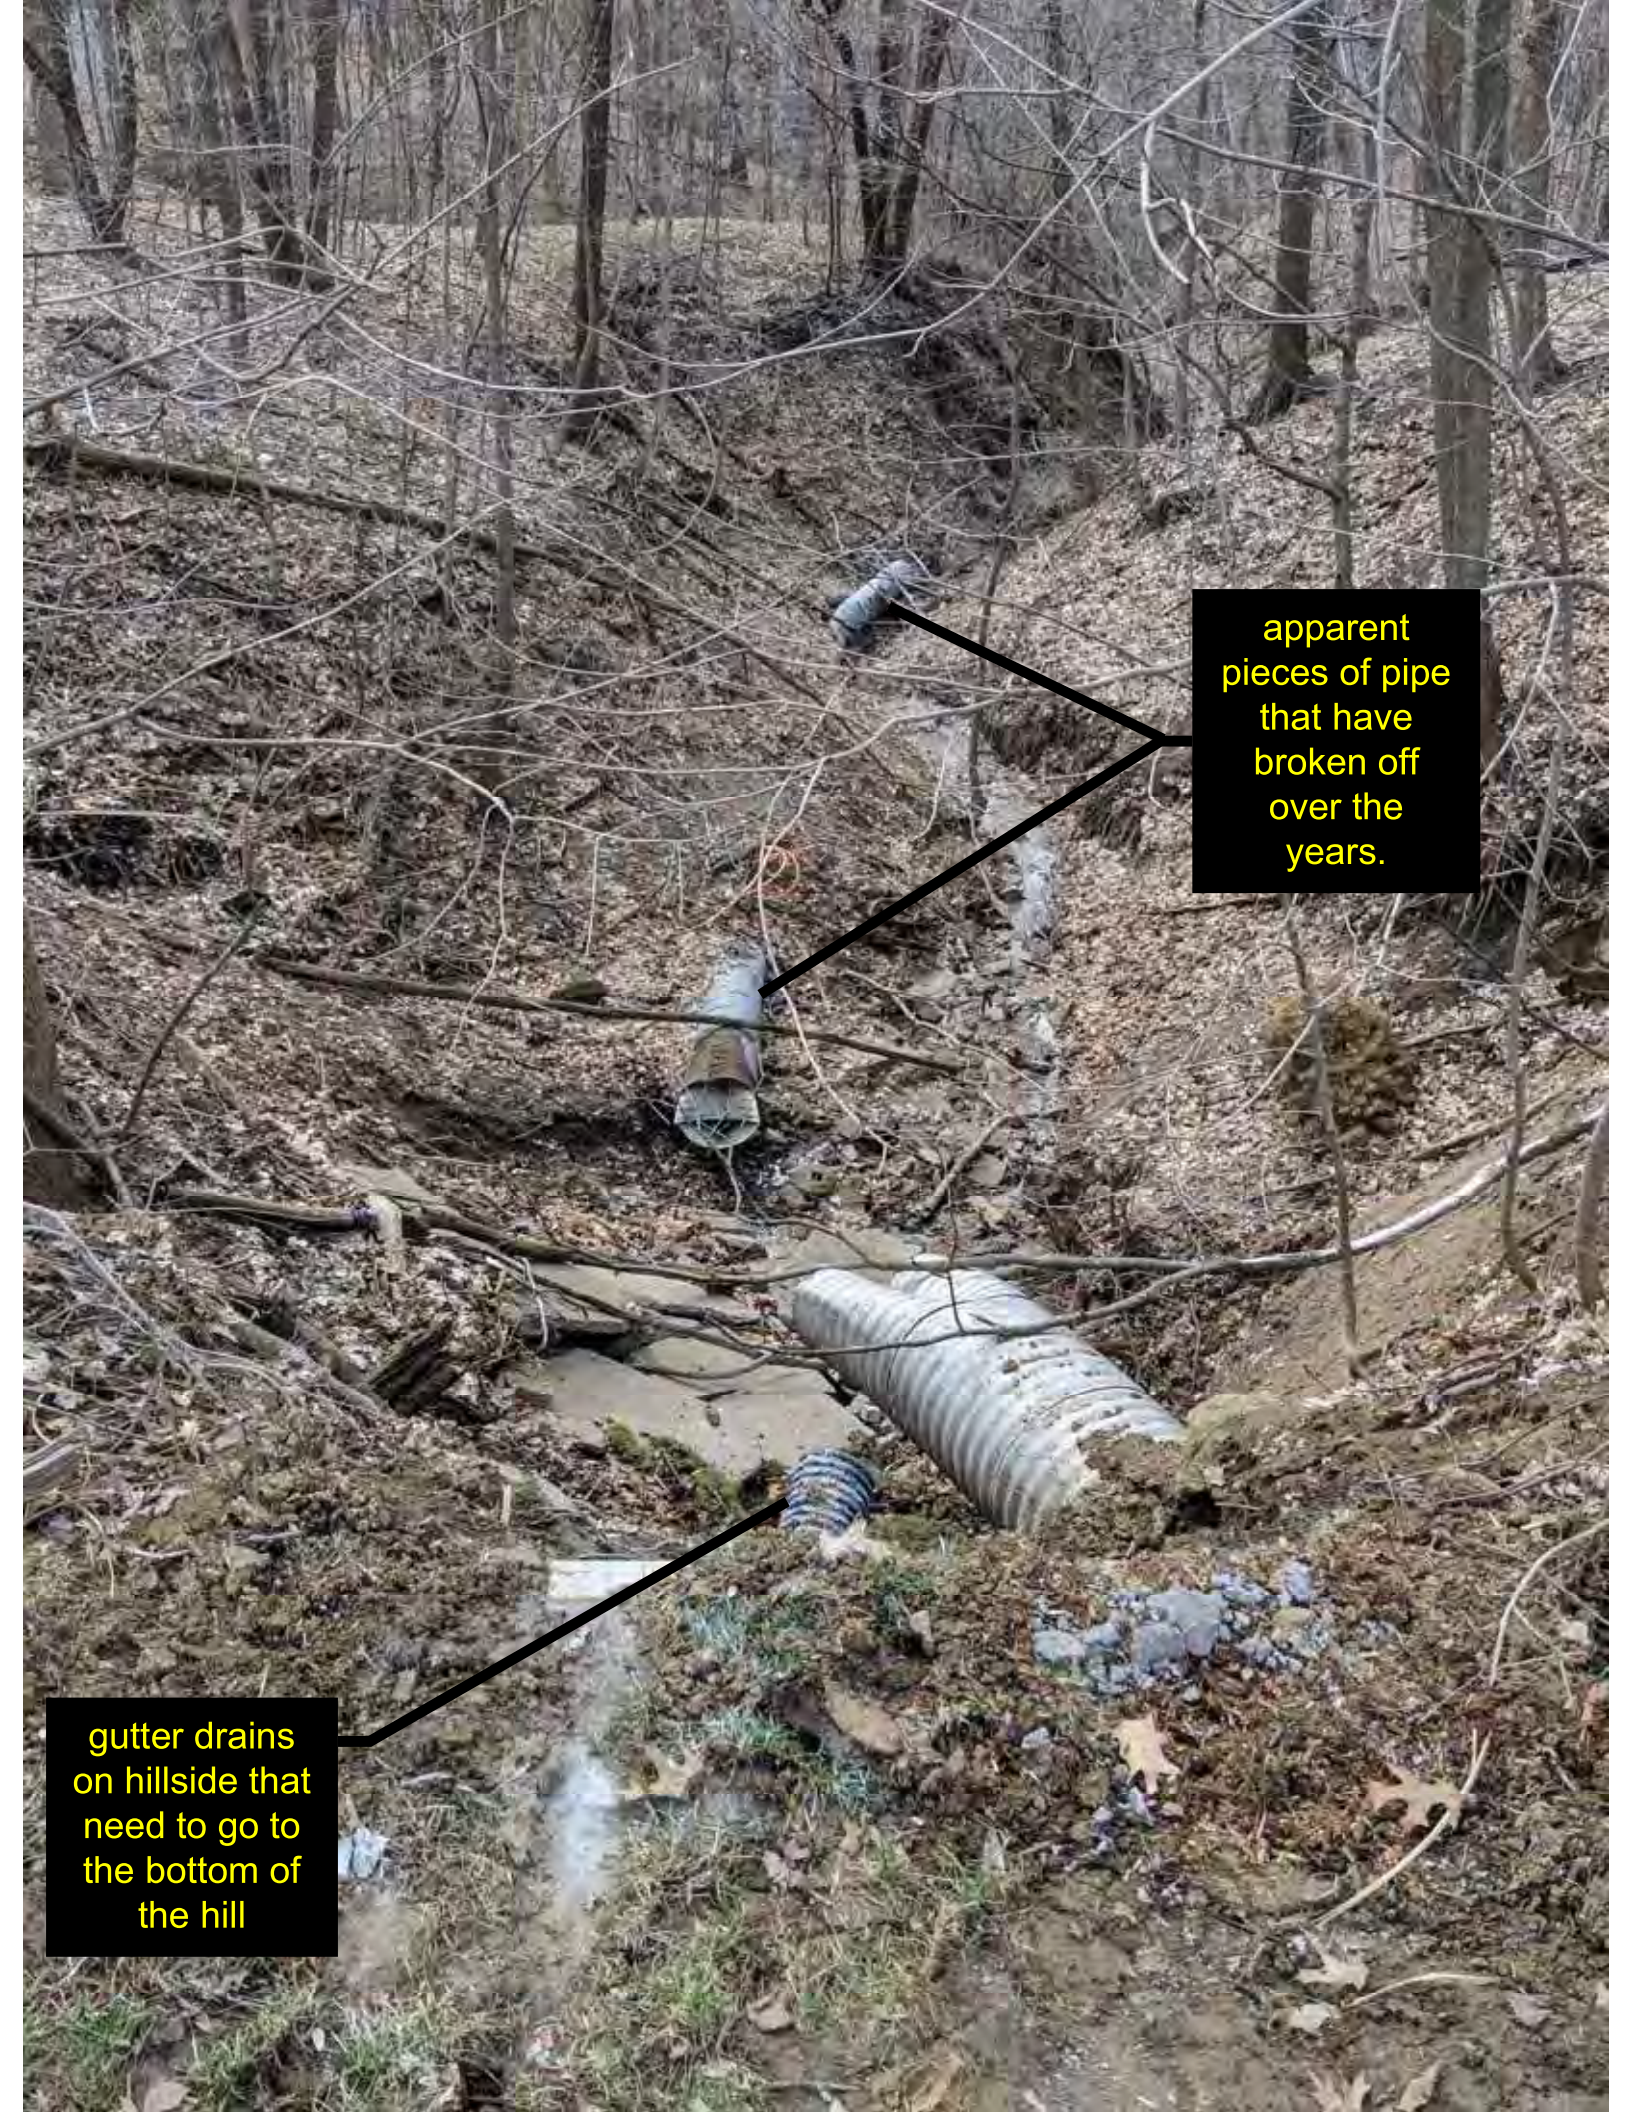
apparent  
pieces of pipe  
that have  
broken off  
over the  
years.

gutter drains  
on hillside that  
need to go to  
the bottom of  
the hill

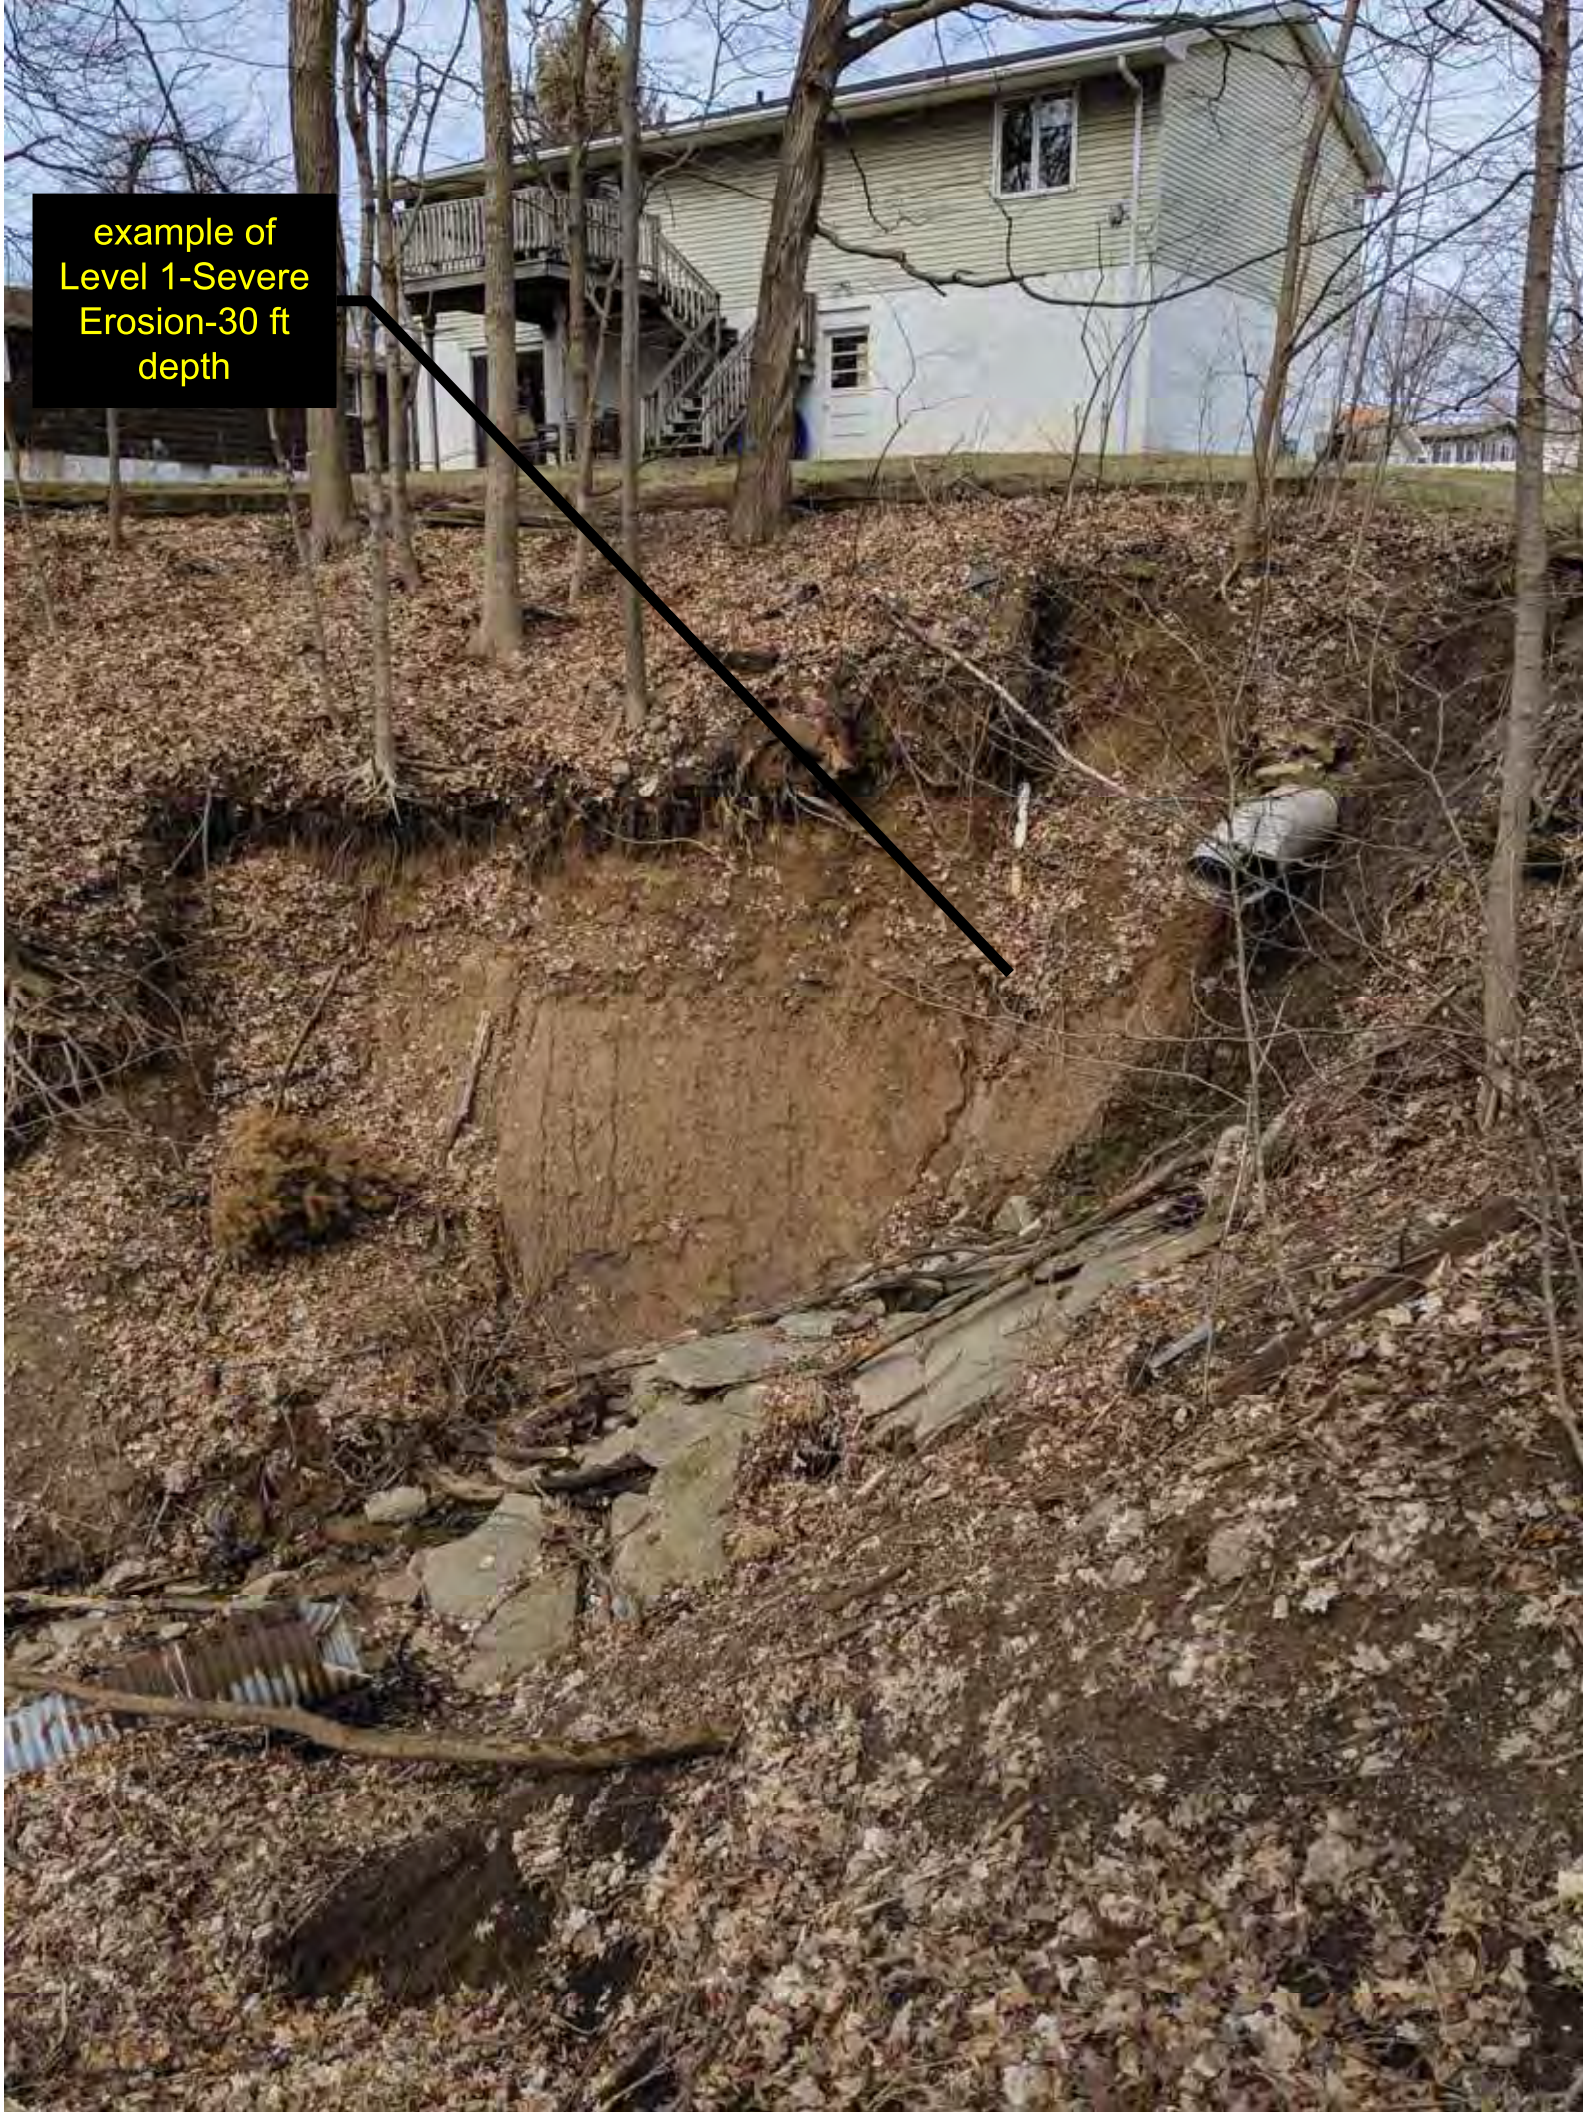
example of  
Level 1-Severe  
Erosion-30 ft  
depth

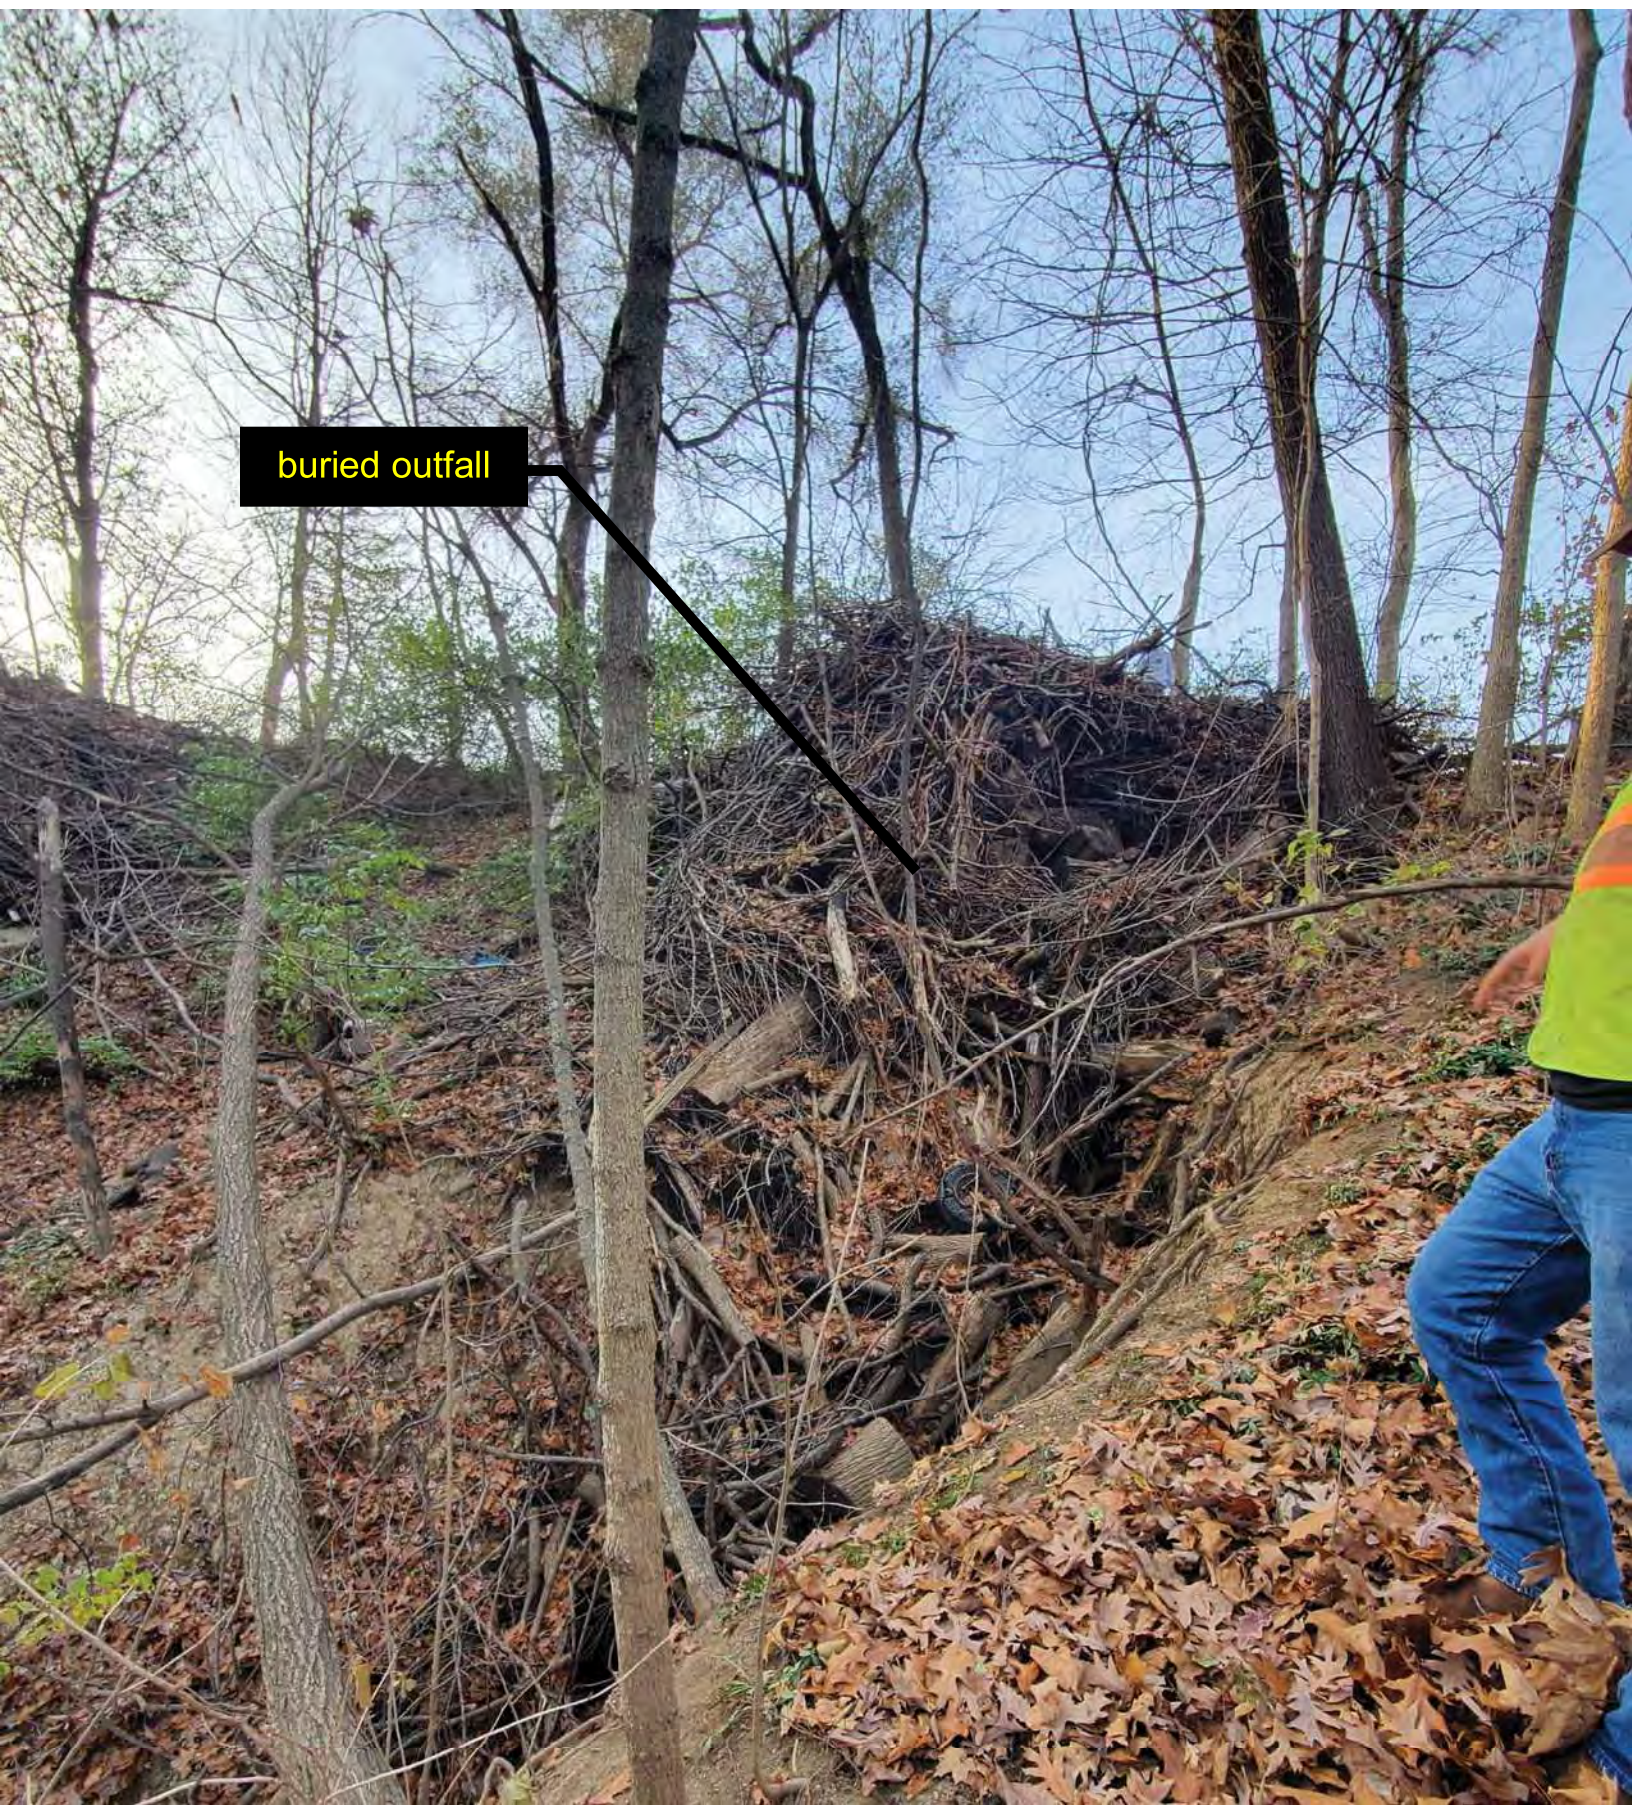
buried outfall

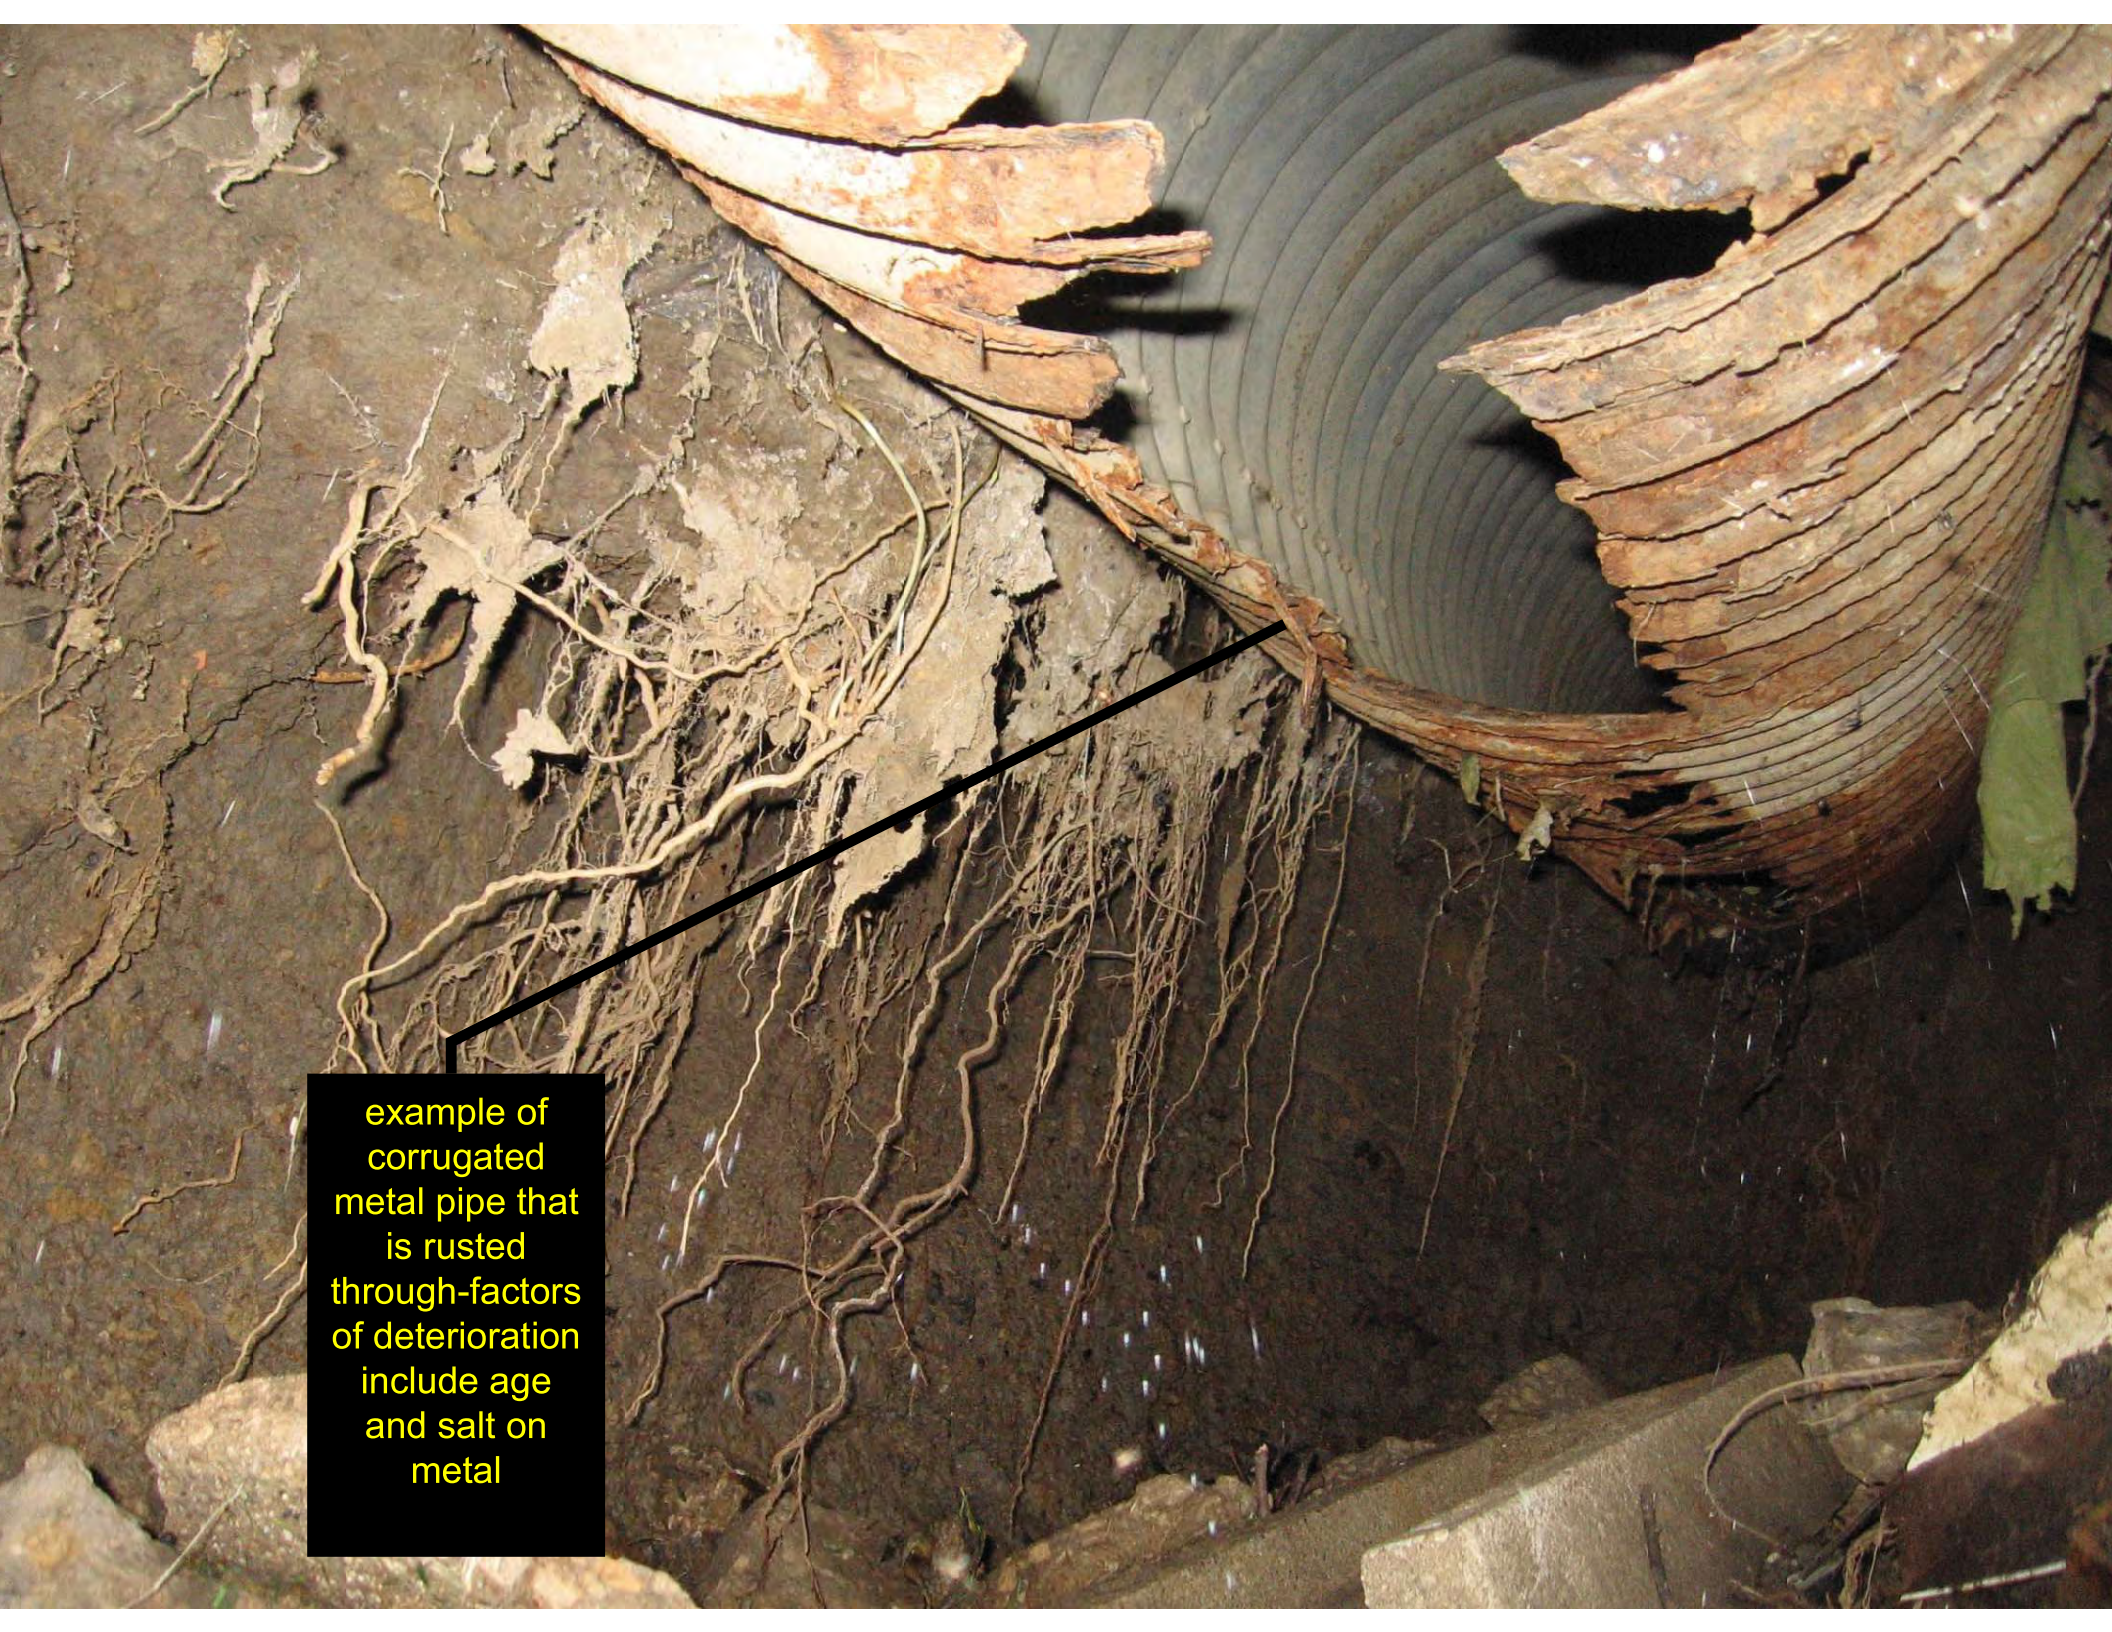
example of  
corrugated  
metal pipe that  
is rusted  
through-factors  
of deterioration  
include age  
and salt on  
metal

rehabilitation such as CIPP (Cured In Place Piping). CIPP is simply installing a liner in an existing pipe without digging. See **Exhibit H** for an example of a deteriorated CMP. **Exhibit I** contains CIPP projects.
