# **The City of East Peoria Storm Water Management Plan**

December-2022

**Patrick N. Meyer & Associates, Inc.**

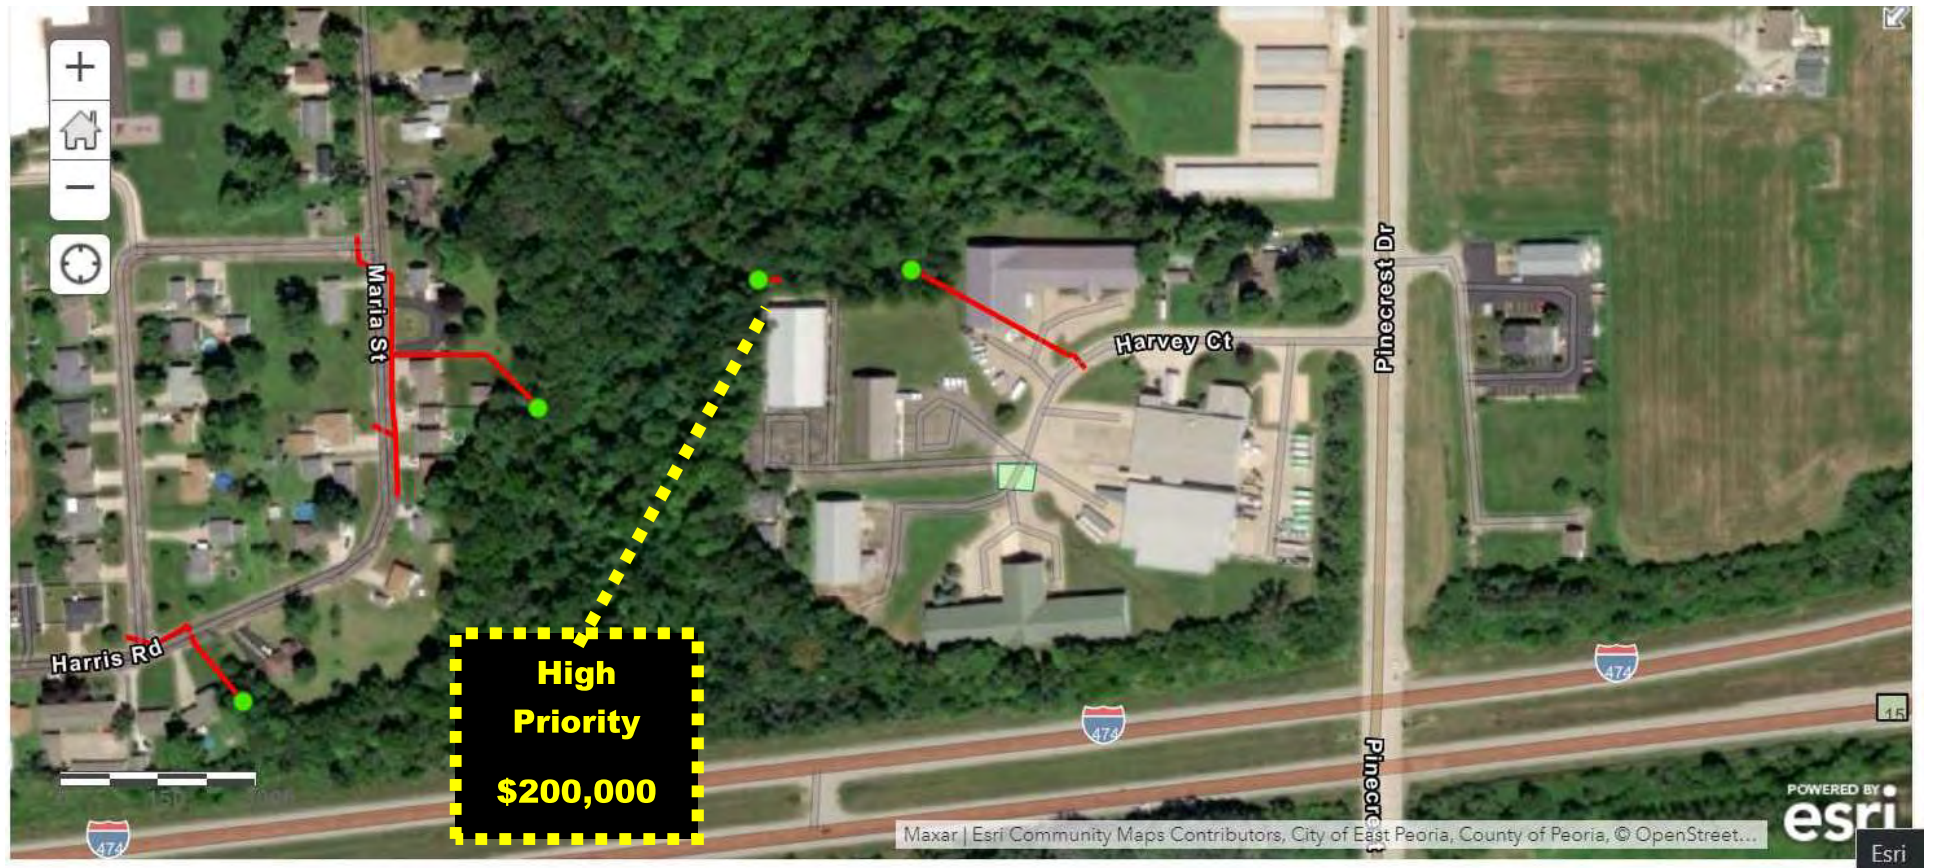
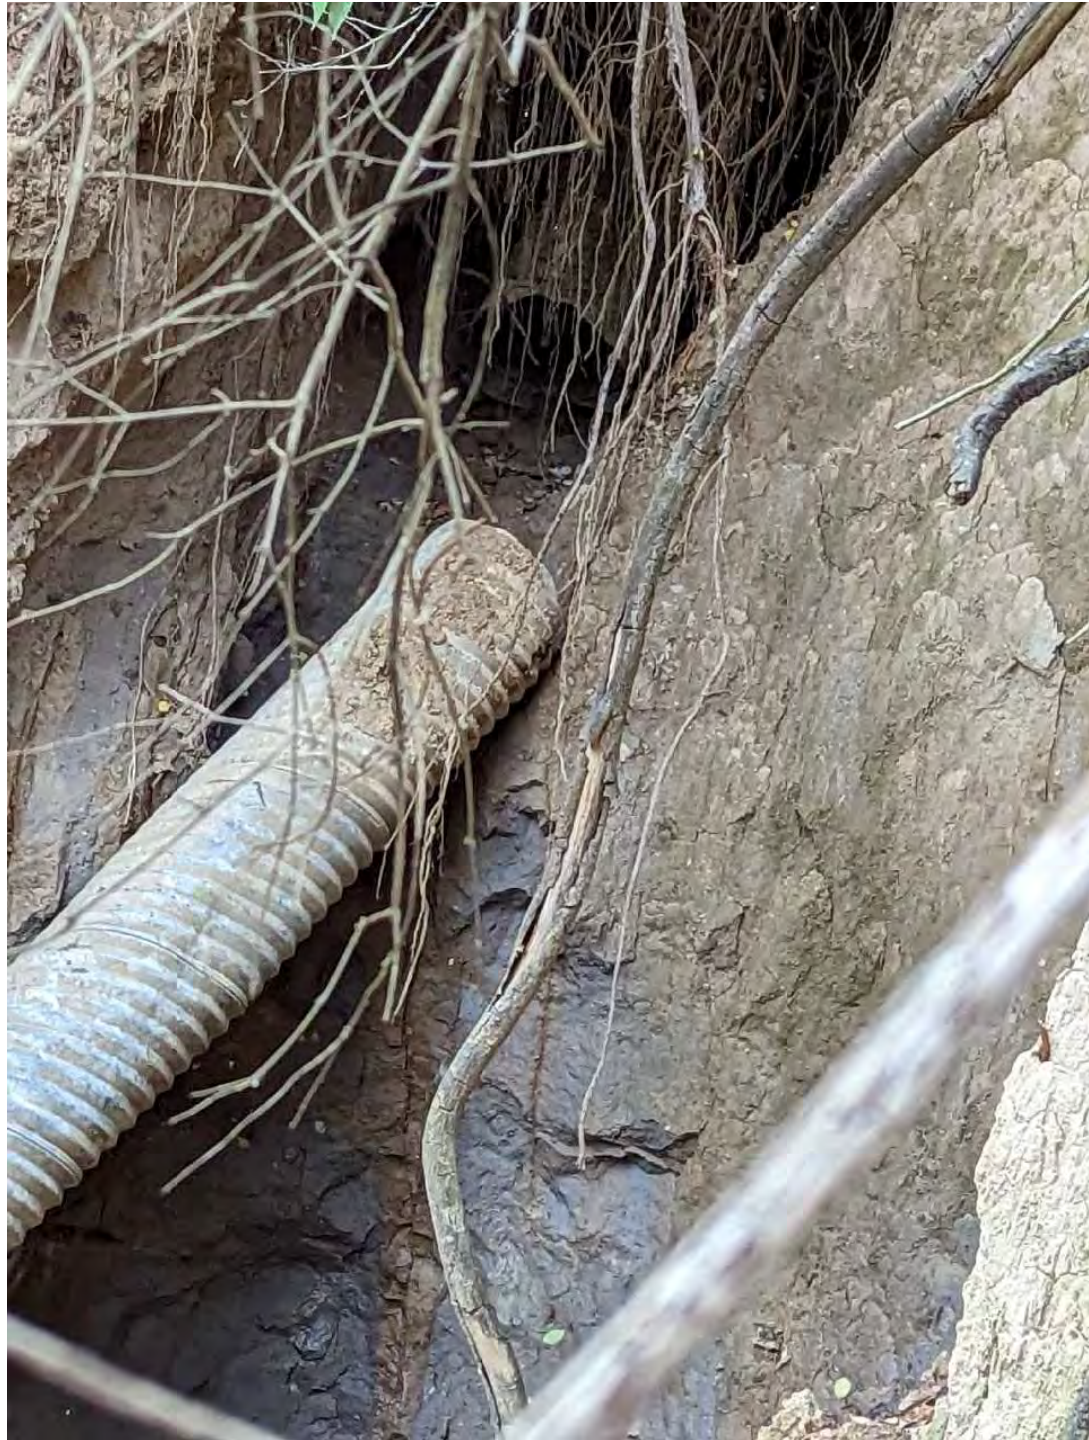
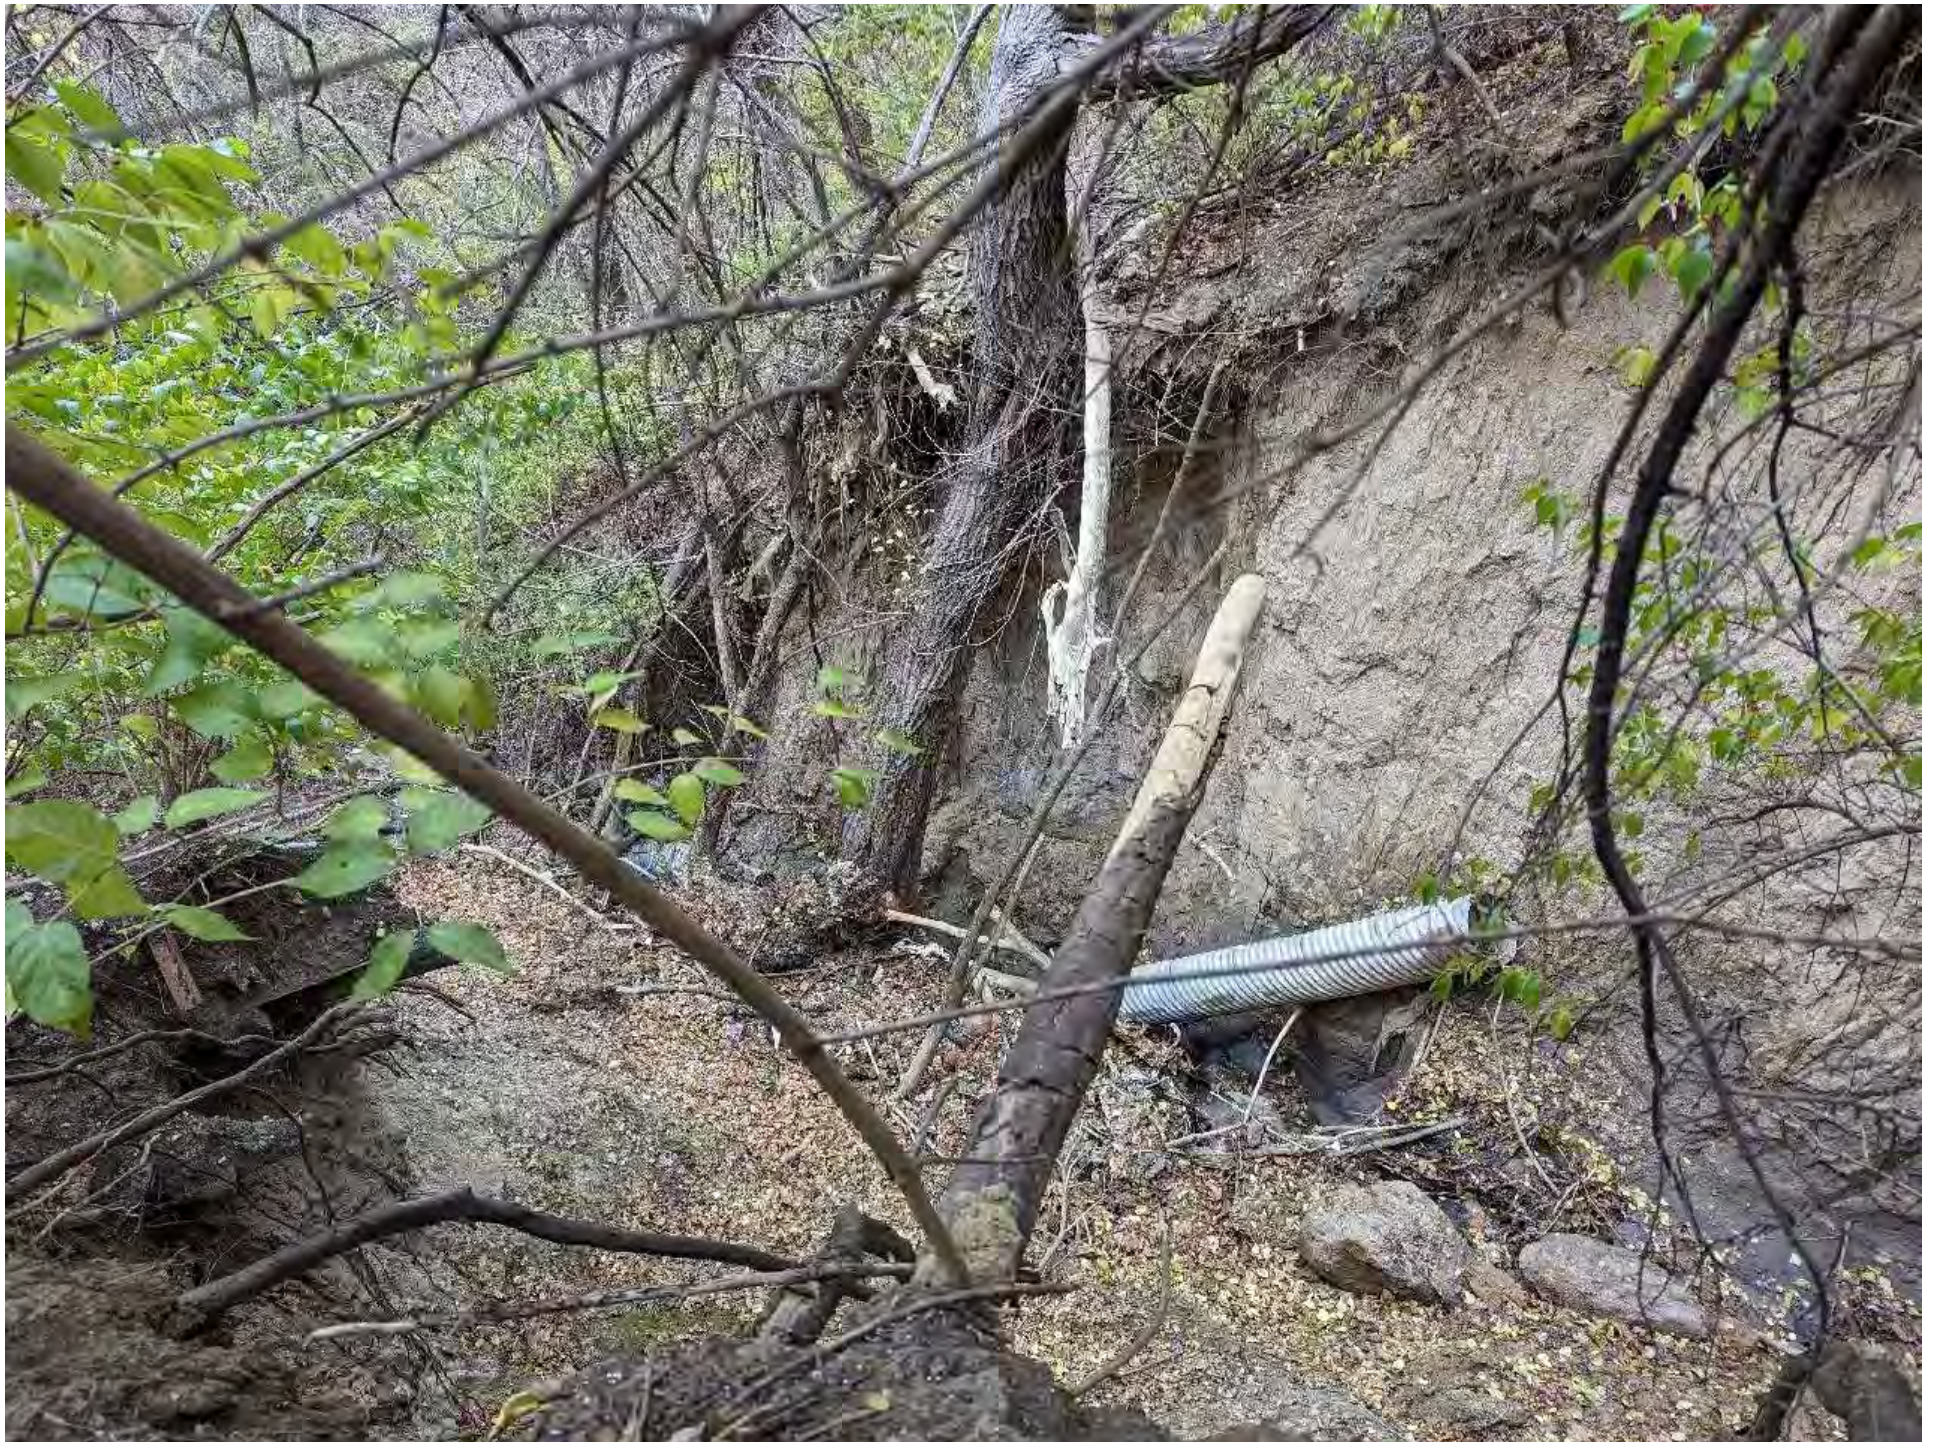
## Object ID 232-Off of Harvey Ct

OBJECTID	Material Type	Diameter (inches)	Pipe Condition	Erosion Condition	Depth of Erosion (ft)	Cost	Location	VI - Other Comments?	Notes
232	Corrugated	15	Very Poor	1 - Severe Erosion (>5ft)	30 ft	\$ 200,000	Off of Harvey	The pipe has extremely SEVERE erosion occurring, up to 30 ft	Pipe sections are coming apart and is in proximity of building
10	Corrugated	18	Very Poor	1 - Severe Erosion (>5ft)	20ft plus	\$ 200,000	Off of Centennial Hill	The pipe has bad rust and is broken near the bottom of the pipe... Also, the end section fell off	There is extreme erosion on the hillside behind the pipe, creeping towards the road... Also, not completely sure on the pipe size, somewhere close to a 18" pipe
92	Corrugated	24	Very Poor	1 - Severe Erosion (>5ft)	14-15 ft	\$ 75,000	Off of Illini	Severe erosion up to 14-15 ft and little to no standing water	The pipe itself is in good shape but parts of the pipe have come off due to erosion

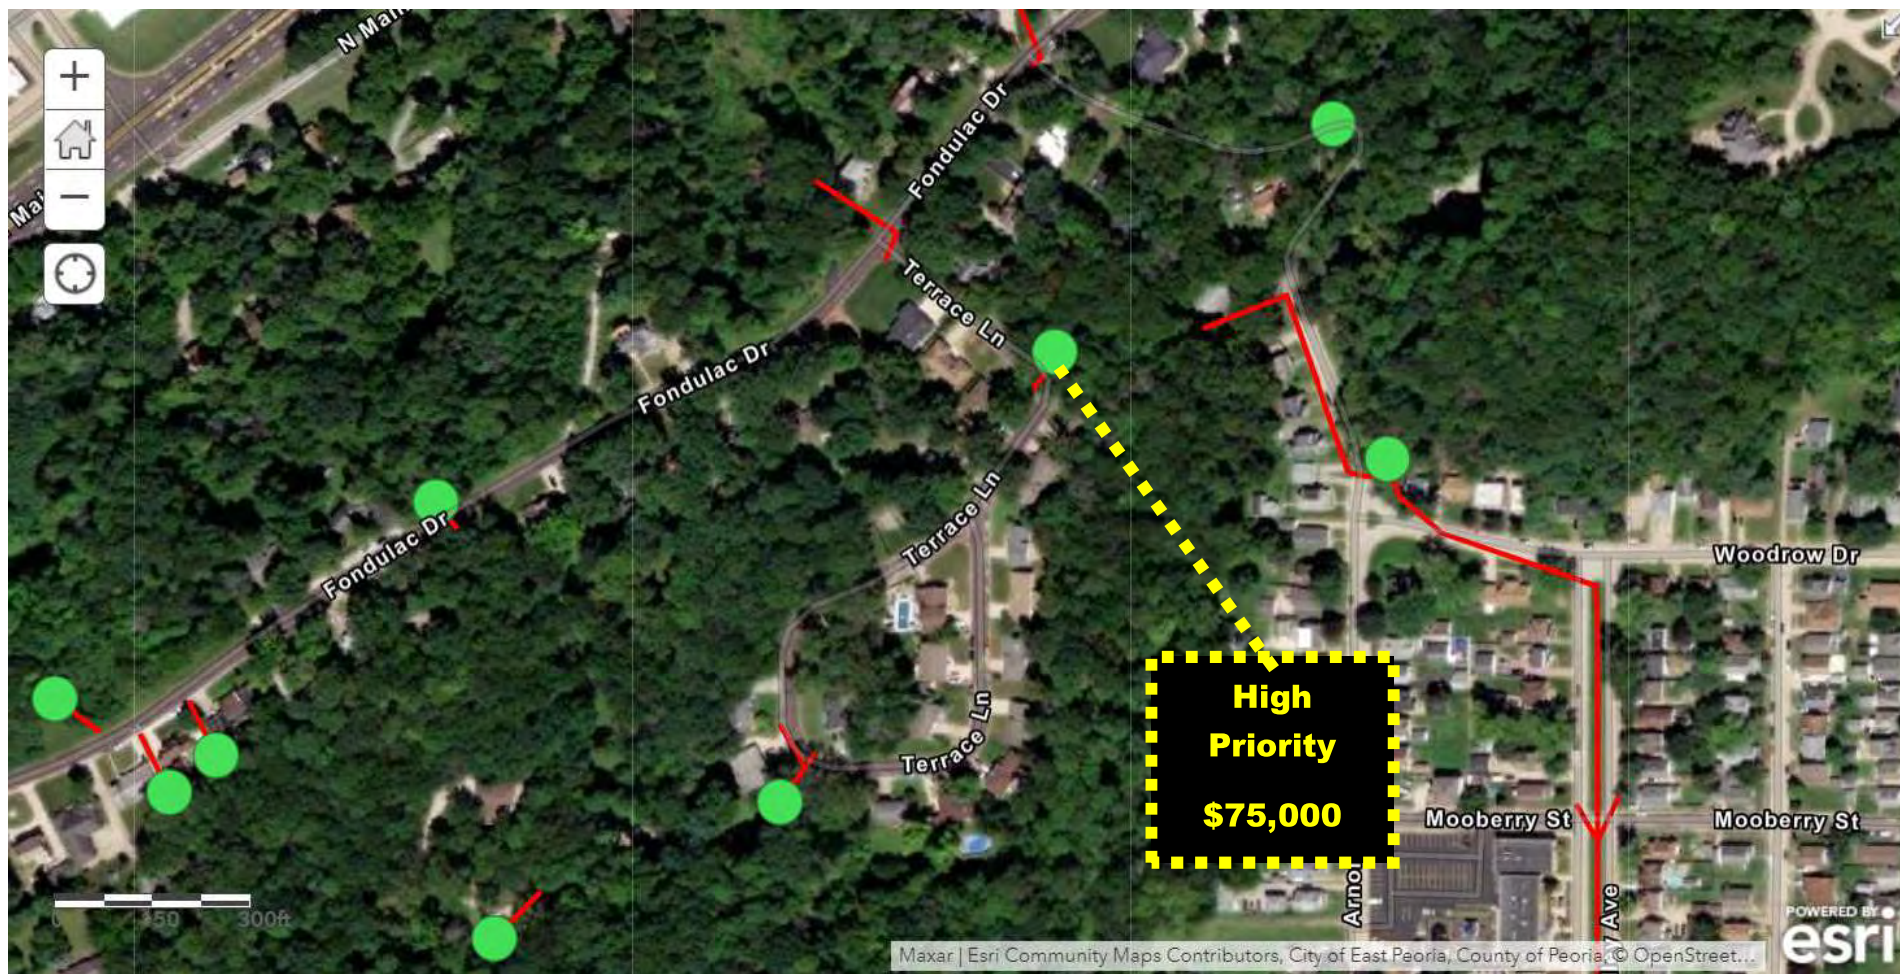
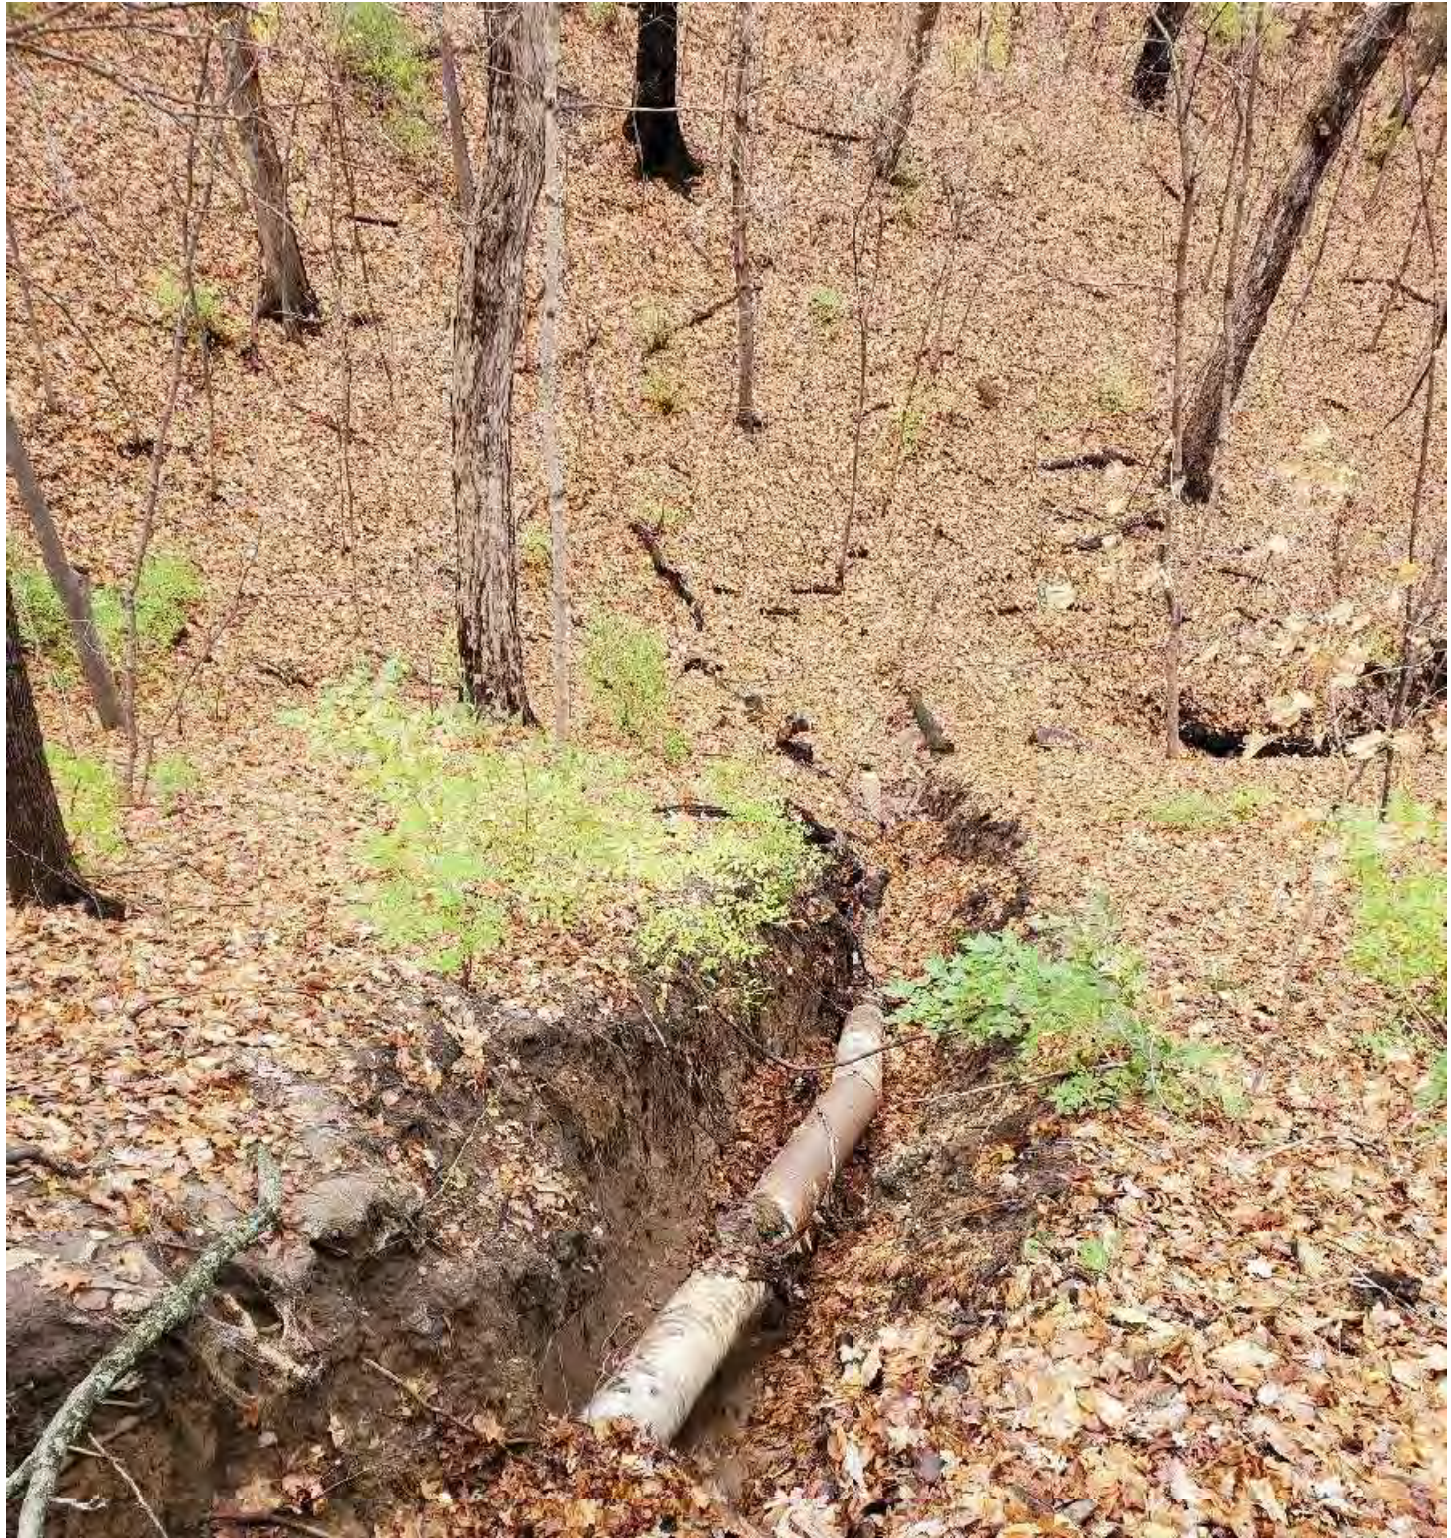
## Object ID 194-Off Terrace Ln

194	Corrugated	18	Poor	1 - Severe Erosion (>5ft)	15 ft	\$ 75,000	Off of Terrace Ln	This outfall has SEVERE erosion	The pipe is rusting
260	Steel	13	Poor	1 - Severe Erosion (>5ft)	15 ft	\$ 75,000	Off of Maria	Televised!	The pipe is rusted
214	Corrugated	15	Very Poor	1 - Severe Erosion (>5ft)	10-12 ft	\$ 75,000	Off of Springfield Rd	The pipe has severe erosion up to 10-12 ft	The pipe is rusting bad causing severe erosion
263	Corrugated	12	Fair	1 - Severe Erosion (>5ft)	12	\$ 75,000	Off of Maria	There is major erosion at the outfall due to break in pipe	Pipes been broken in places and is eroding
94	Corrugated	18	Very Poor	1 - Severe Erosion (>5ft)	9-10	\$ 150,000	Off of Illini	9-10 feet of erosion, no standing water	Belly of pipe is completely rusted out and is completely falling apart as it's coming off the hillside.
166	Corrugated	24	Poor	1 - Severe Erosion (>5ft)	10 ft	\$ 150,000	Off of Oakwood	Bad erosion around the outfall	The pipe bottom is rusted

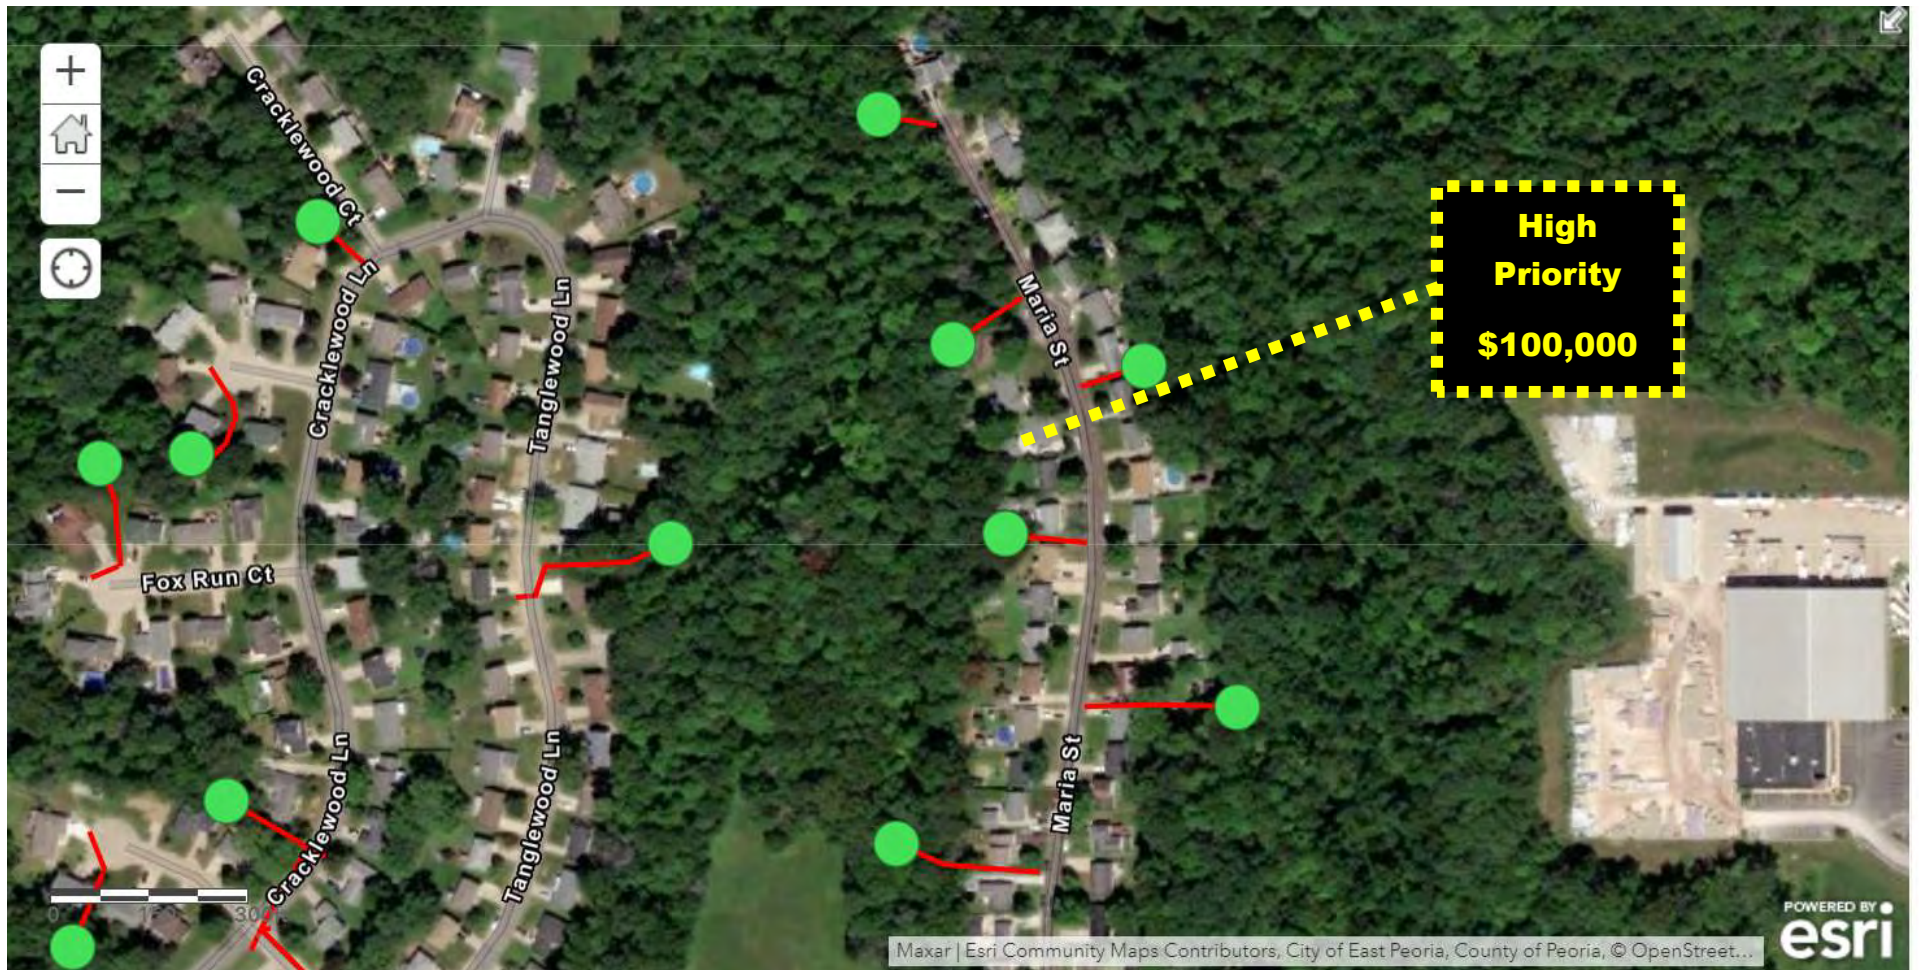
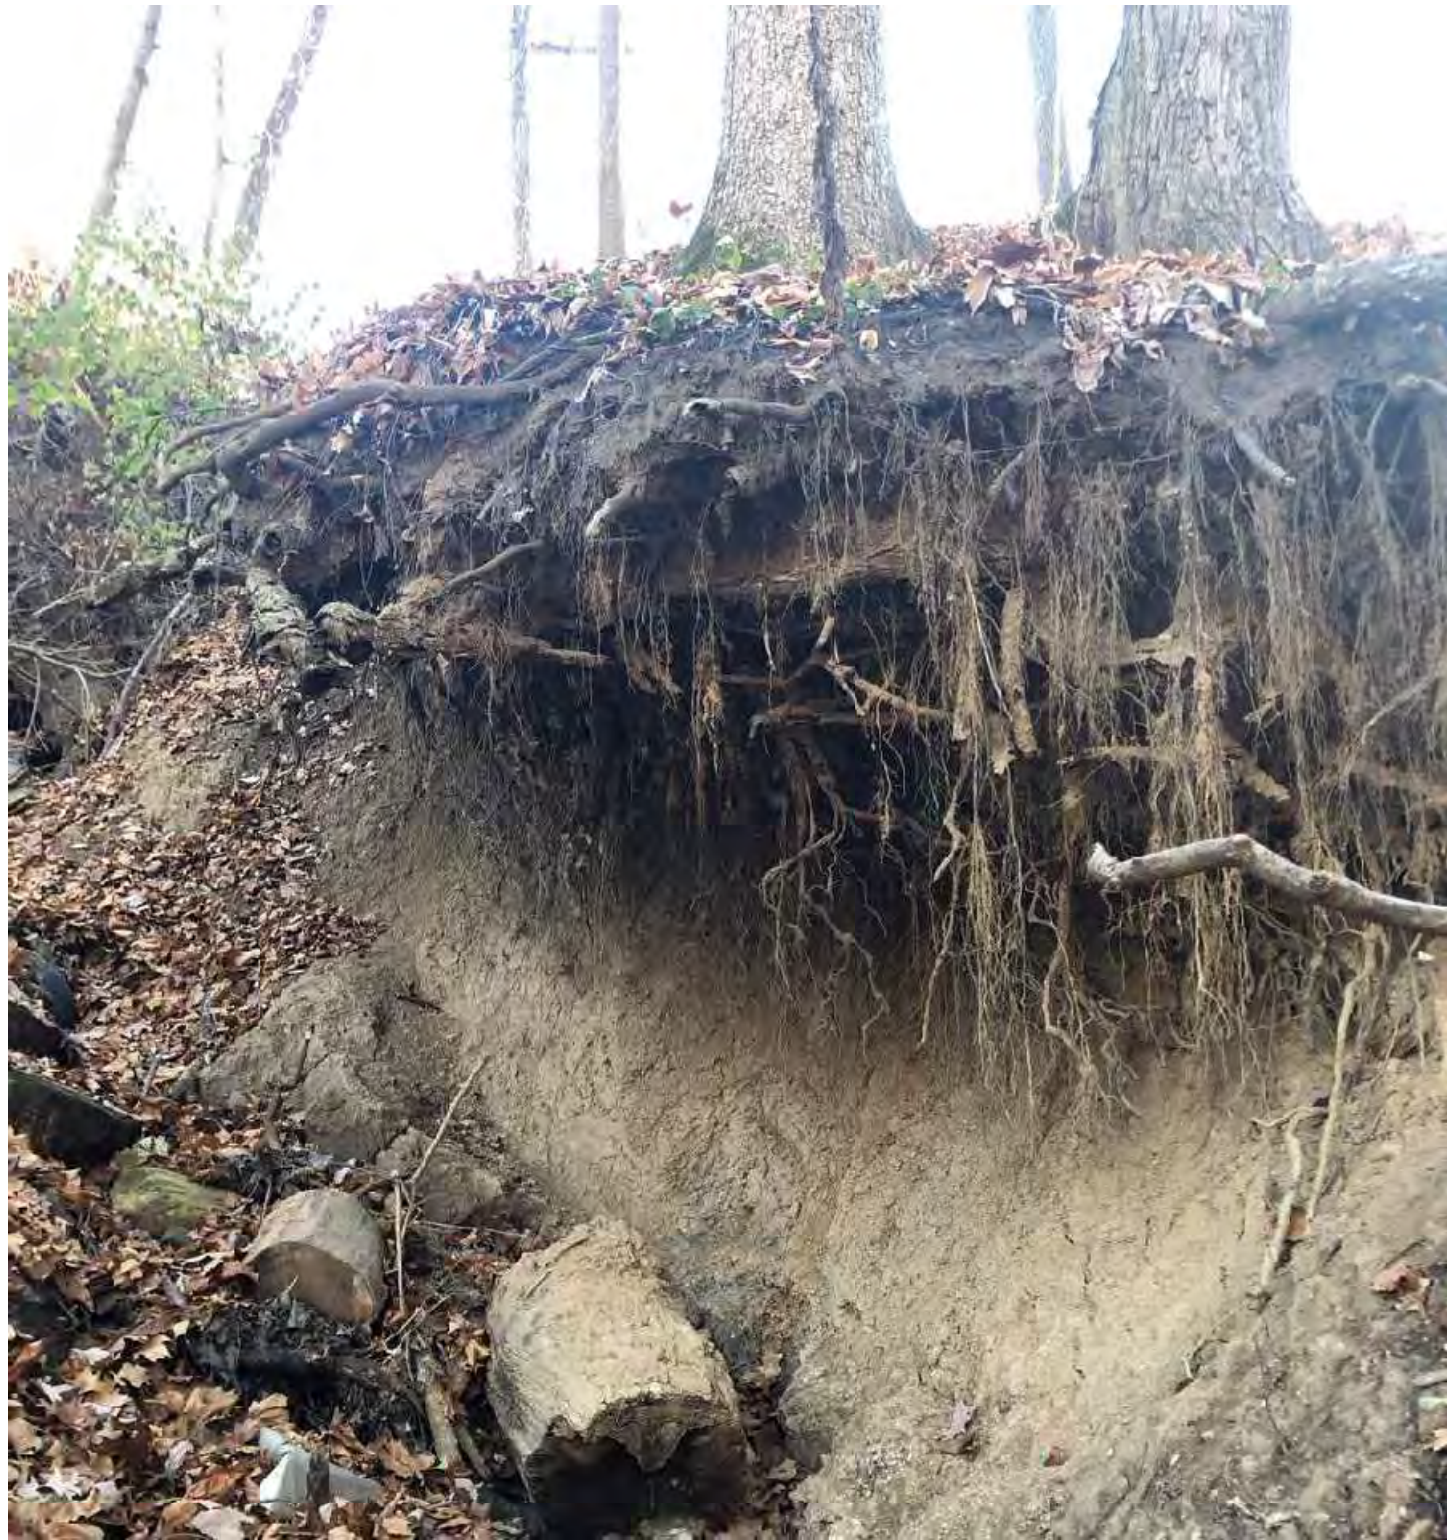
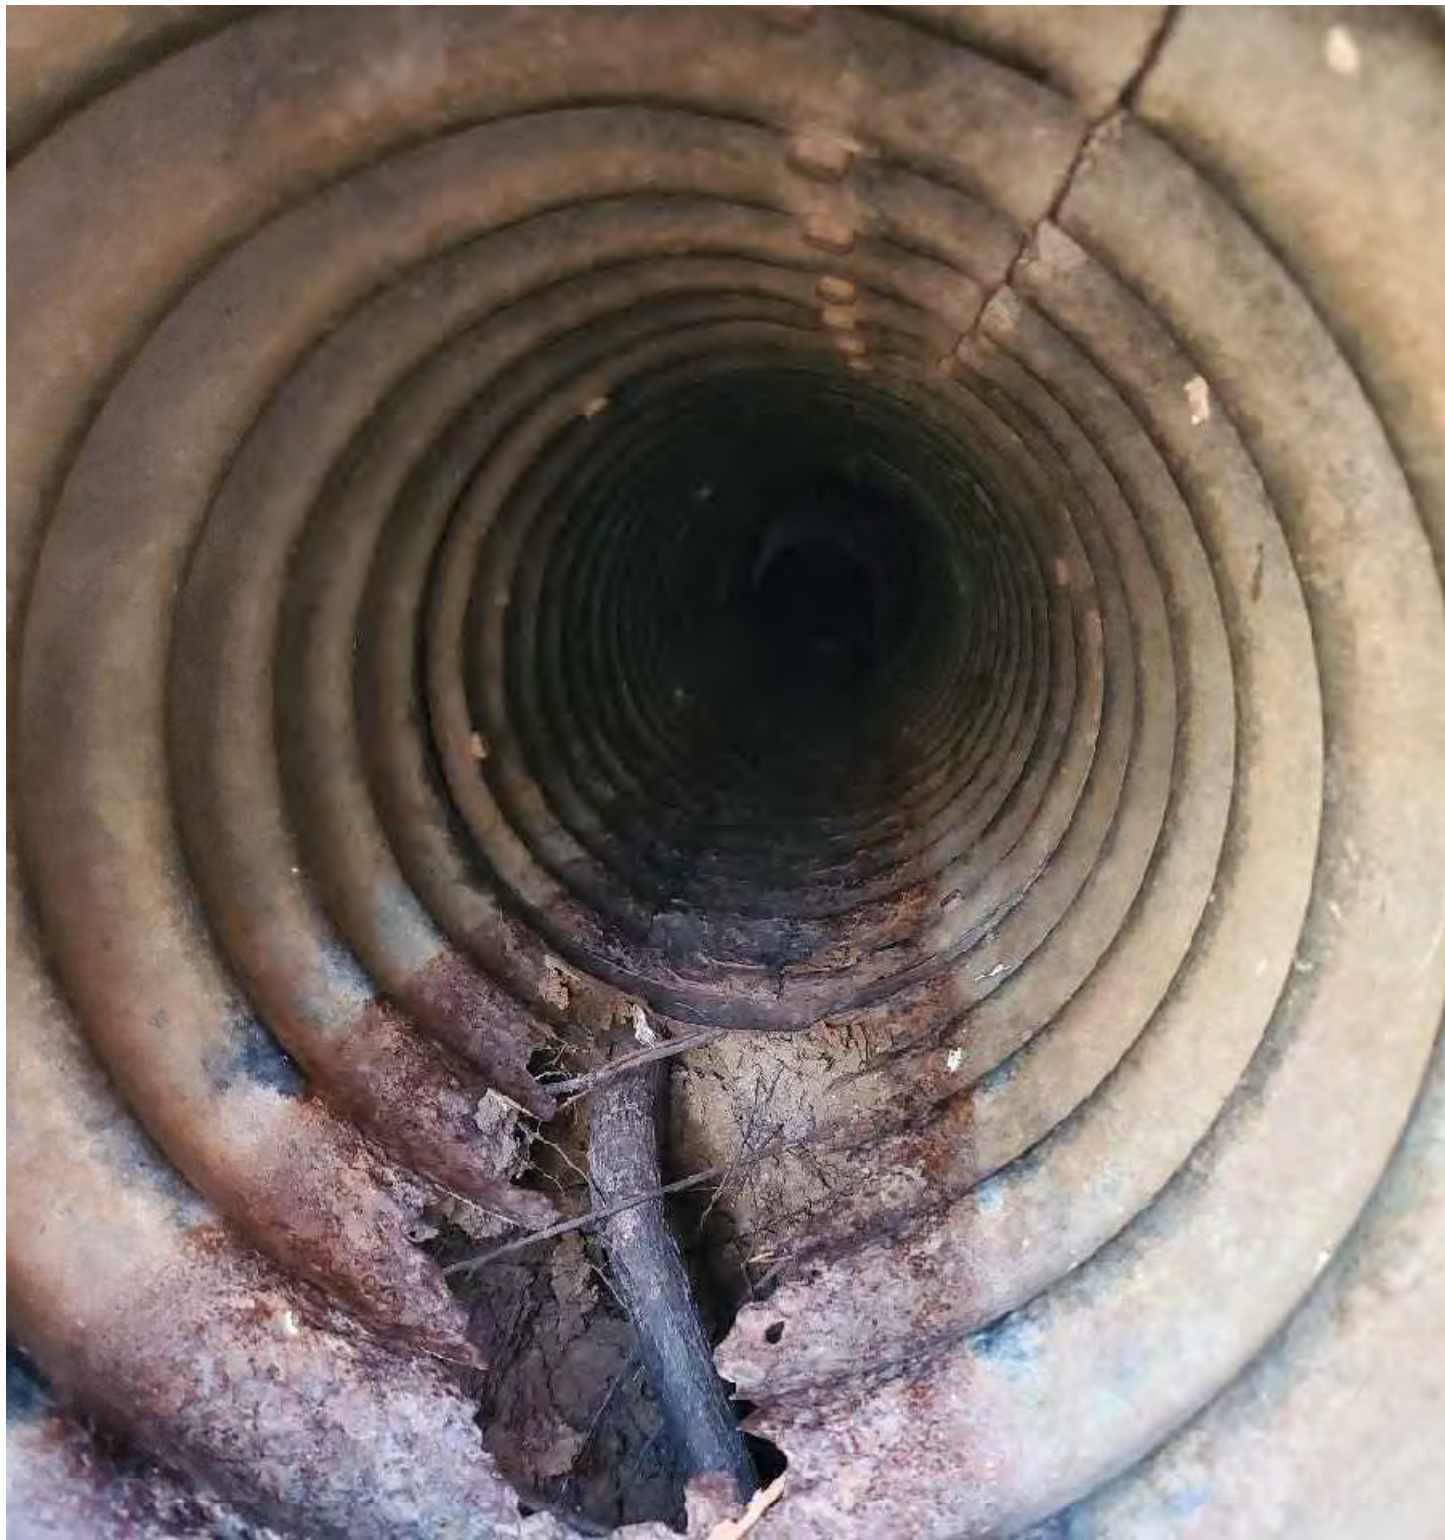
## Object ID 261-Off of Maria St

261	Corrugated	10	Poor	1 - Severe Erosion (>5ft)	10 ft	\$ 100,000	Off of Maria	Severe erosion occurring outside the outfall pipe	Rusty with holes, may be broken off in the pipe
