# **The City of East Peoria Storm Water Management Plan**

November - 2025

**Patrick N. Meyer & Associates, Inc.**

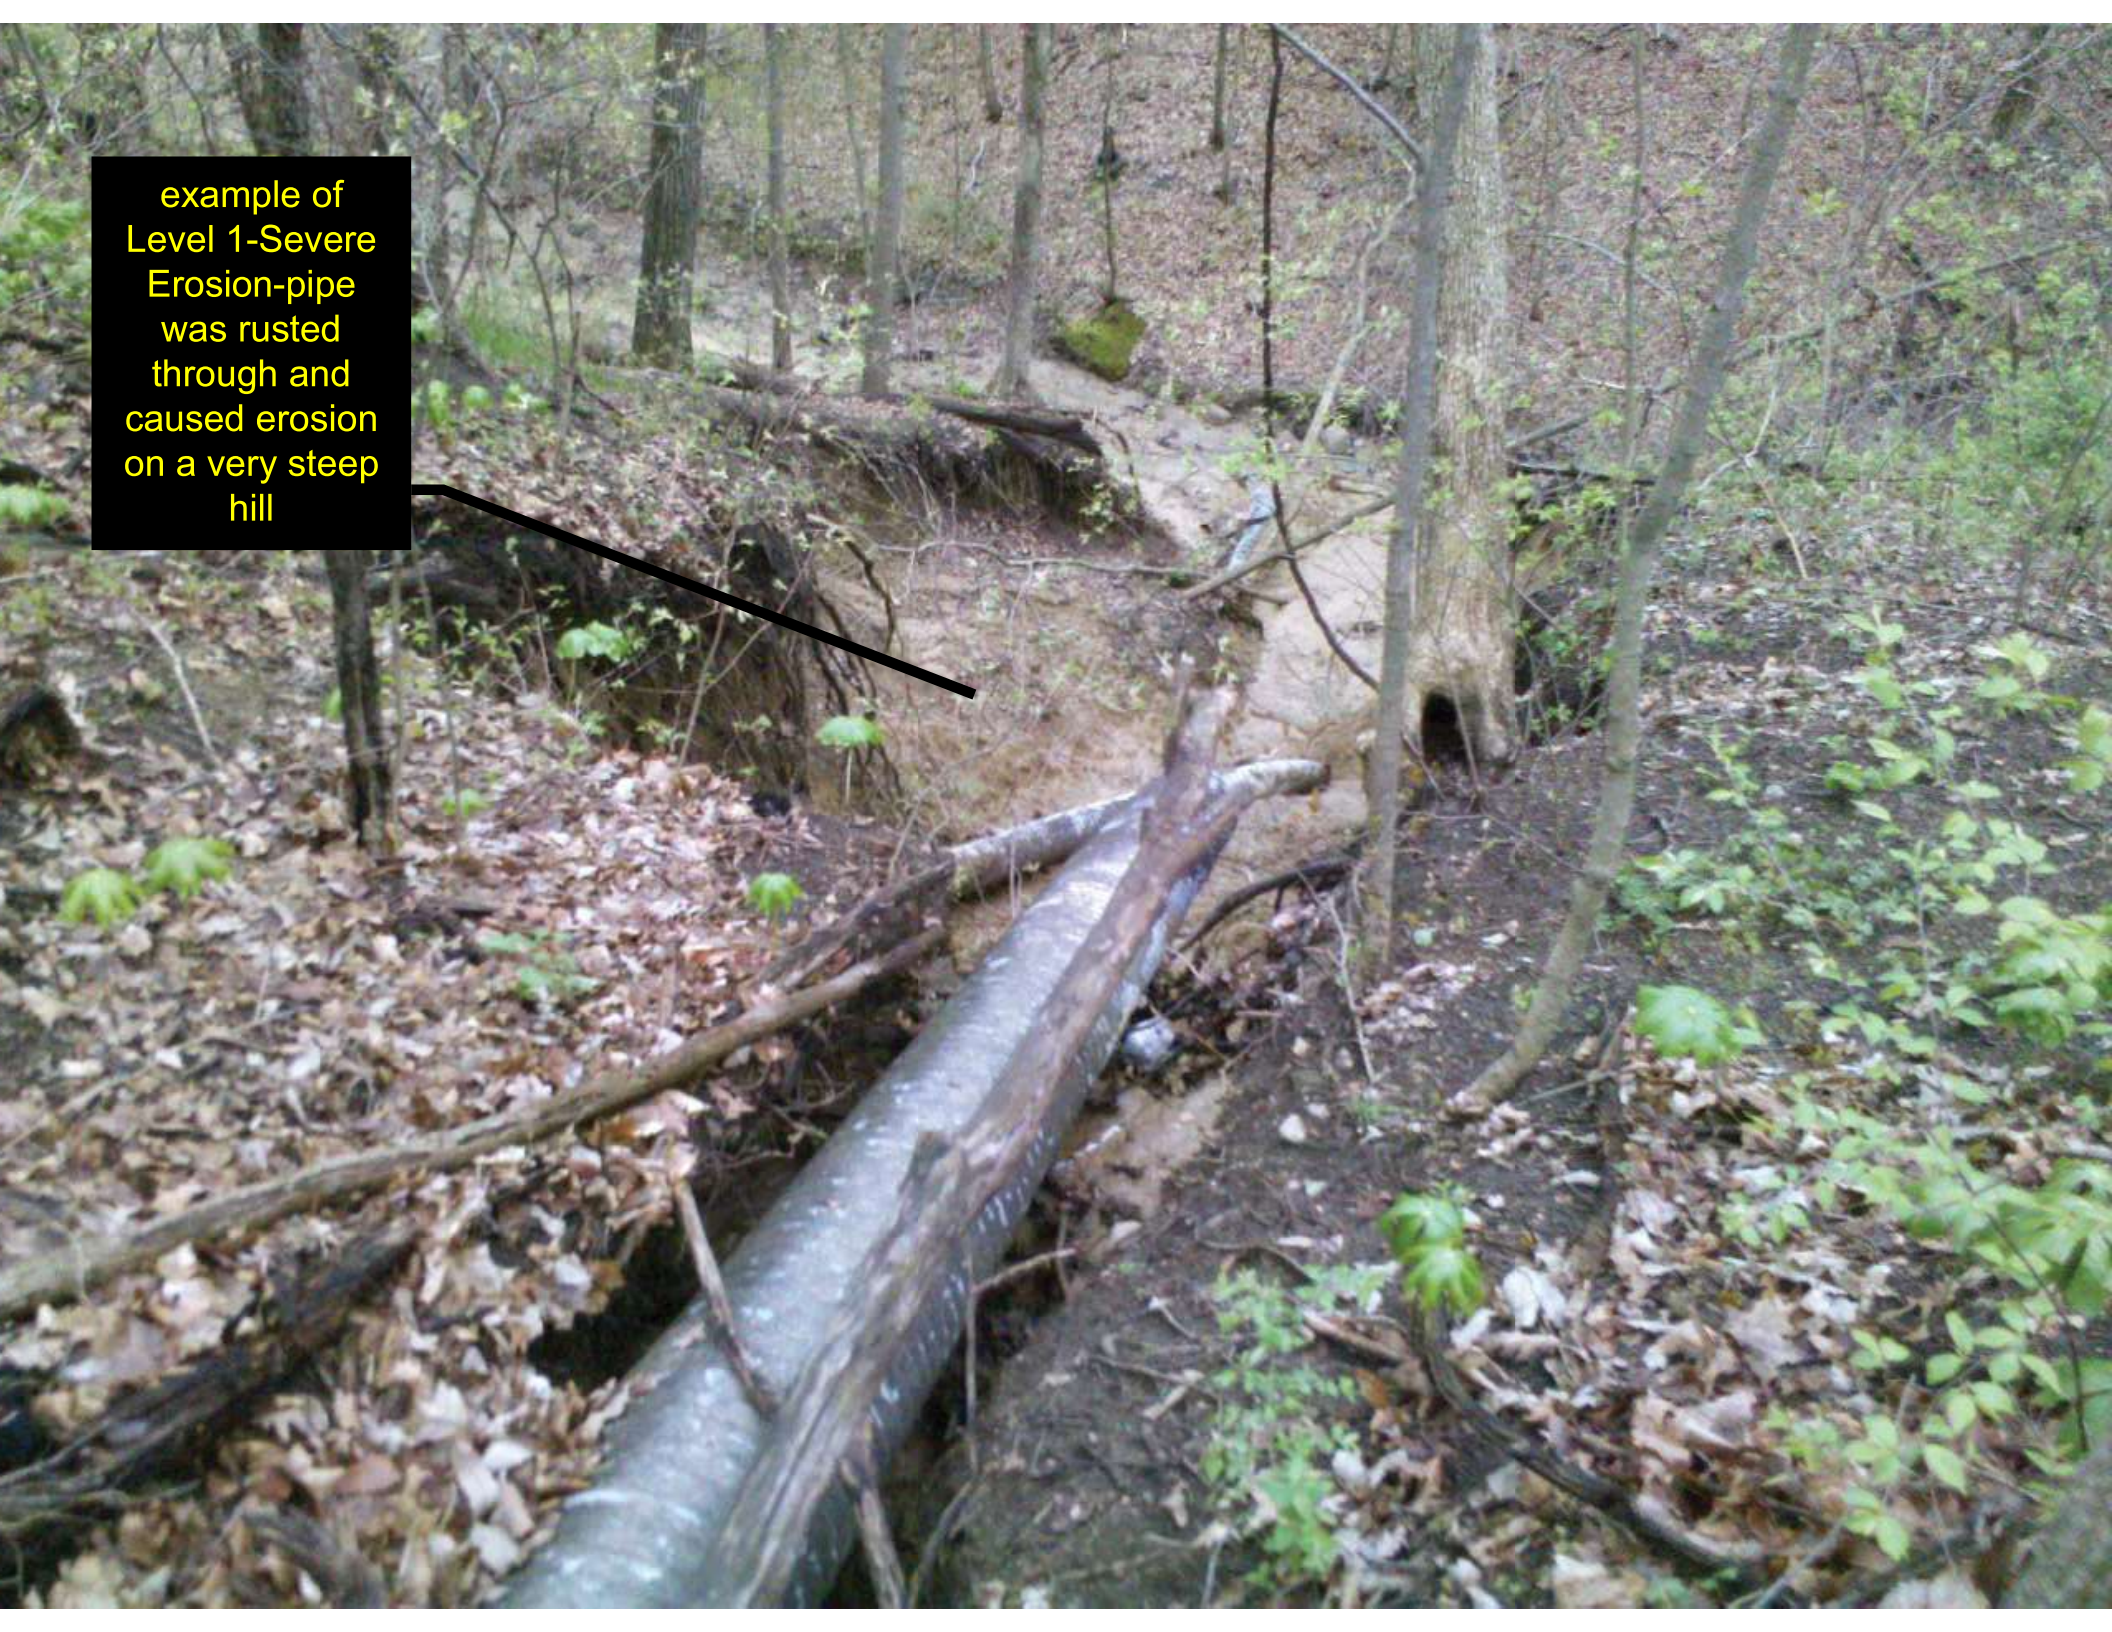
example of  
Level 1-Severe  
Erosion-pipe  
was rusted  
through and  
caused erosion  
on a very steep  
hill

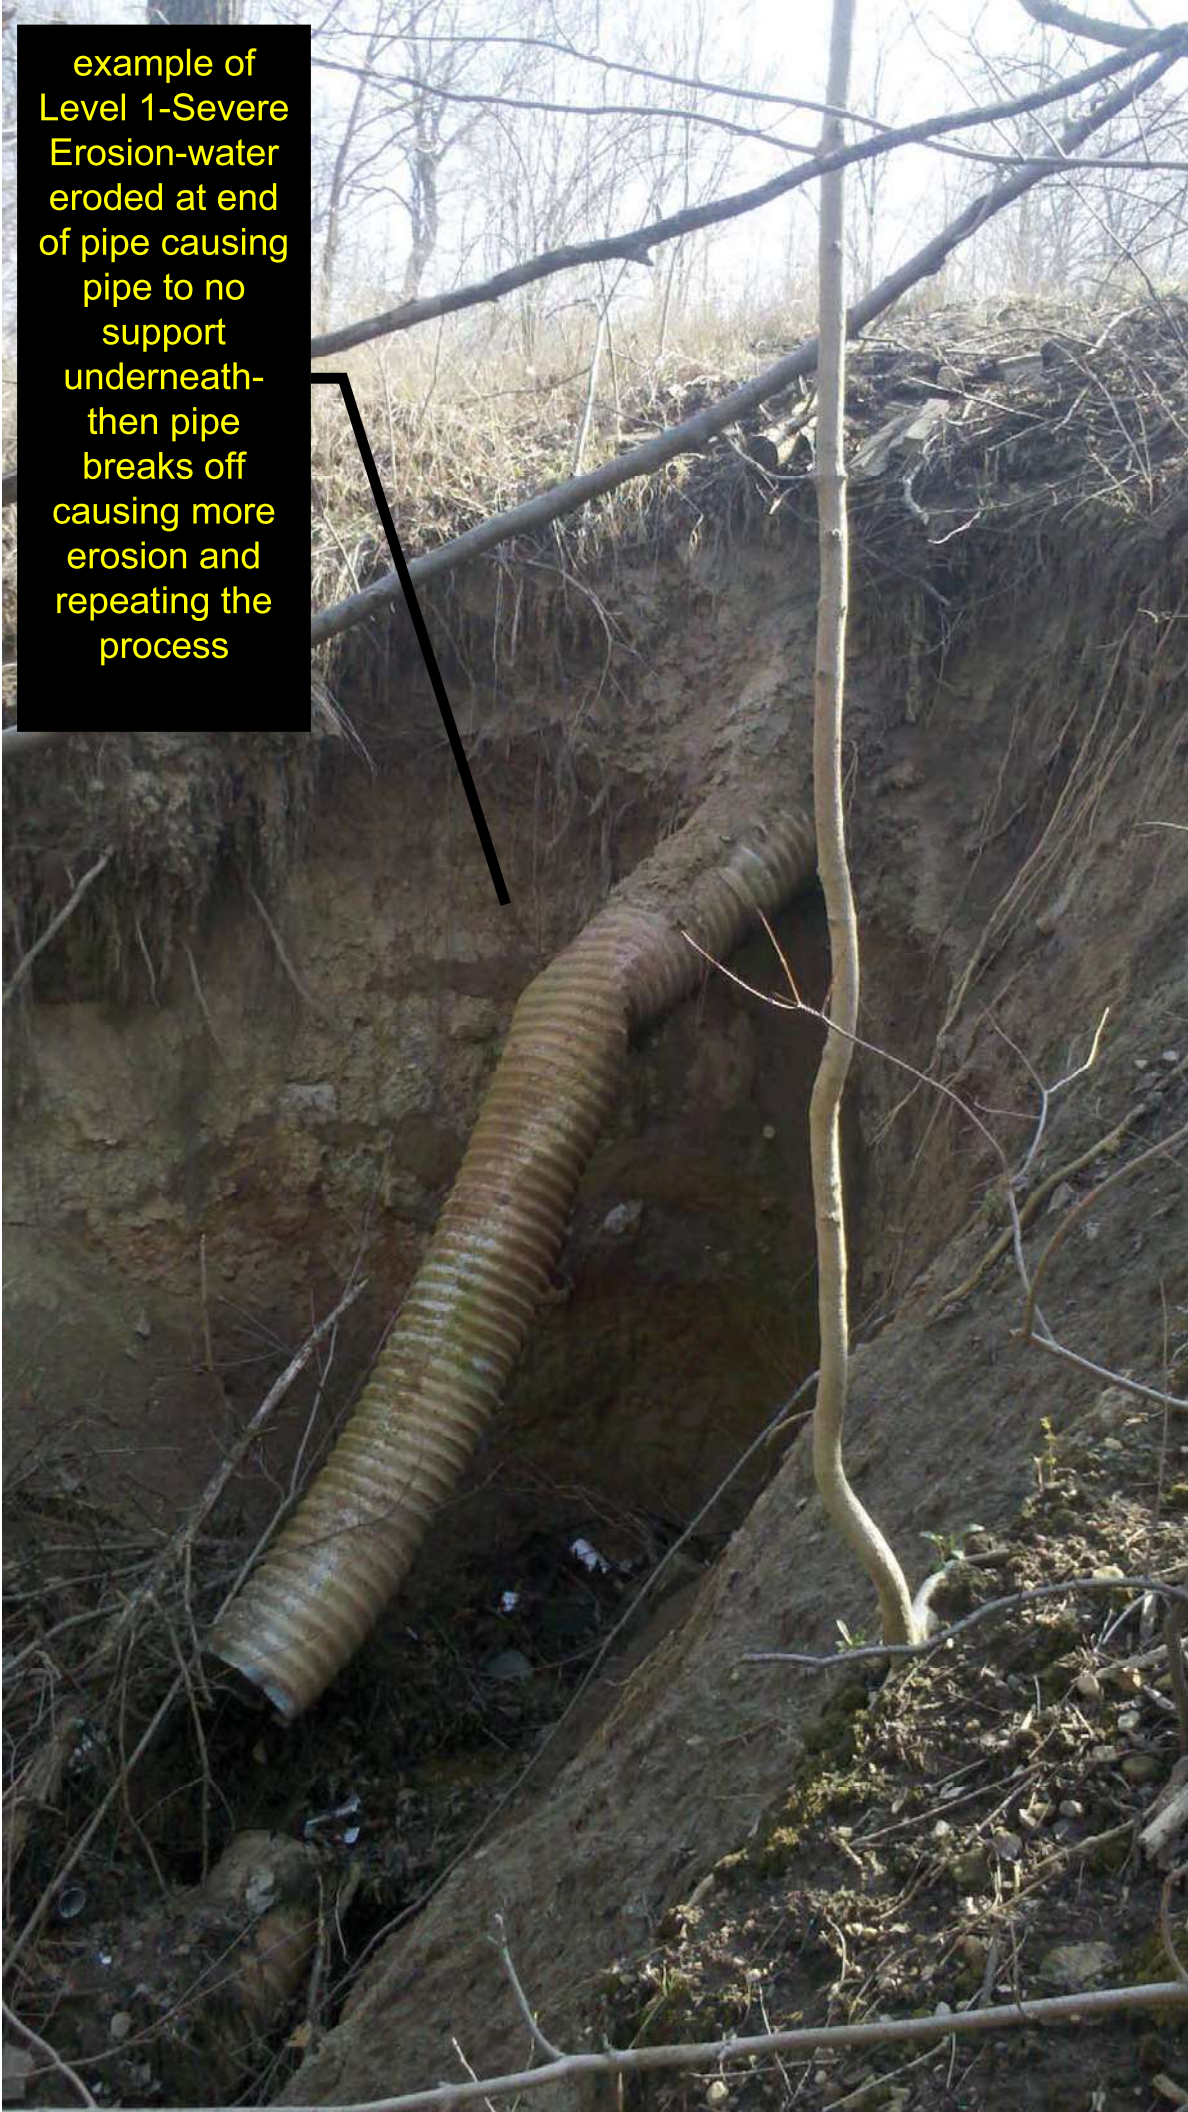
example of  
Level 1-Severe  
Erosion-water  
eroded at end  
of pipe causing  
pipe to no  
support  
underneath-  
then pipe  
breaks off  
causing more  
erosion and  
repeating the  
process

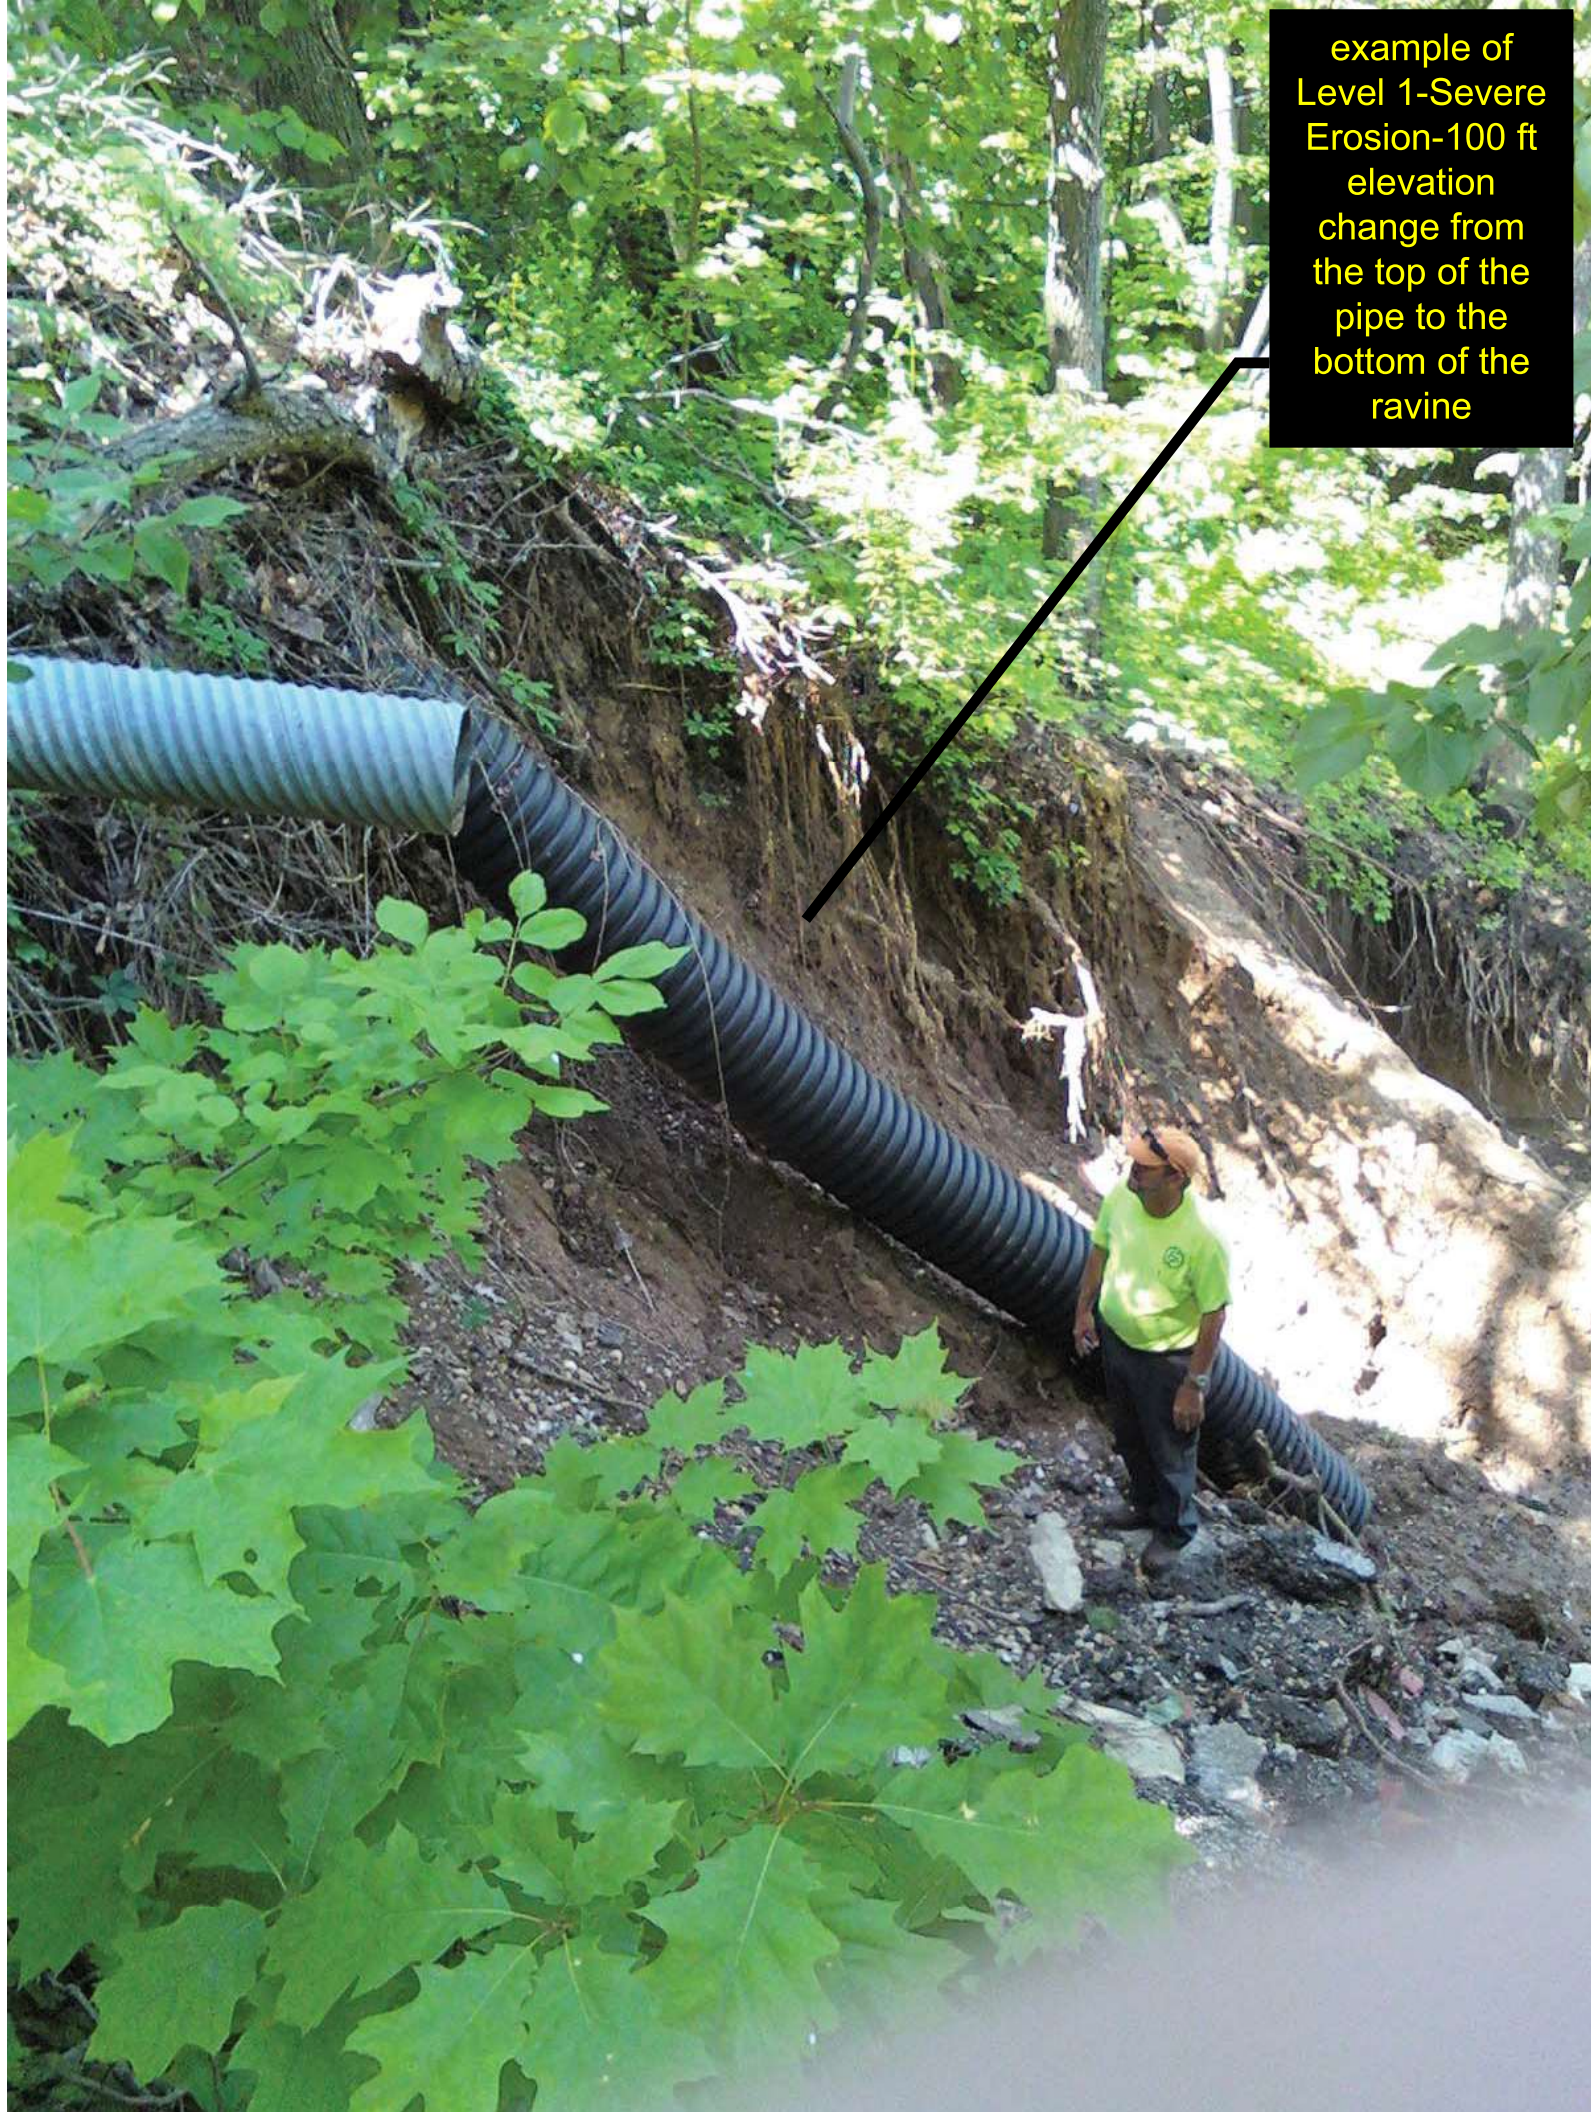
example of  
Level 1-Severe  
Erosion-100 ft  
elevation  
change from  
the top of the  
pipe to the  
bottom of the  
ravine

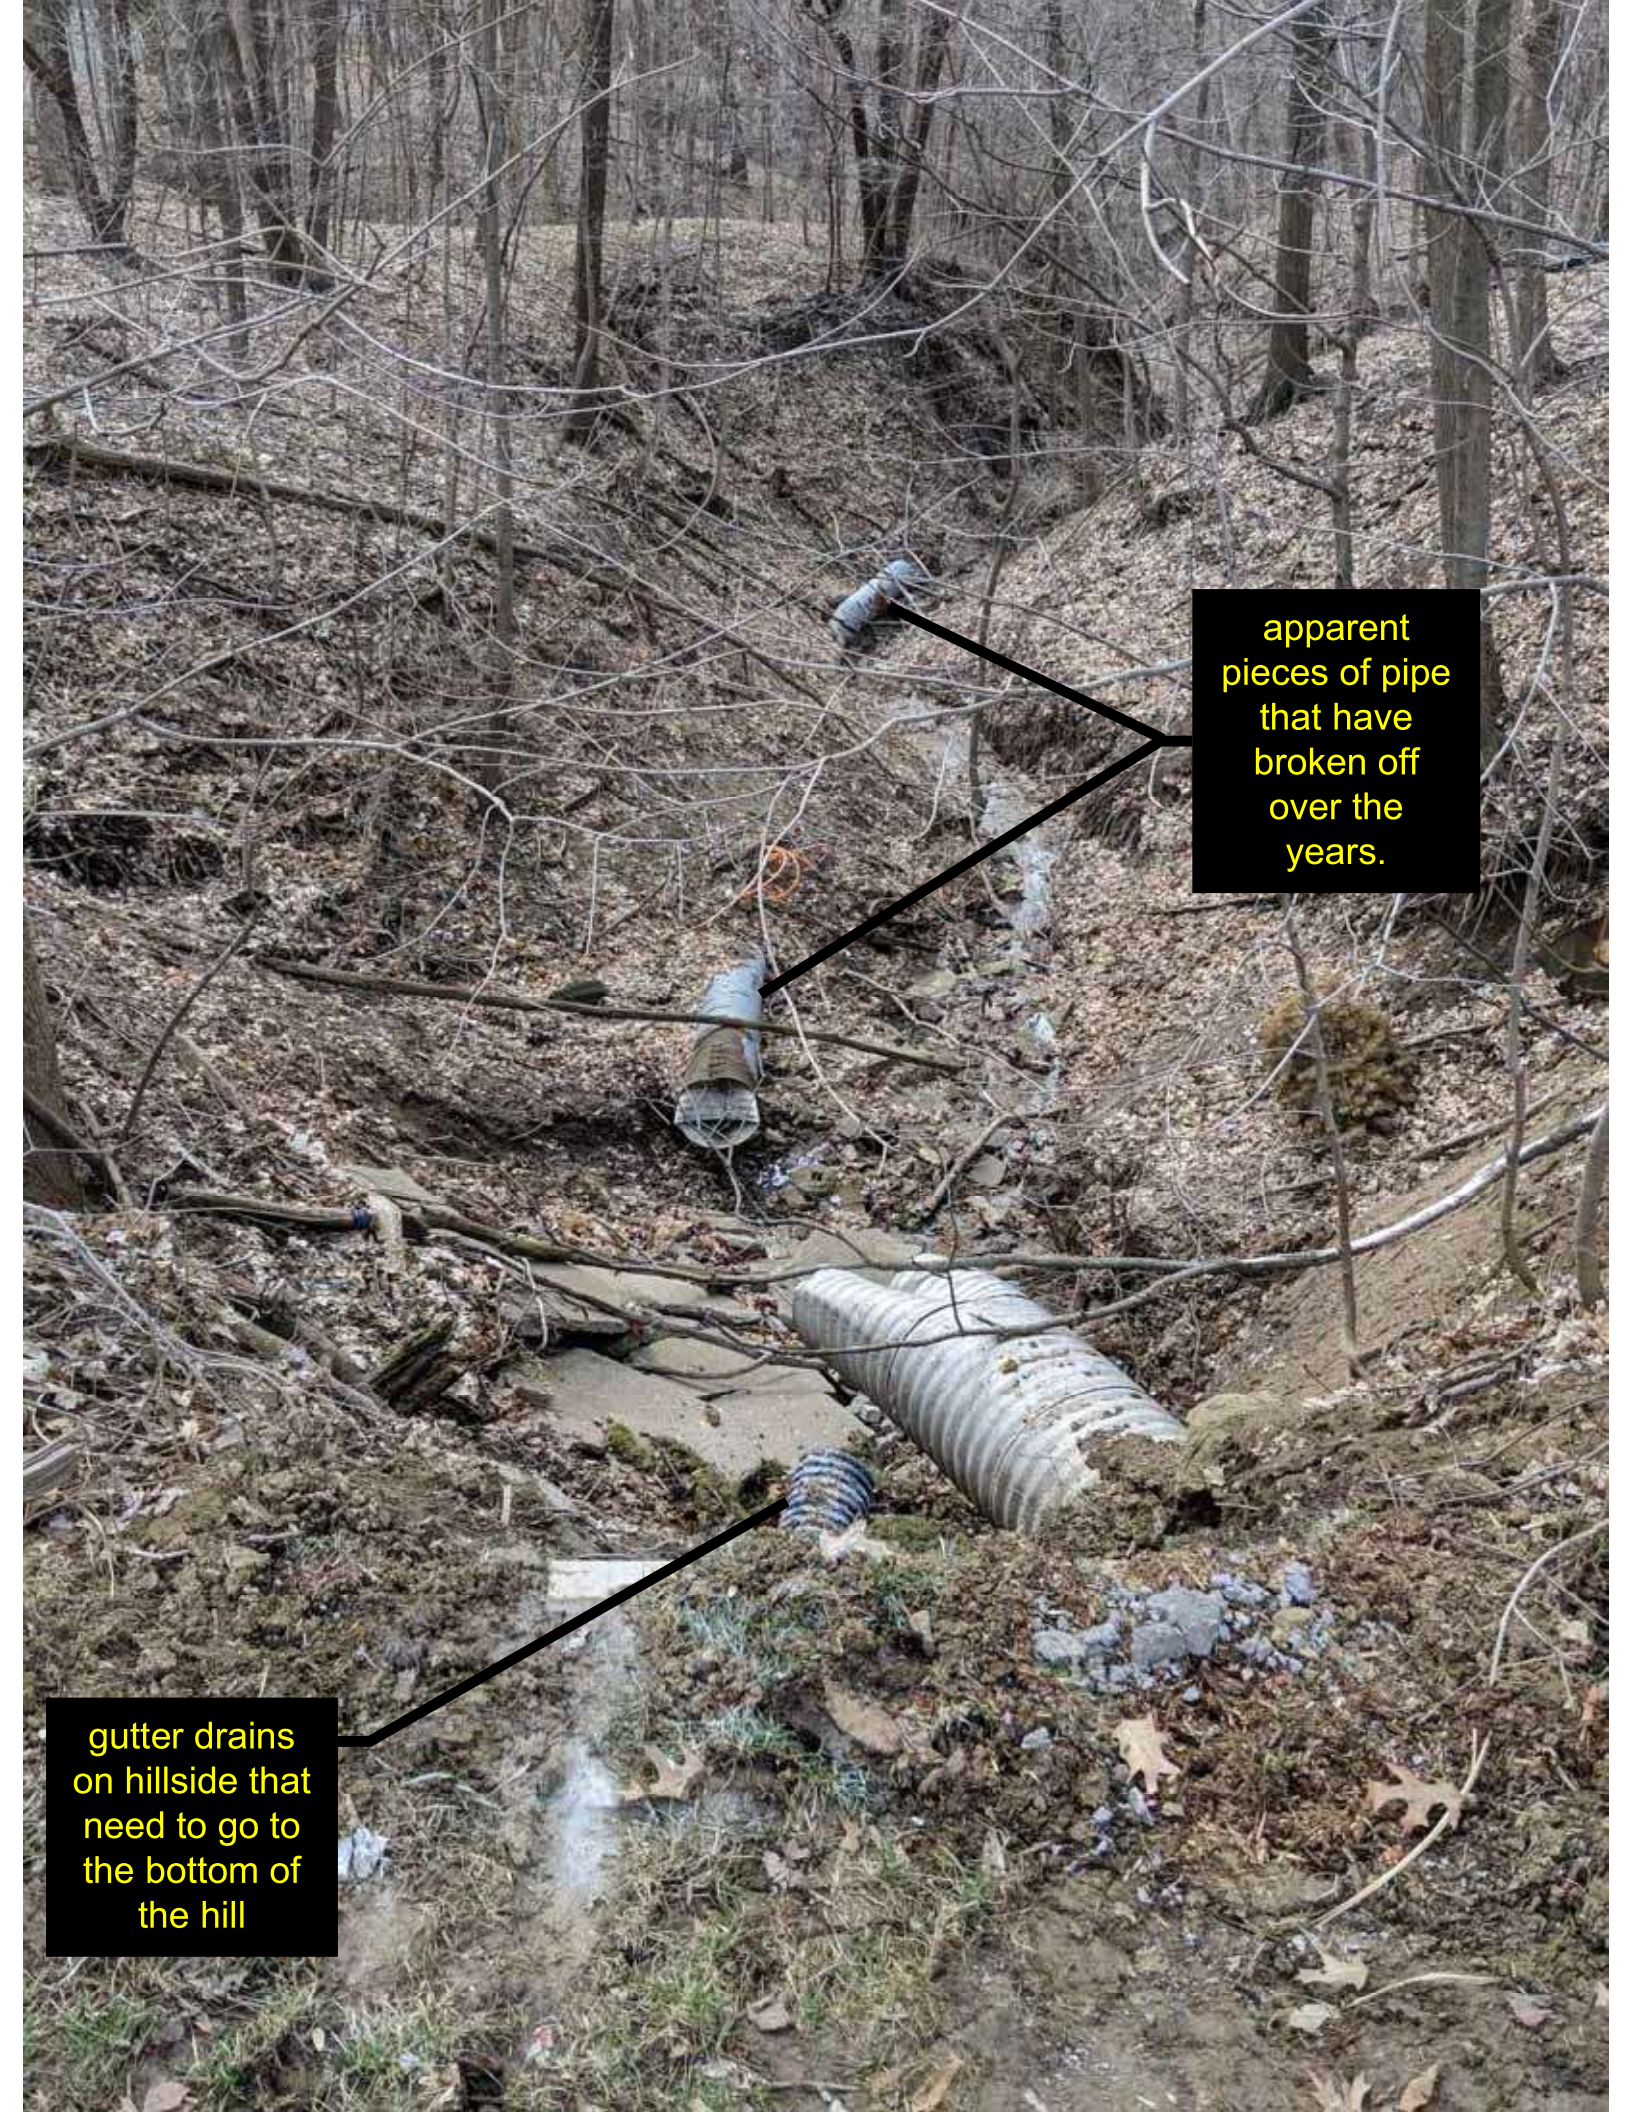
apparent  
pieces of pipe  
that have  
broken off  
over the  
years.

gutter drains  
on hillside that  
need to go to  
the bottom of  
the hill

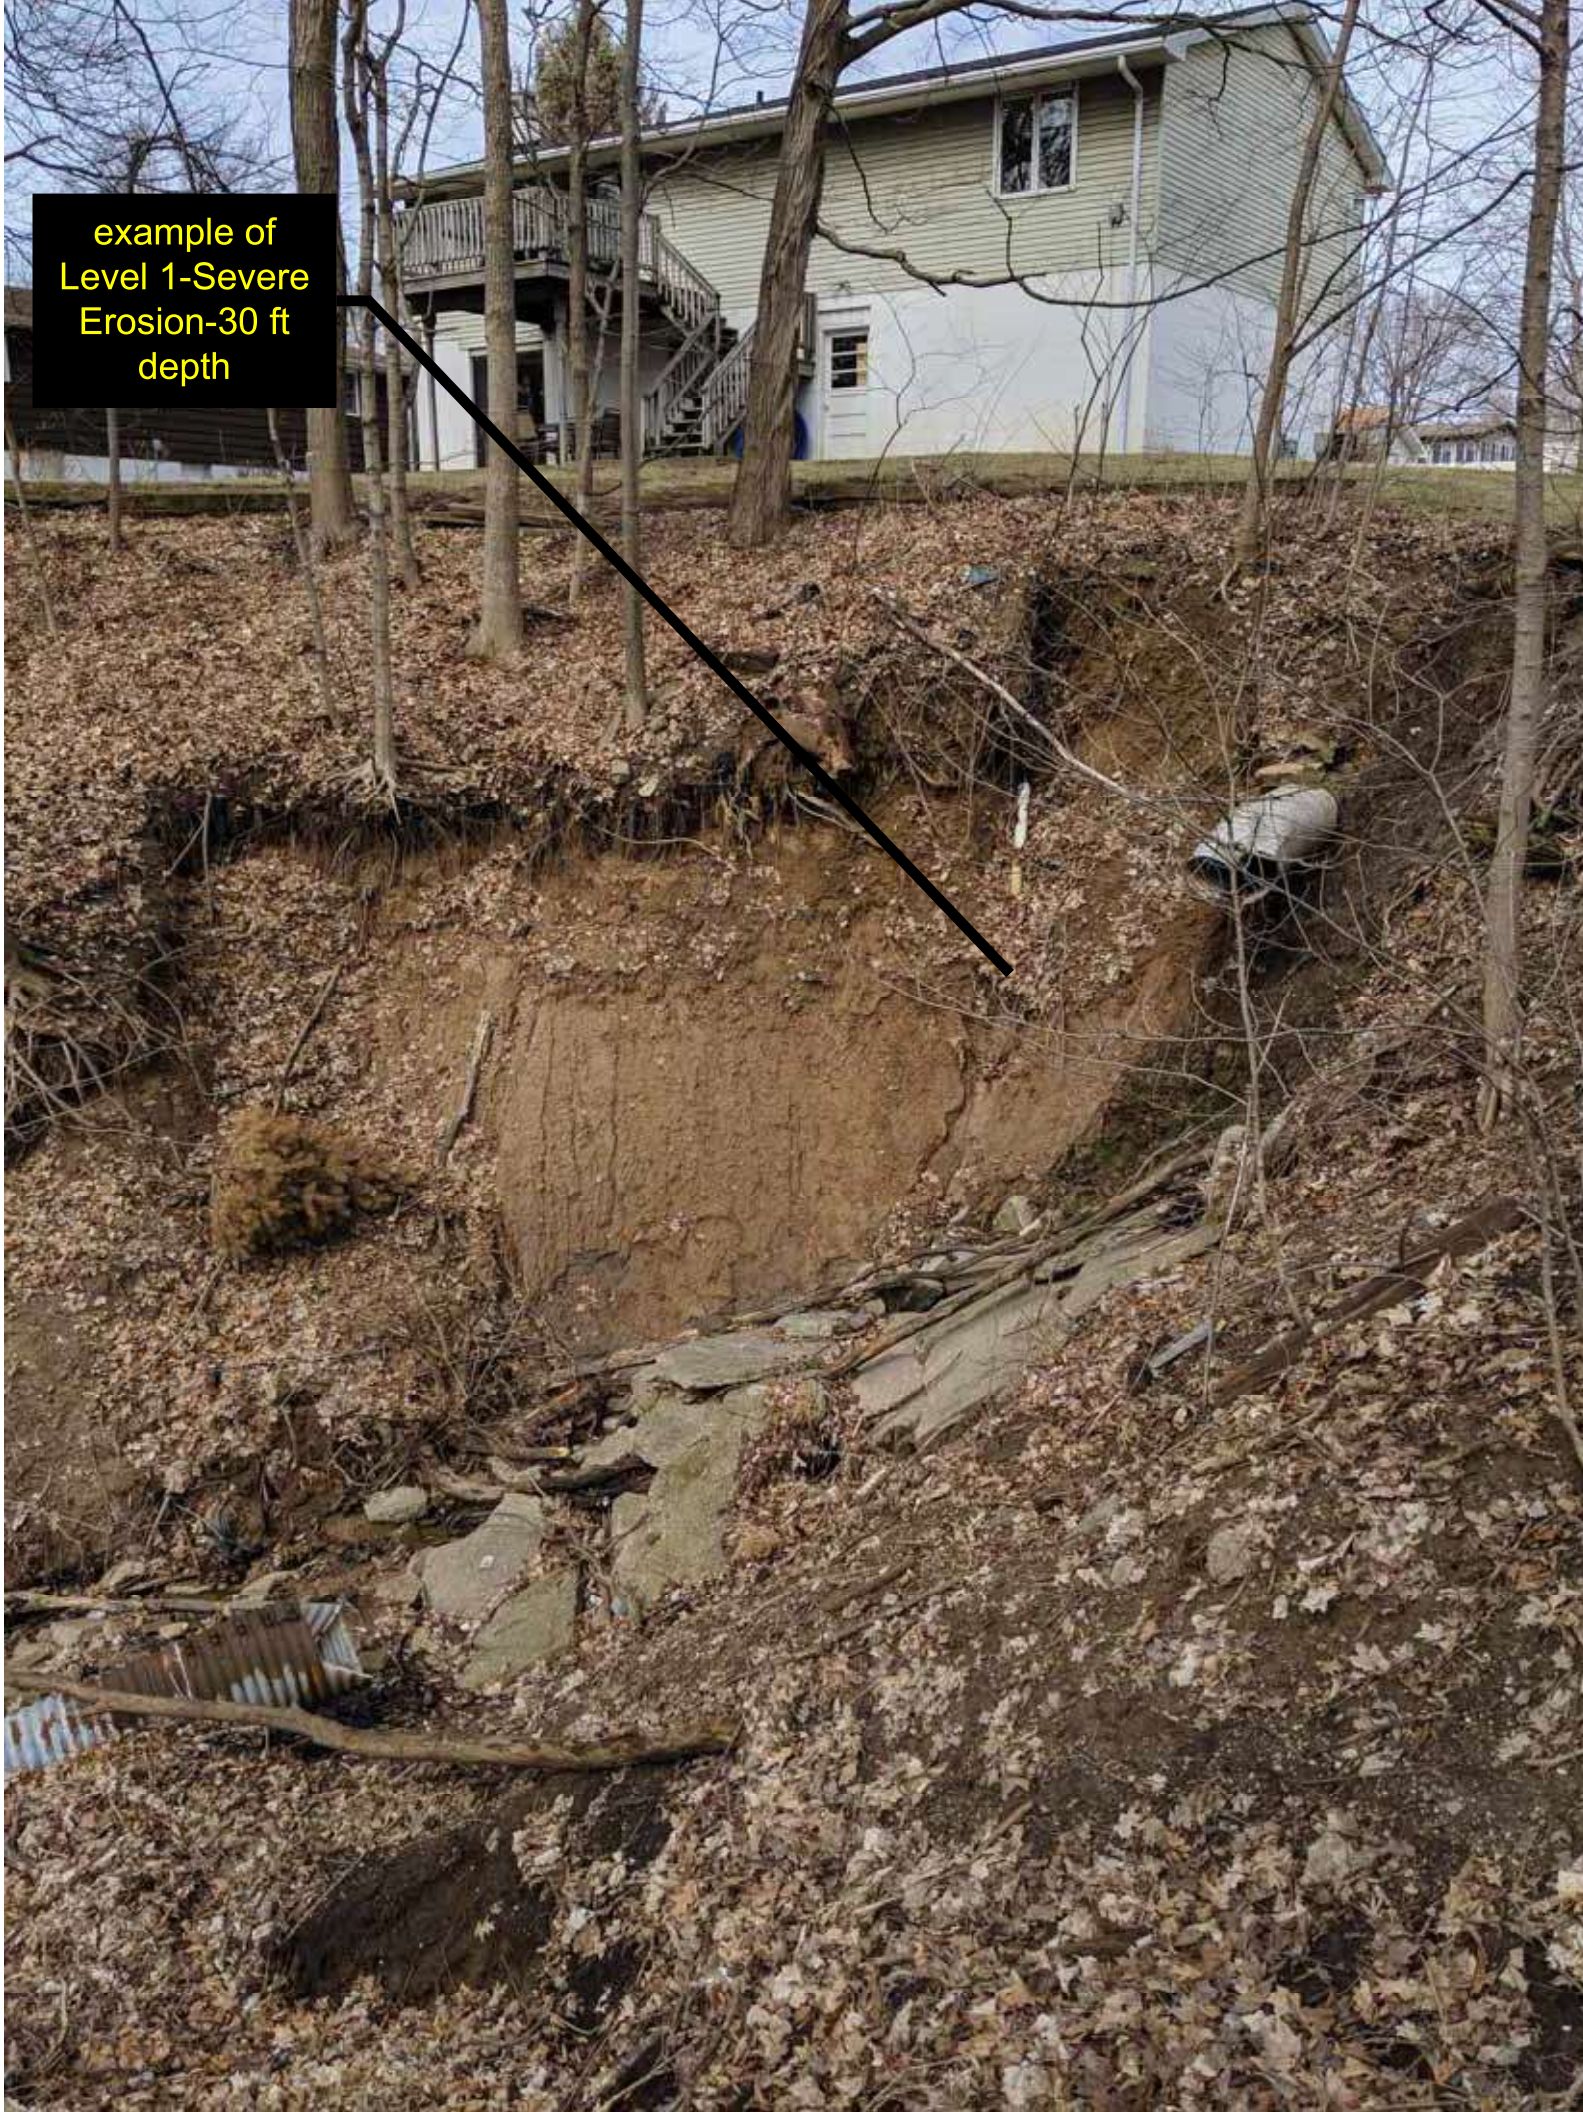
example of  
Level 1-Severe  
Erosion-30 ft  
depth

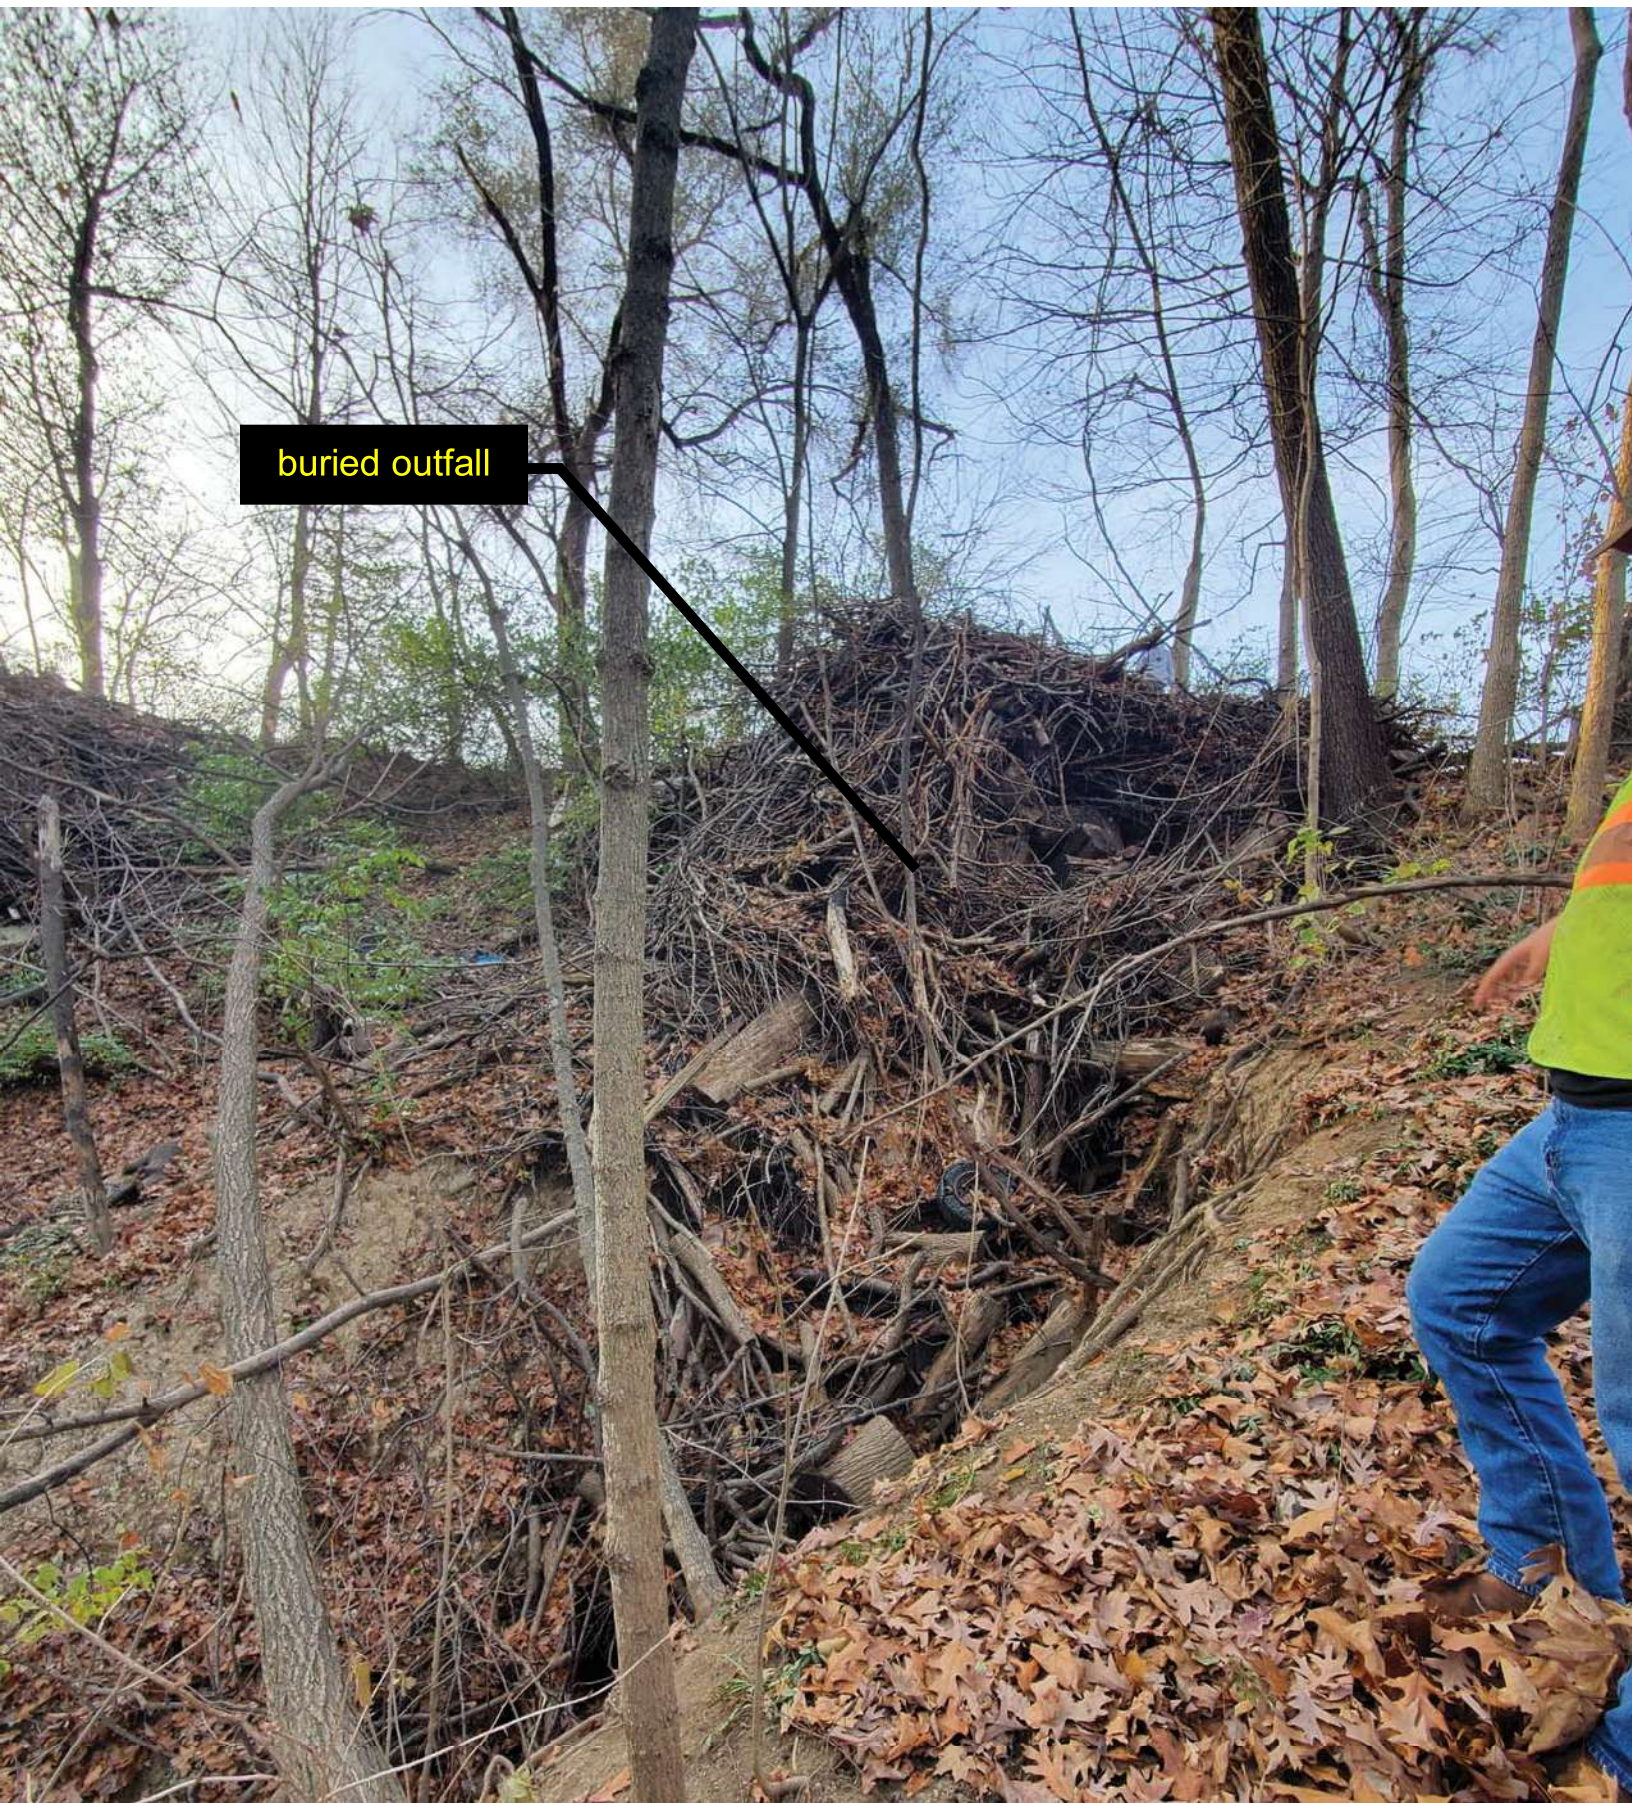
Televising and Buried were also noted attributes. PNMAI identified both of these attributes since some of the pipe locations were either unknown as far as direction or they were buried. The City could utilize this list to perform further investigation to enhance the inventory. A photograph of a buried pipe is in **Exhibit G**.

buried outfall

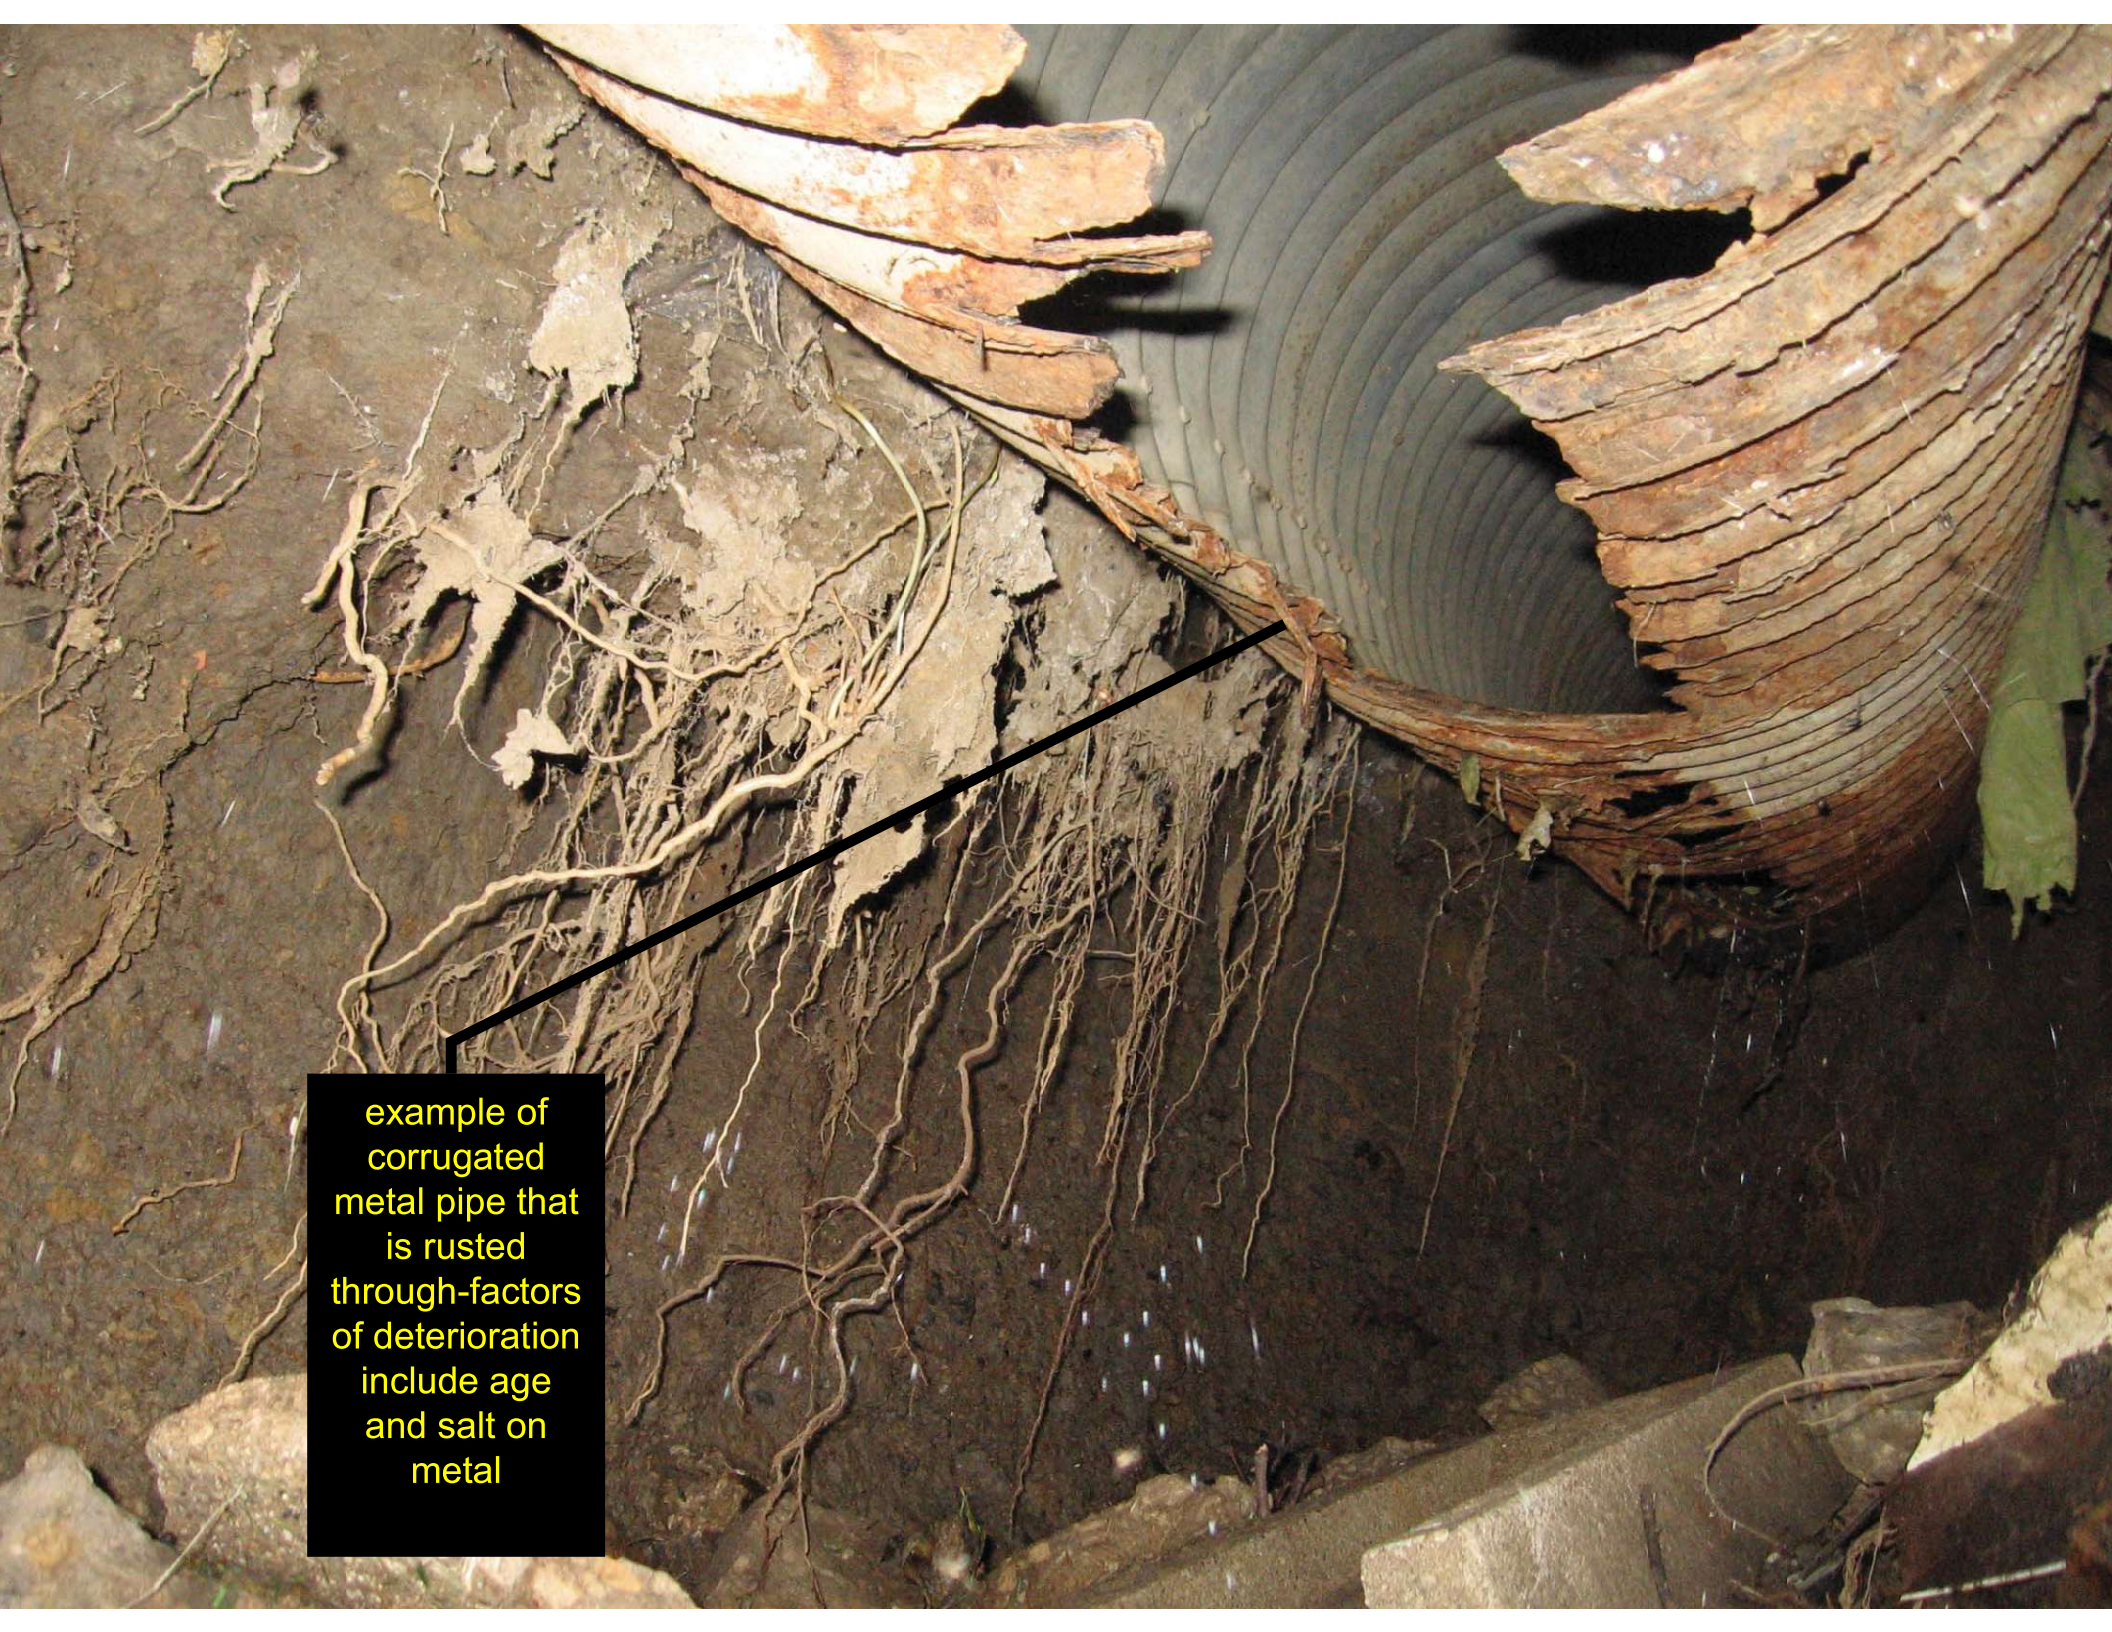
example of  
corrugated  
metal pipe that  
is rusted  
through-factors  
of deterioration  
include age  
and salt on  
metal
