# **The City of East Peoria Storm Water Management Plan**

November - 2025

**Patrick N. Meyer & Associates, Inc.**

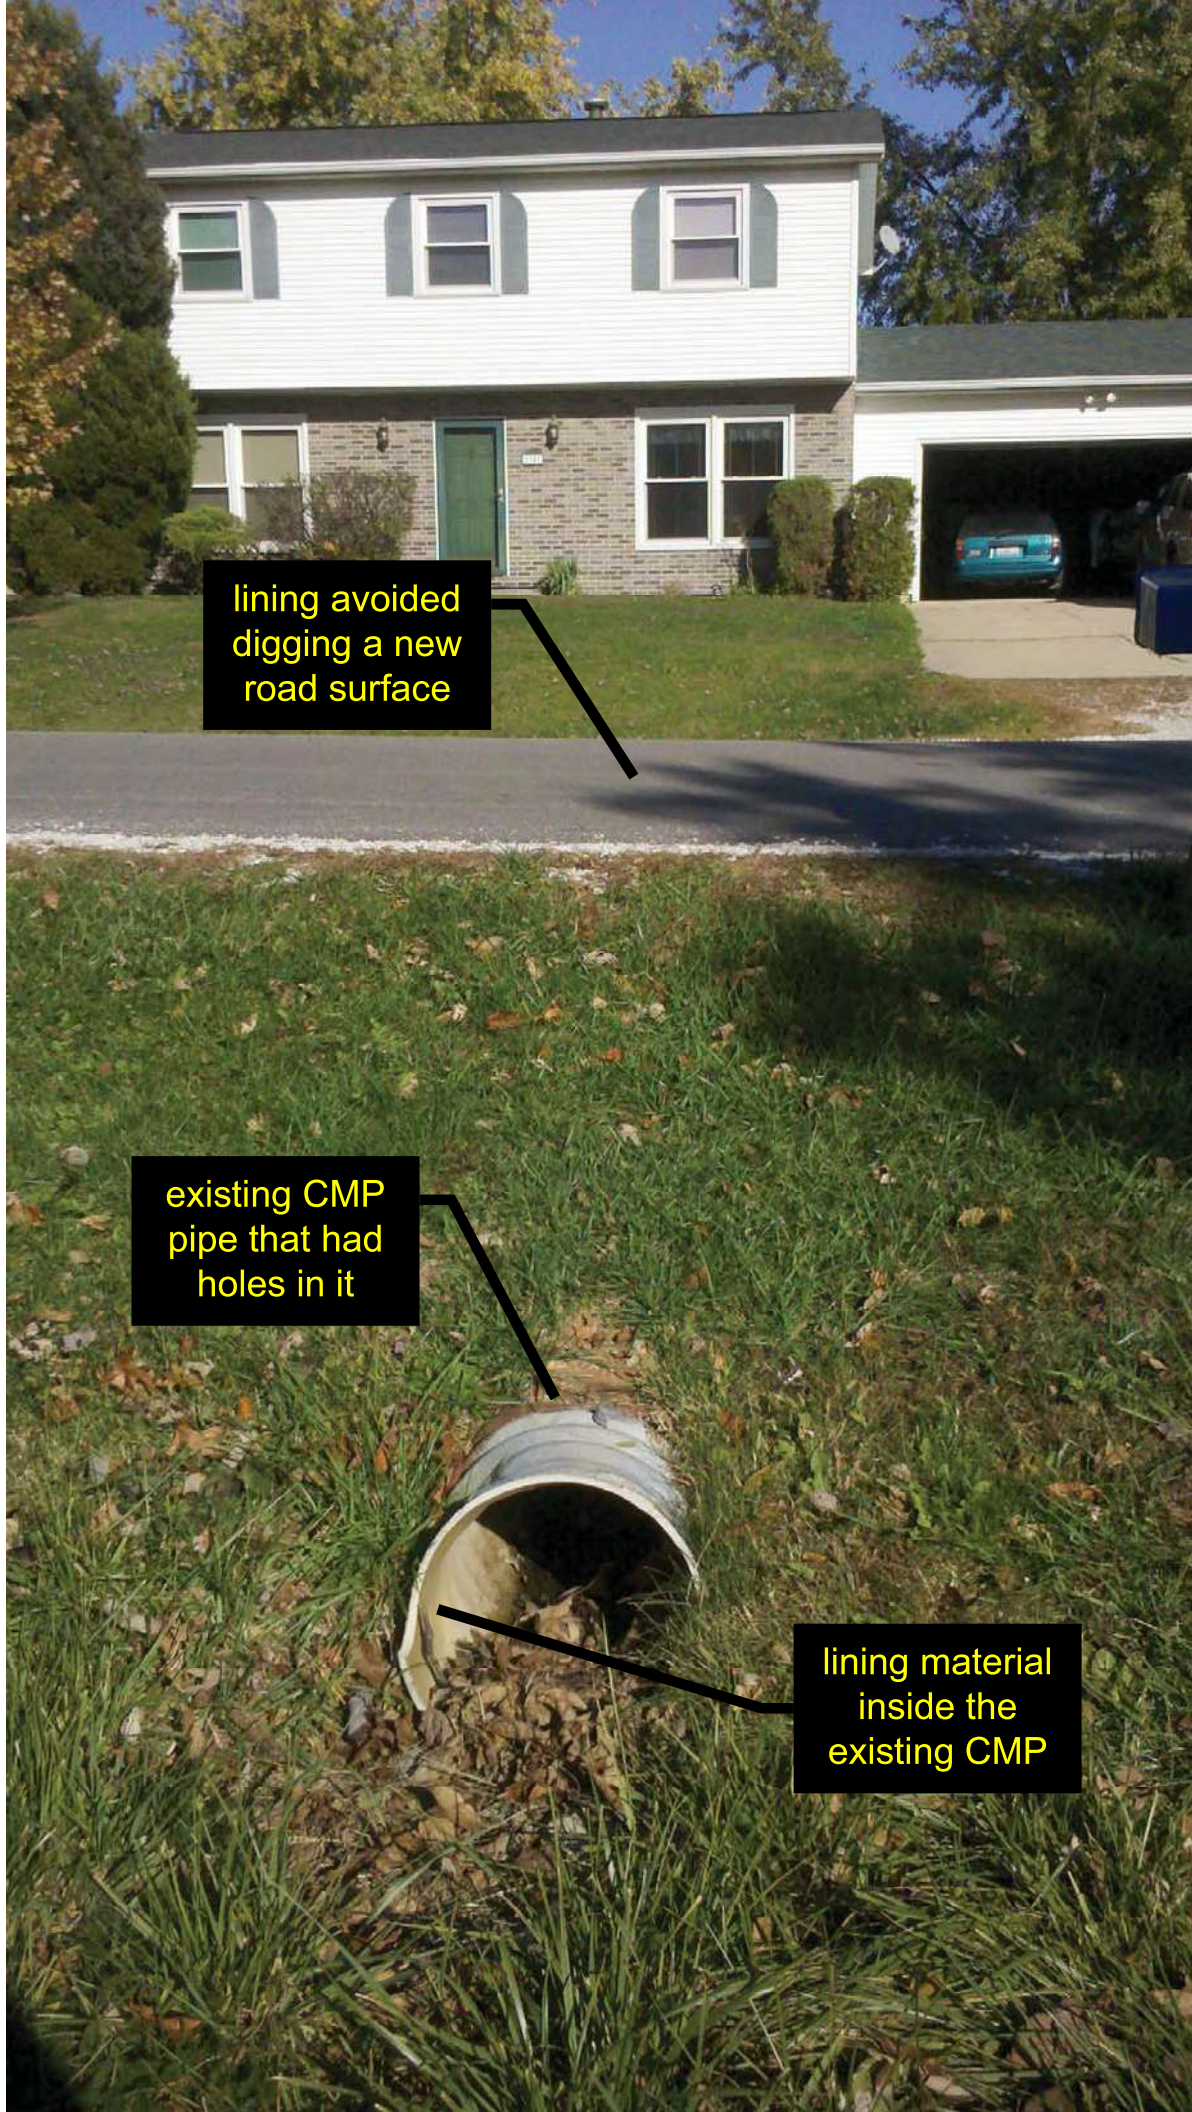
existing CMP  
pipe that had  
holes in it

lining avoided  
digging a new  
road surface

lining material  
inside the  
existing CMP

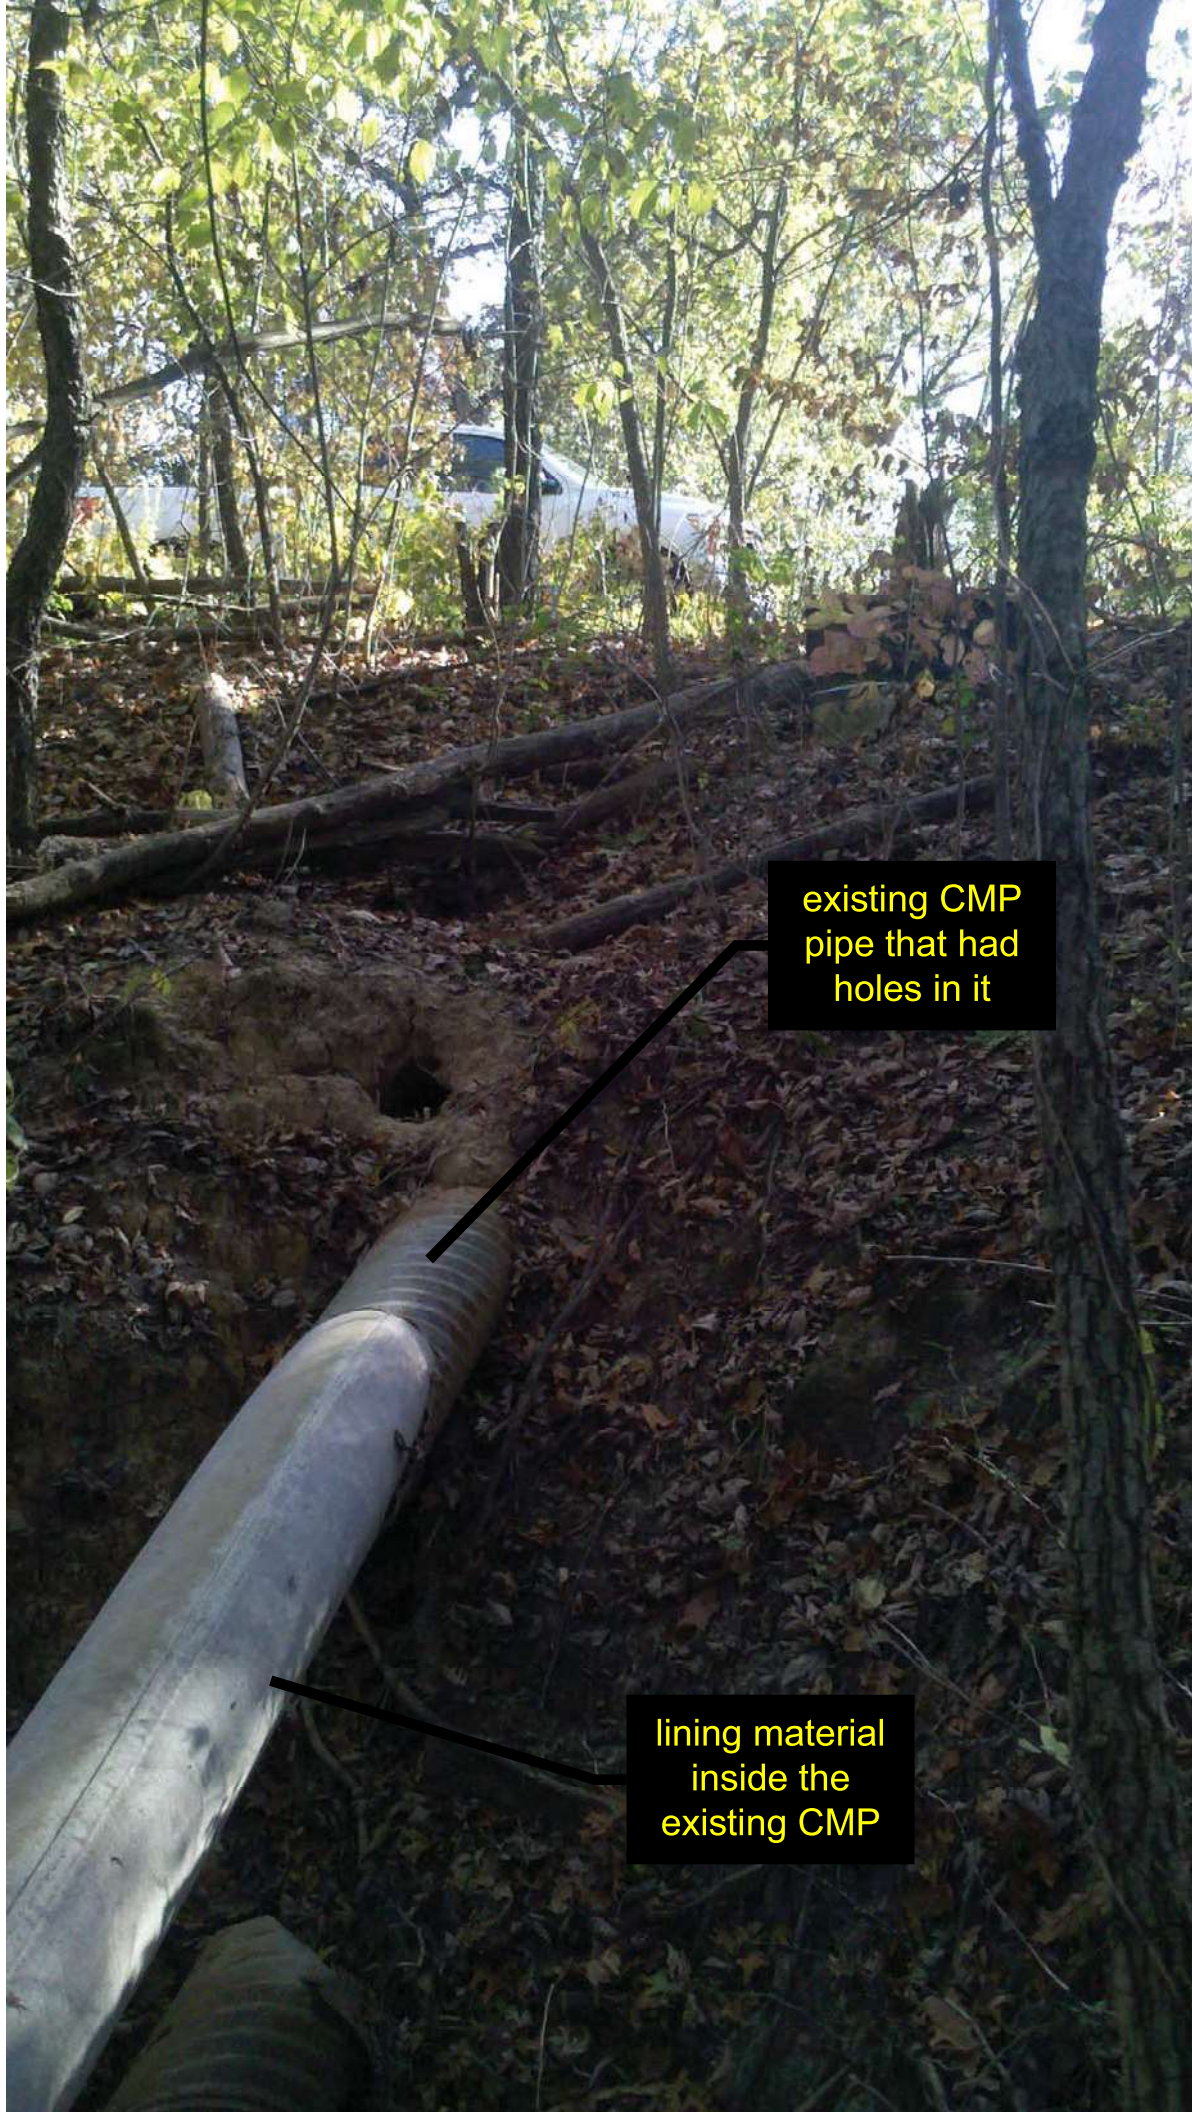
existing CMP  
pipe that had  
holes in it

lining material  
inside the  
existing CMP

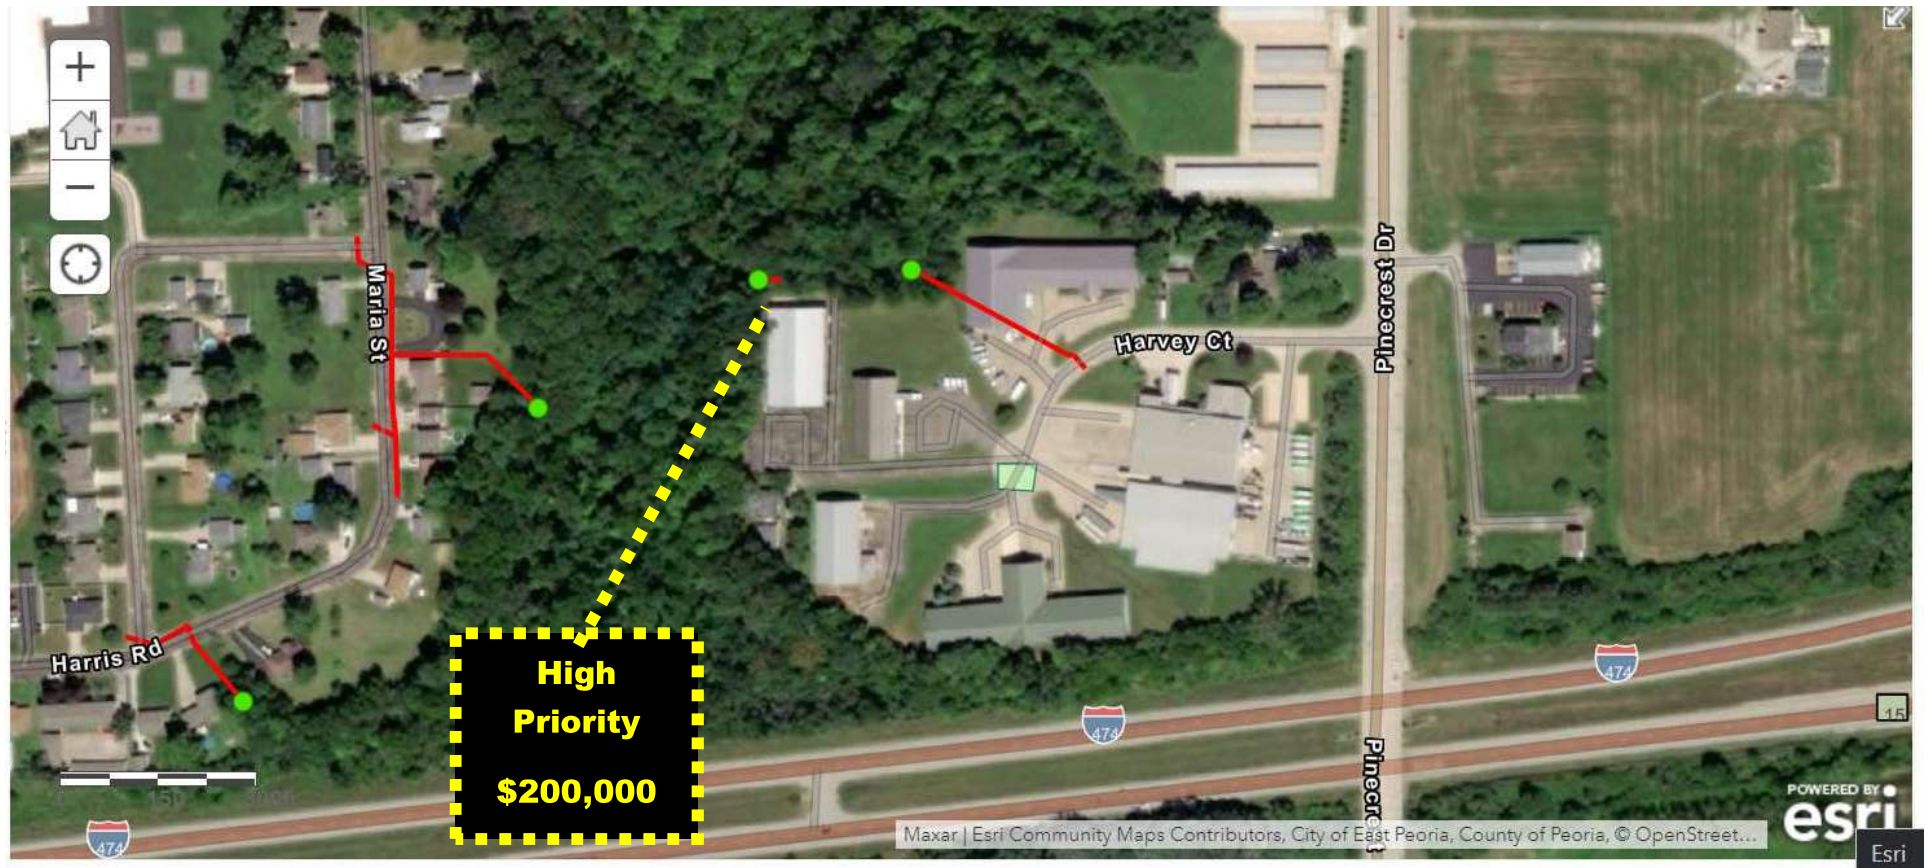
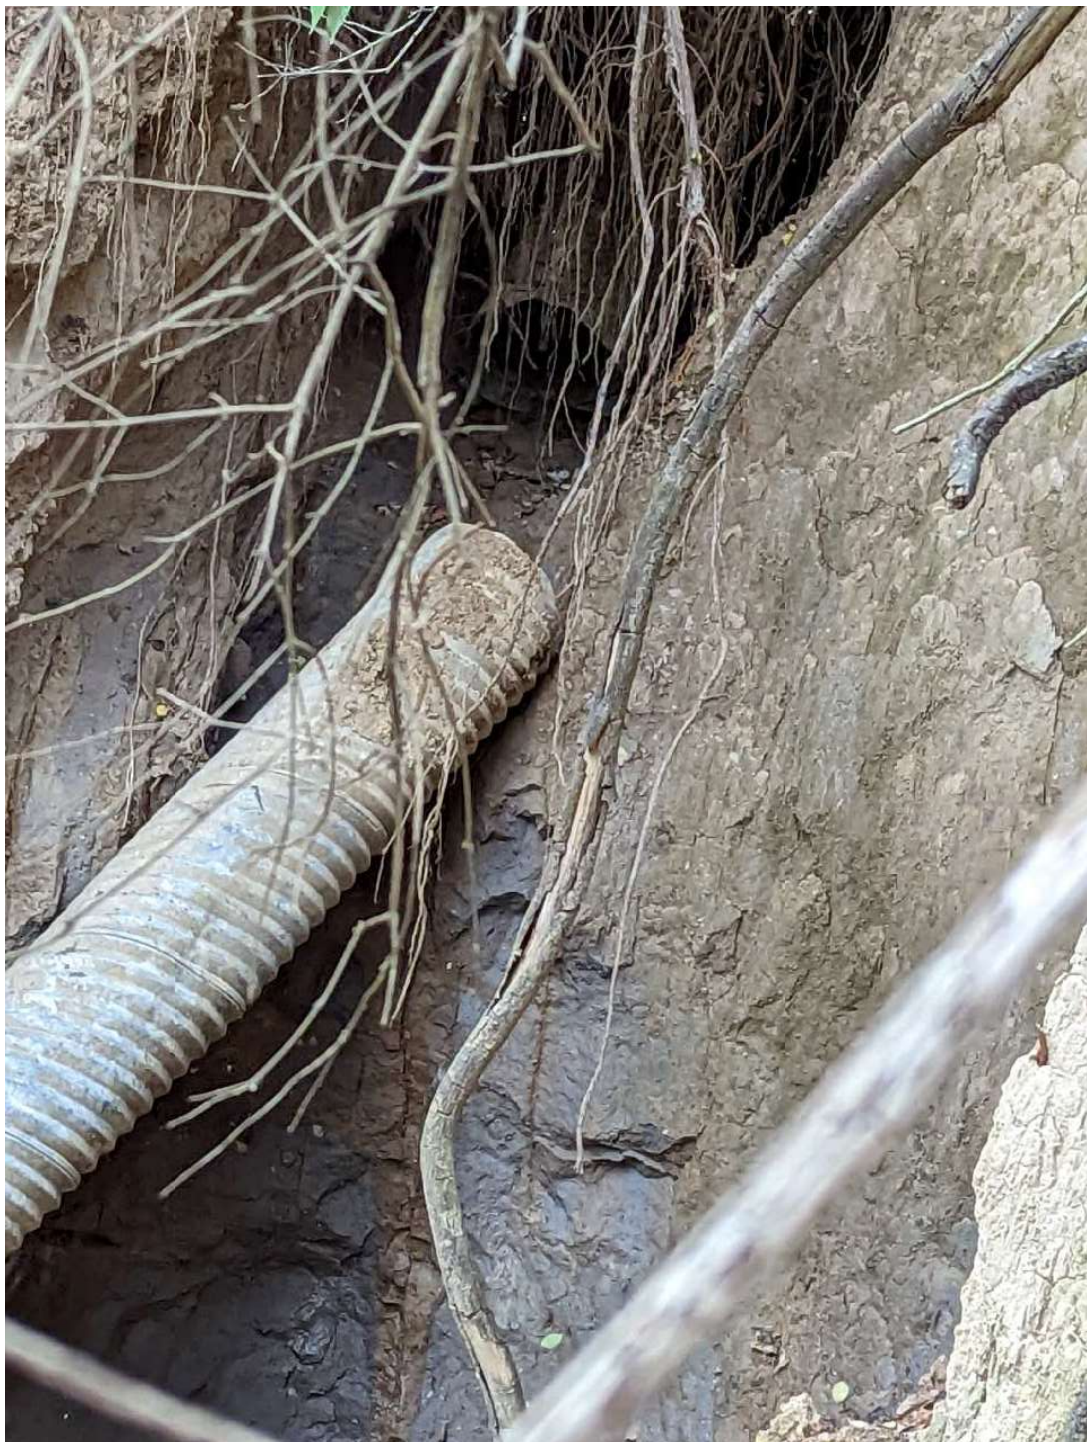
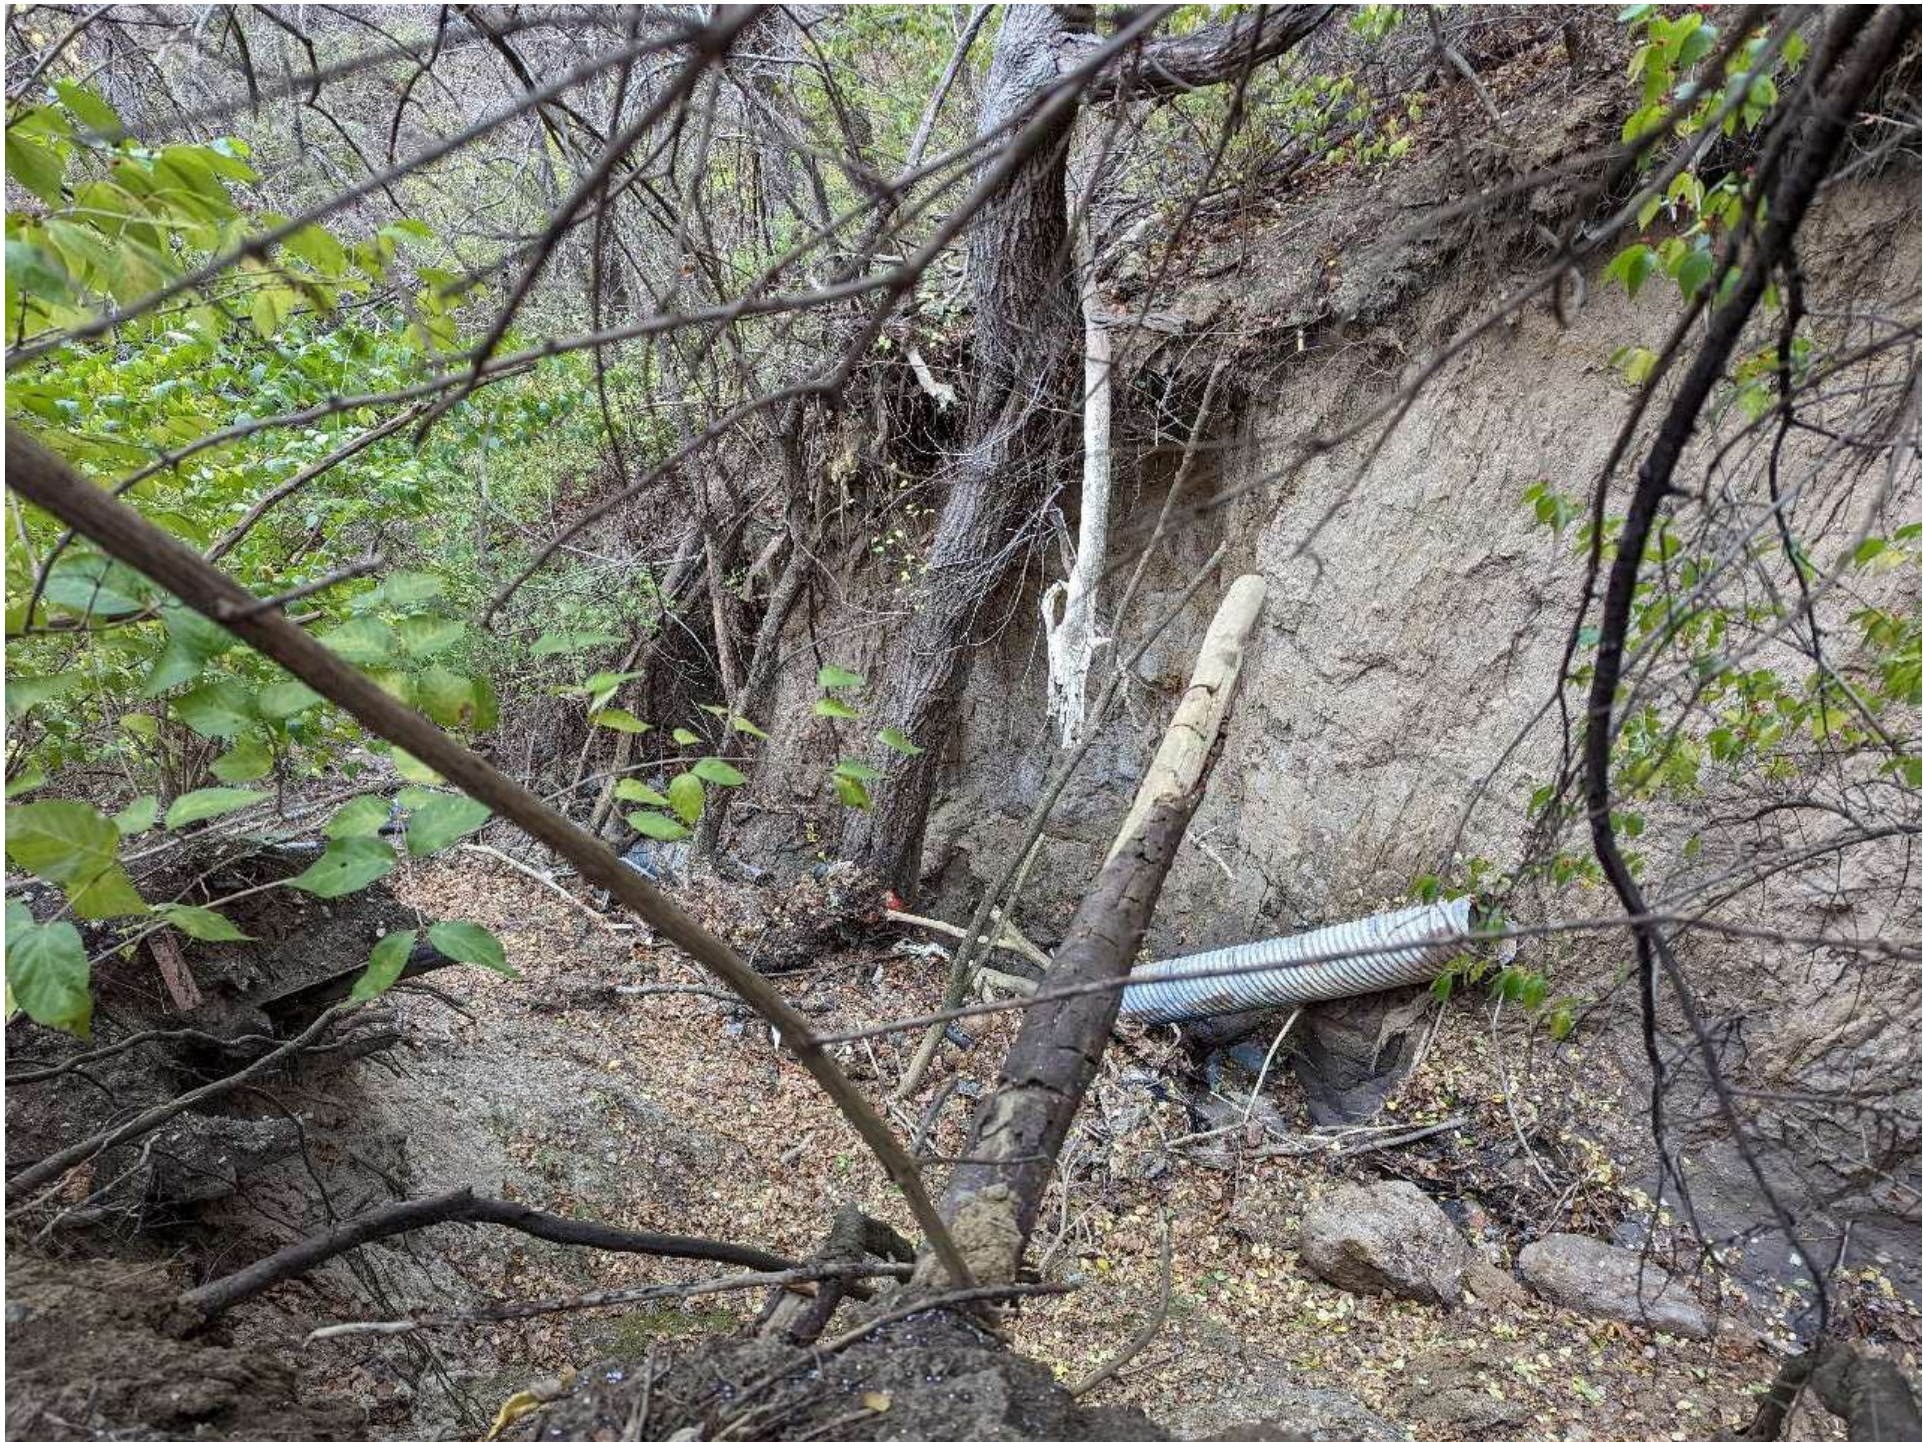
## Object ID 232-Off of Harvey Ct

OBJECTID	Material Type	Diameter (inches)	Pipe Condition	Erosion Condition	Depth of Erosion (ft)	Cost	Location	VI - Other Comments?	Notes
232	Corrugated	15	Very Poor	1 - Severe Erosion (>5ft)	30 ft	\$ 200,000	Off of Harvey	The pipe has extremely SEVERE erosion occurring, up to 30 ft	Pipe sections are coming apart and is in proximity of building
10	Corrugated	18	Very Poor	1 - Severe Erosion (>5ft)	20ft plus	\$ 200,000	Off of Centennial Hill	The pipe has bad rust and is broken near the bottom of the pipe... Also, the end section fell off	There is extreme erosion on the hillside behind the pipe, creeping towards the road... Also, not completely sure on the pipe size, somewhere close to a 18" pipe
92	Corrugated	24	Very Poor	1 - Severe Erosion (>5ft)	14-15 ft	\$ 75,000	Off of Illini	Severe erosion up to 14-15 ft and little to no standing water	The pipe itself is in good shape but parts of the pipe have come off due to erosion

# COMPLETED

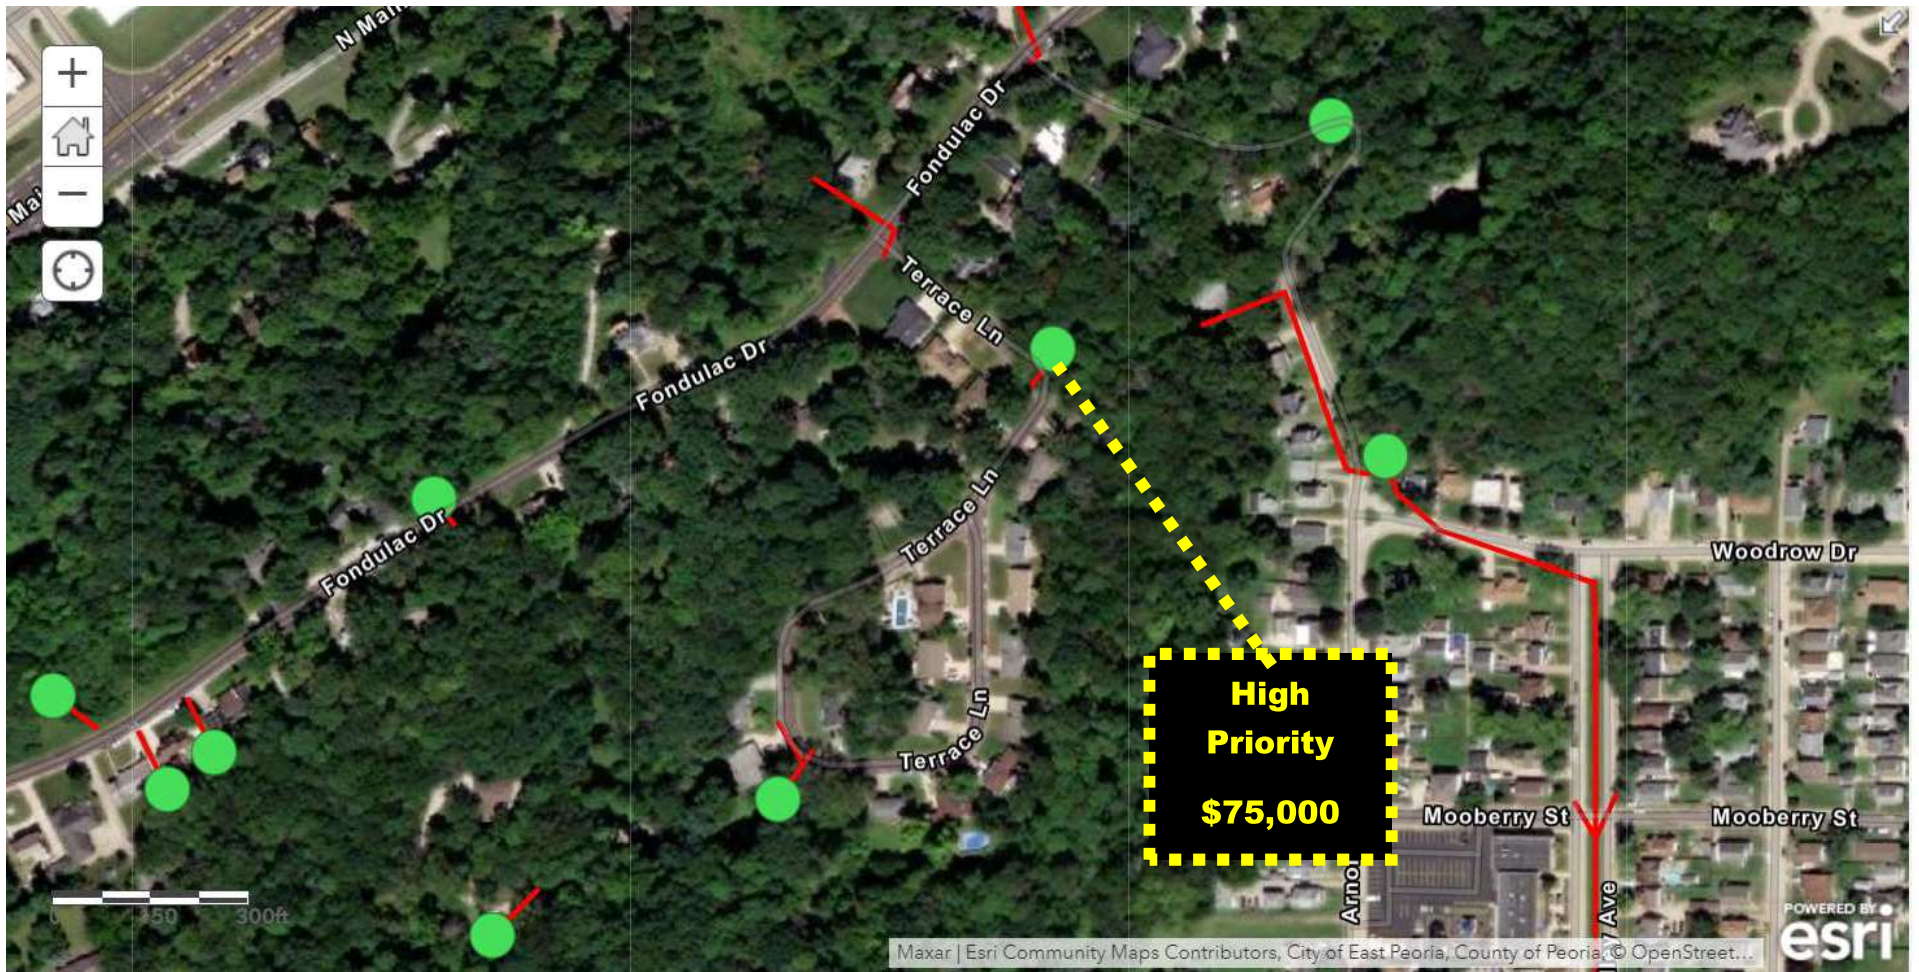
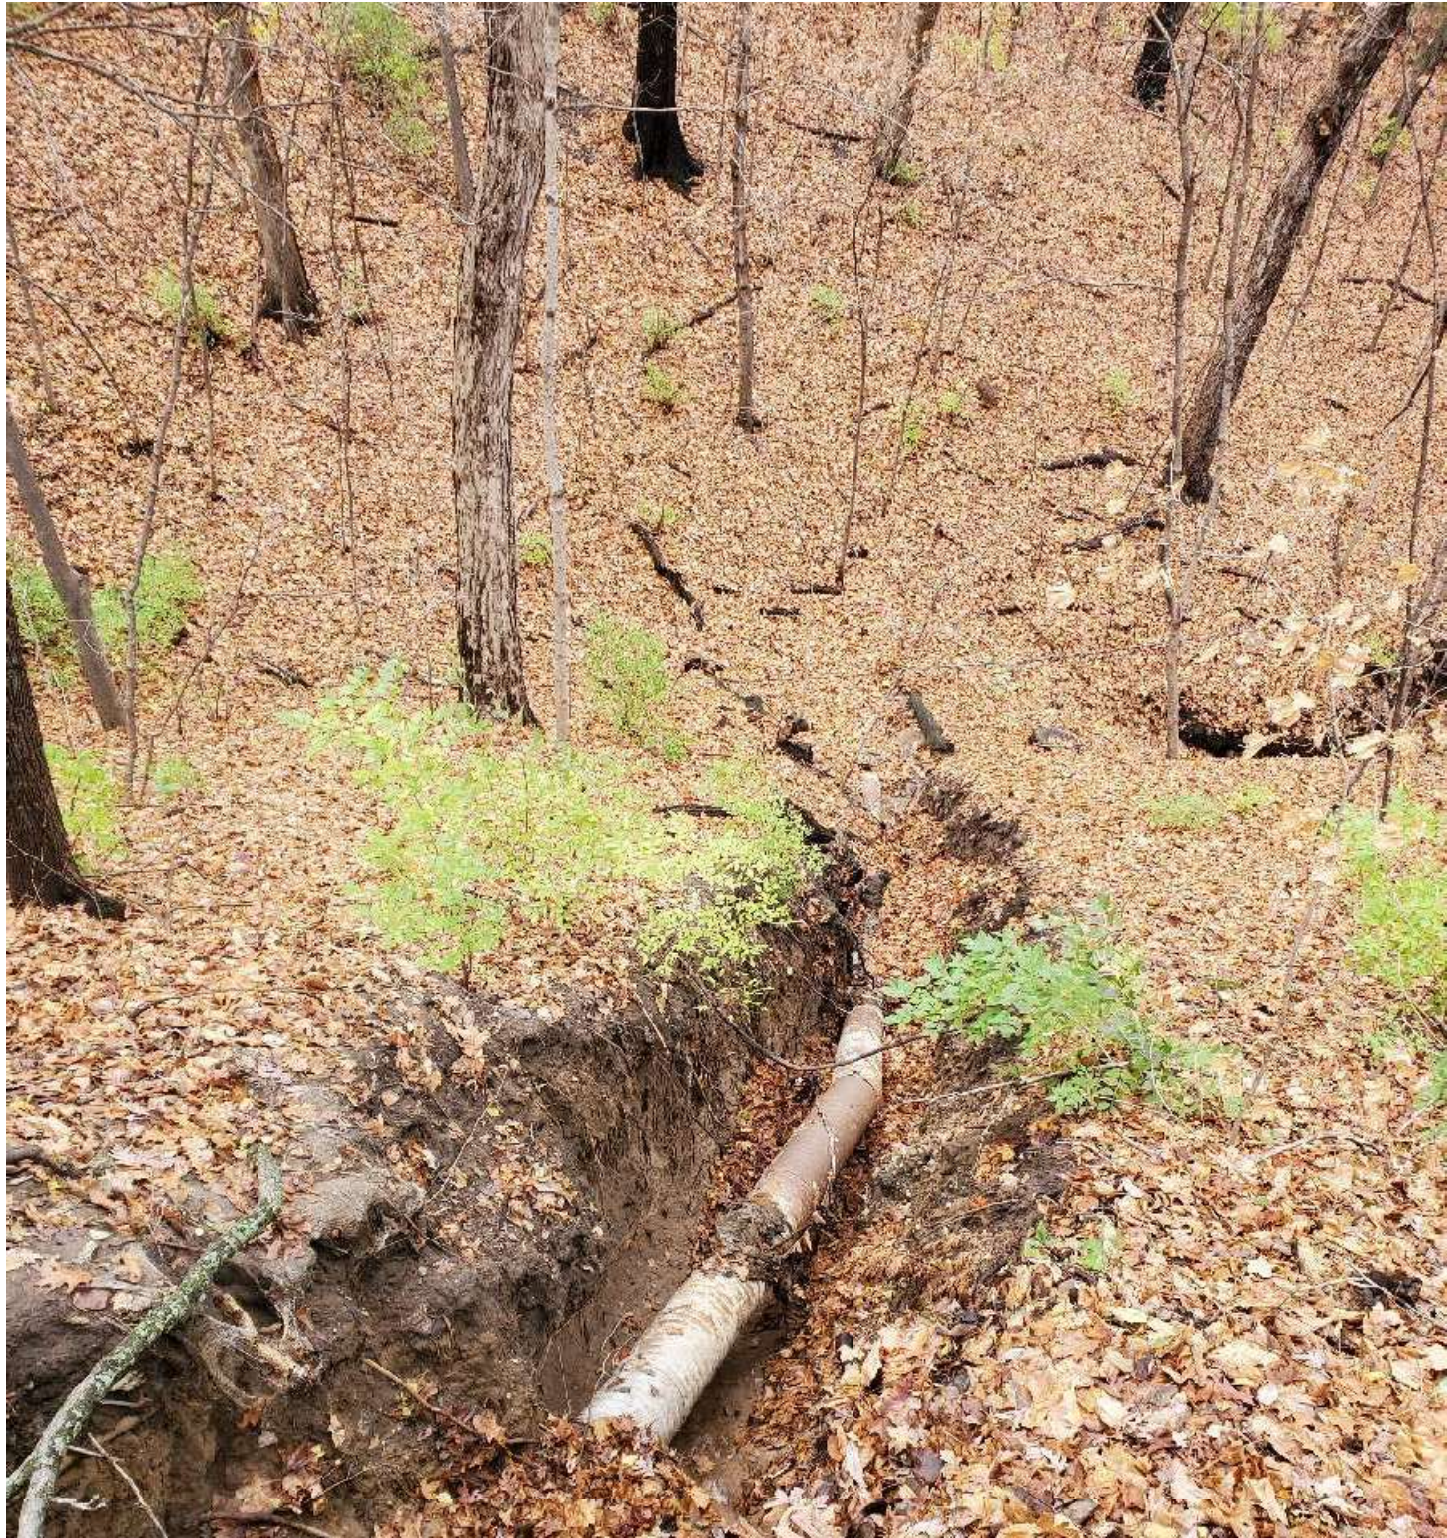
## Object ID 194-Off Terrace Ln

194	Corrugated	18	Poor	1 - Severe Erosion (>5ft)	15 ft	\$ 75,000	Off of Terrace Ln	This outfall has SEVERE erosion	The pipe is rusting
260	Steel	13	Poor	1 - Severe Erosion (>5ft)	15 ft	\$ 75,000	Off of Maria	Televised!	The pipe is rusted
214	Corrugated	15	Very Poor	1 - Severe Erosion (>5ft)	10-12 ft	\$ 75,000	Off of Springfield Rd	The pipe has severe erosion up to 10-12 ft	The pipe is rusting bad causing severe erosion
263	Corrugated	12	Fair	1 - Severe Erosion (>5ft)	12	\$ 75,000	Off of Maria	There is major erosion at the outfall due to break in pipe	Pipes been broken in places and is eroding
94	Corrugated	18	Very Poor	1 - Severe Erosion (>5ft)	9-10	\$ 150,000	Off of Illini	9-10 feet of erosion, no standing water	Belly of pipe is completely rusted out and is completely falling apart as it's coming off the hillside.
166	Corrugated	24	Poor	1 - Severe Erosion (>5ft)	10 ft	\$ 150,000	Off of Oakwood	Bad erosion around the outfall	The pipe bottom is rusted

**COMPLETED**

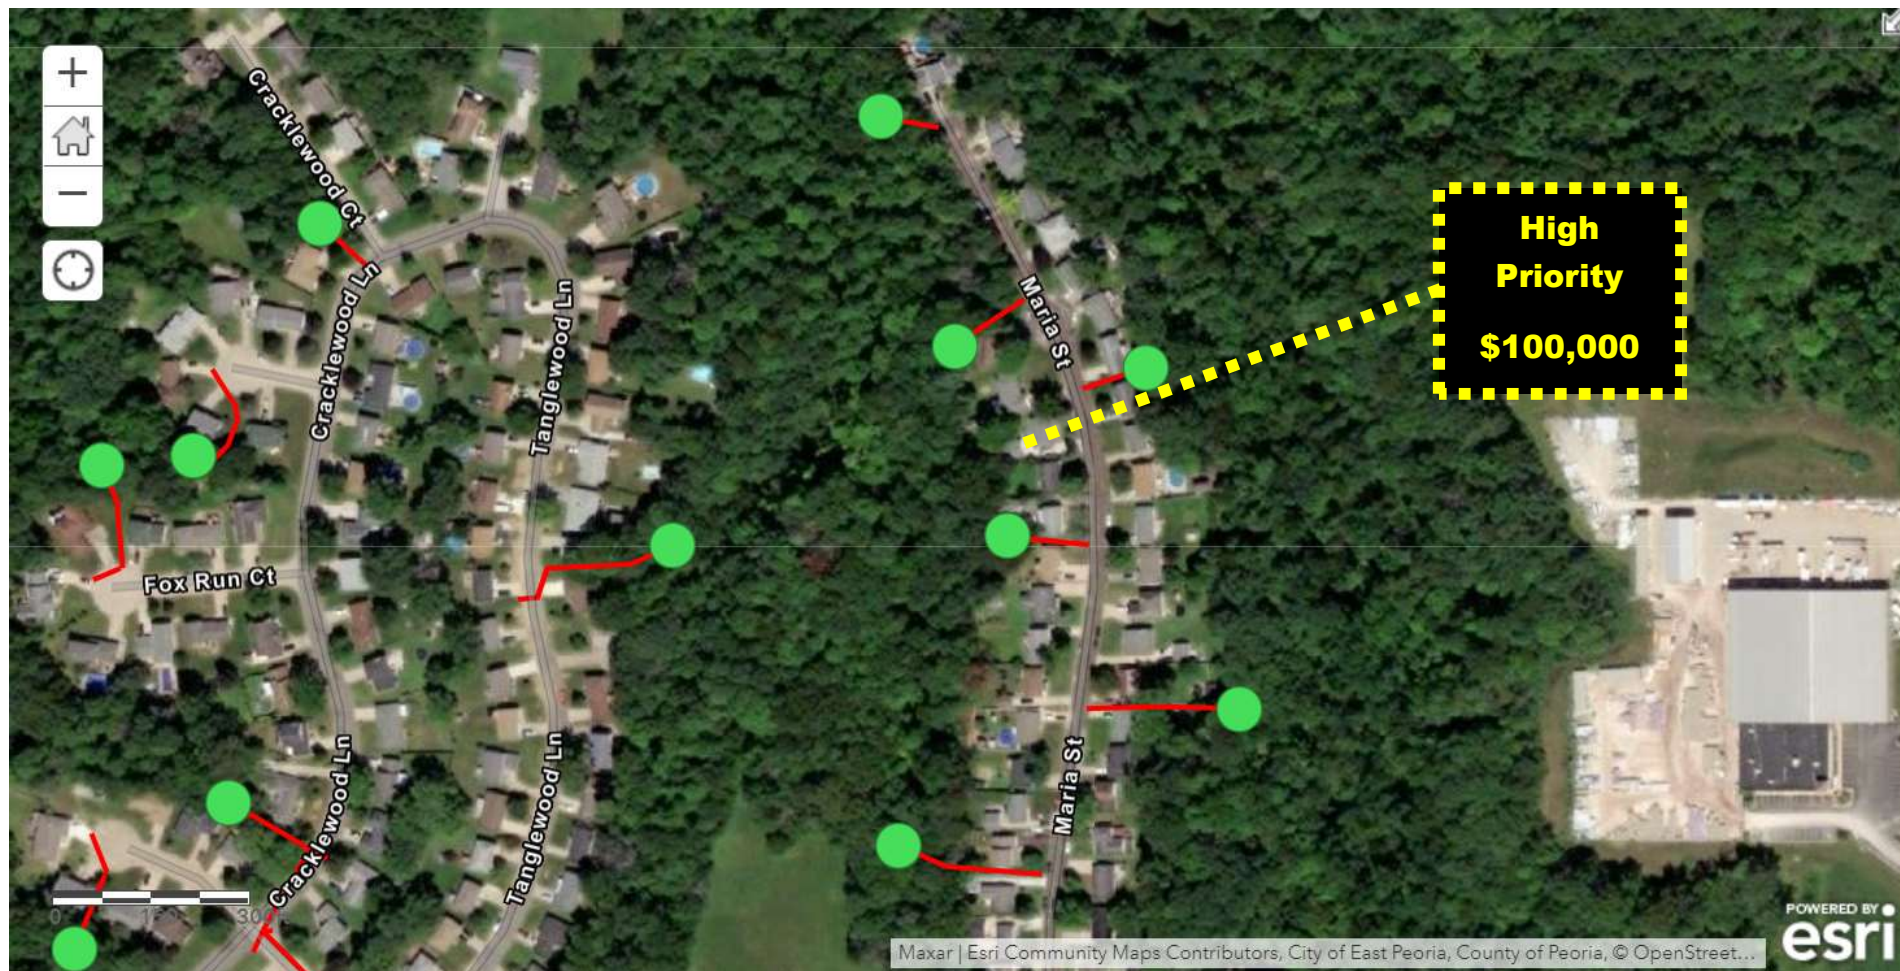
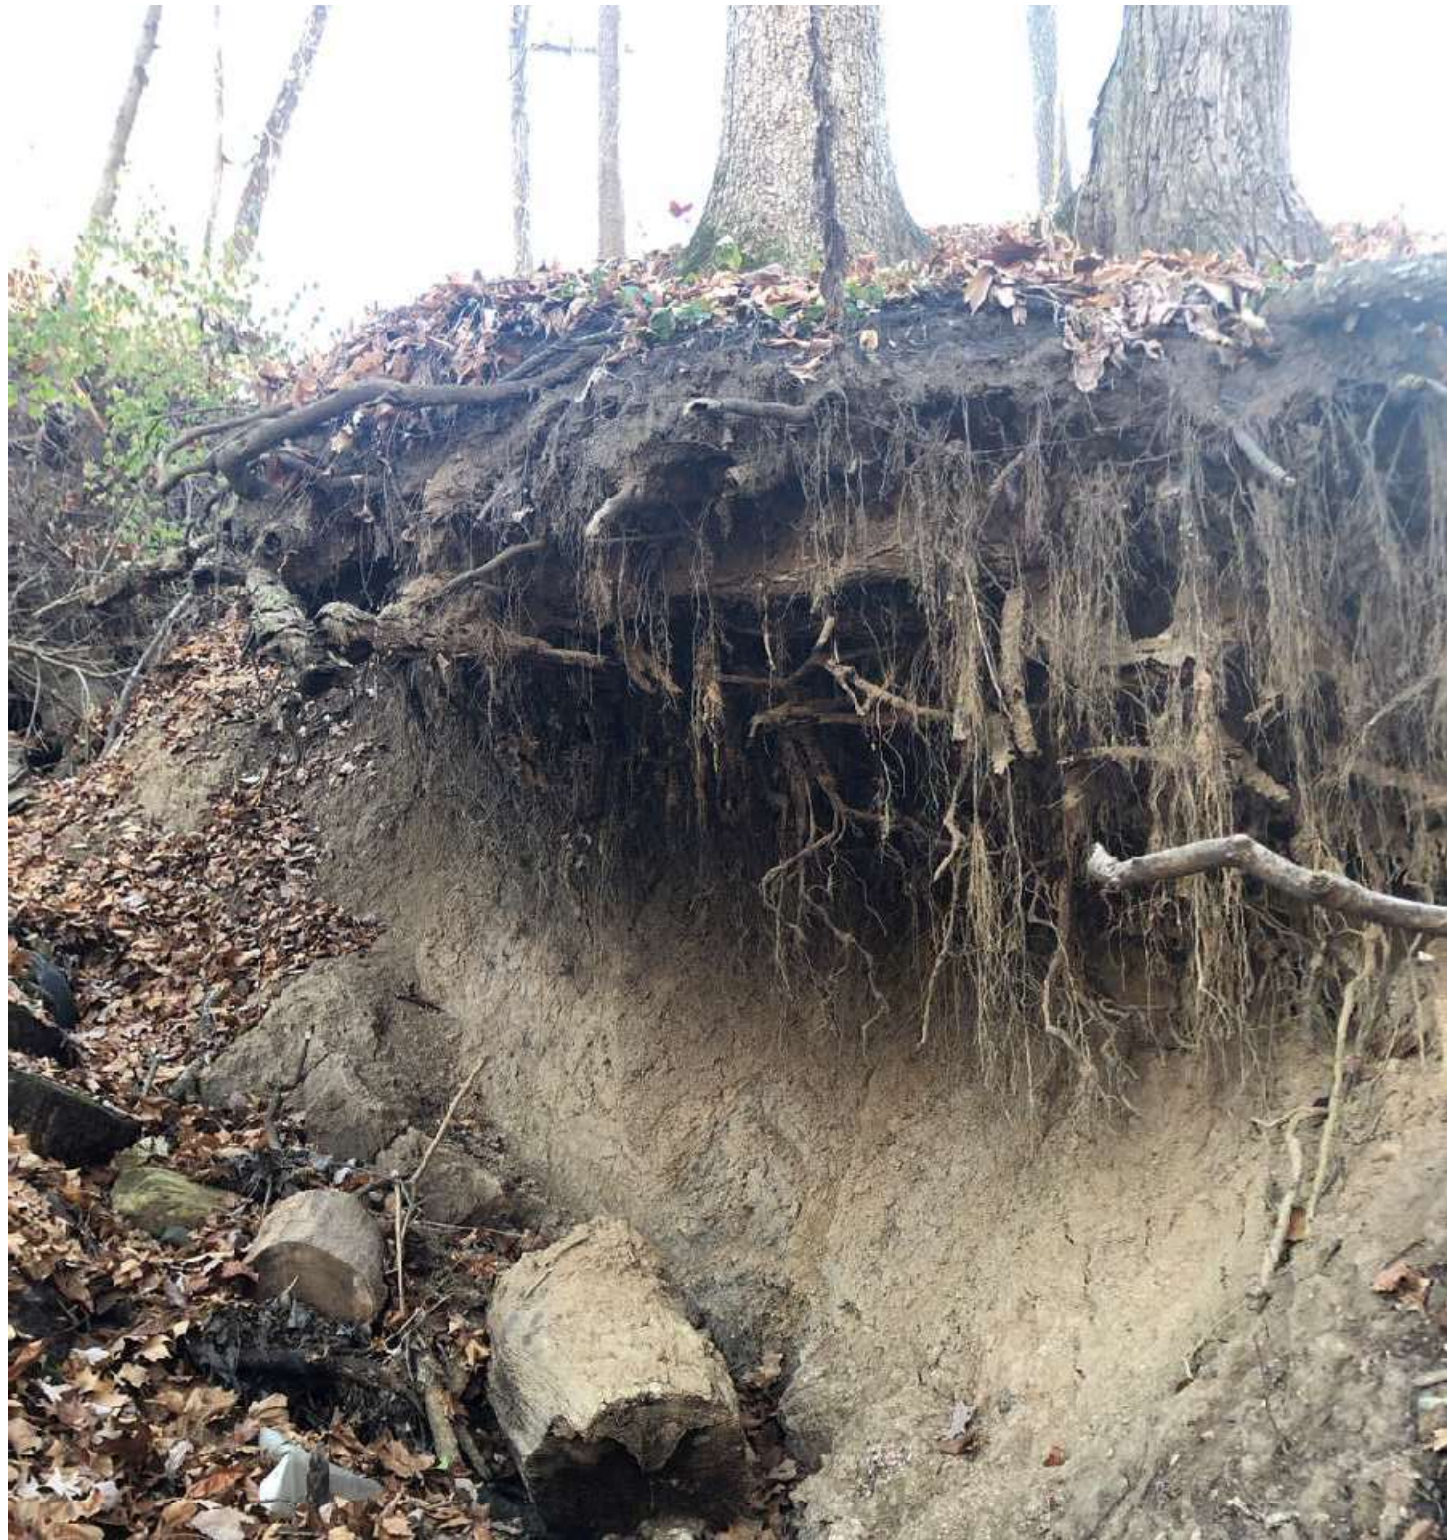
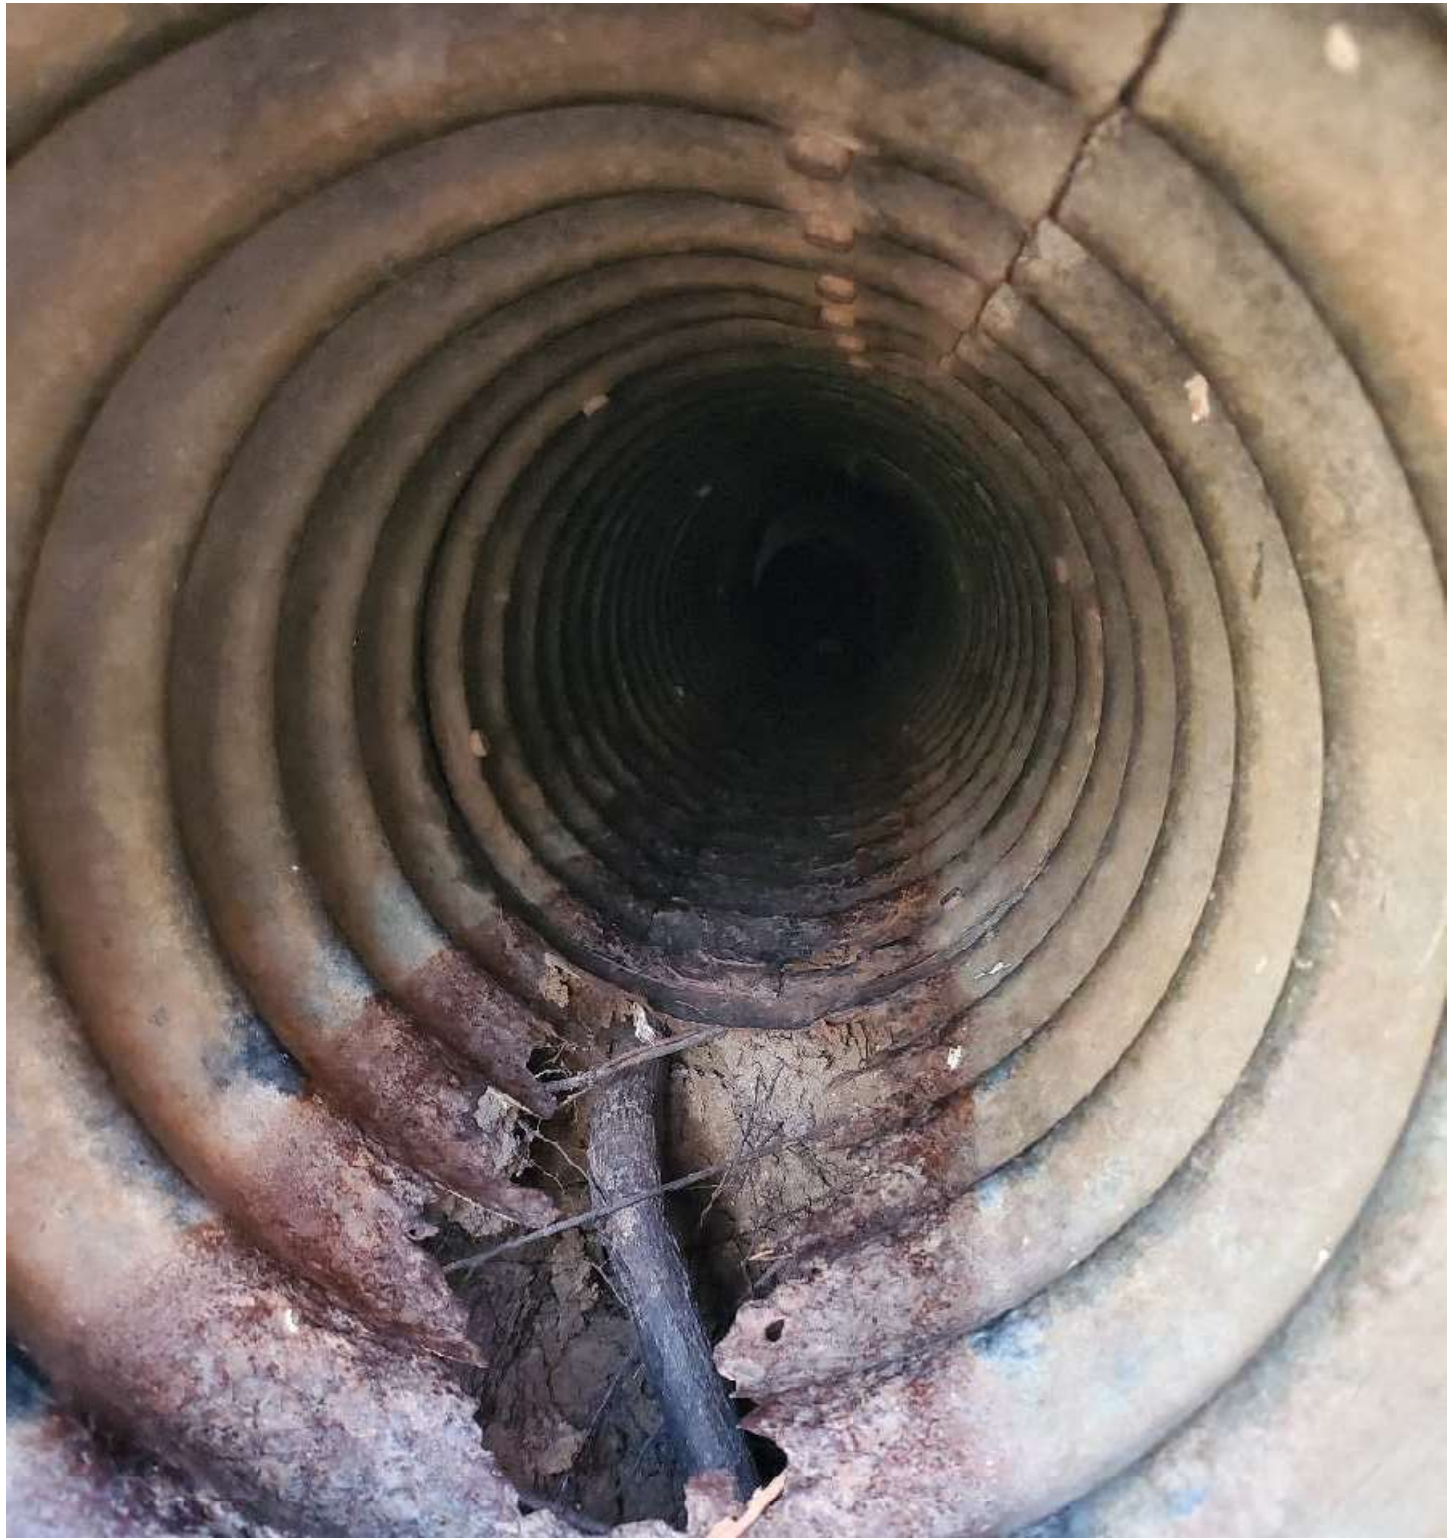
## Object ID 261-Off of Maria St

261	Corrugated	10	Poor	1 - Severe Erosion (>5ft)	10 ft	\$ 100,000	Off of Maria	Severe erosion occurring outside the outfall pipe	Rusty with holes, may be broken off in the pipe

# COMPLETED
