Kickapoo Creek Stabilization Survey

June 2004

Created By: Melissa Eaton, Tri-County Regional Planning Commission
Funded By: Illinois Department of Natural Resources/ Conservation 2000 Ecosystems Program and the State of Illinois Office of Lieutenant Governor

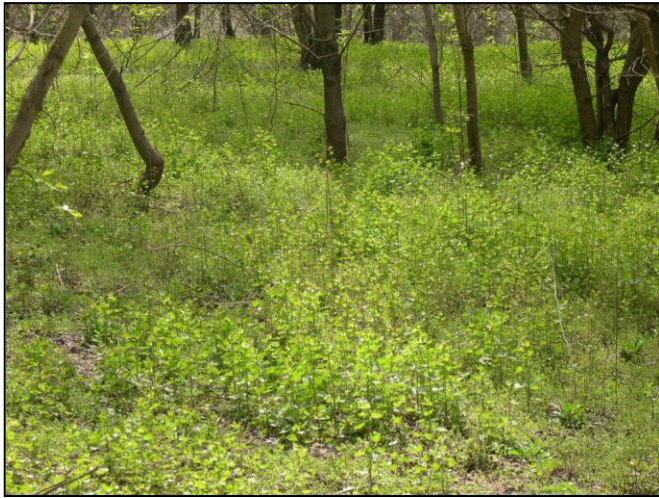
General observations of the riparian zones of Kickapoo Creek indicate that when an extensive vegetative buffer did exist, the quality of that riparian habitat decreased with distance downstream. Near Wildlife Prairie State Park, there was evidence of floral species diversity in herbaceous and trees species (no formal survey was conducted). Riparian areas ten miles downstream were overgrown with the invasive species garlic mustard (figure 9).

Figure 9 Infestation of garlic mustard in lower section of Kickapoo Creek

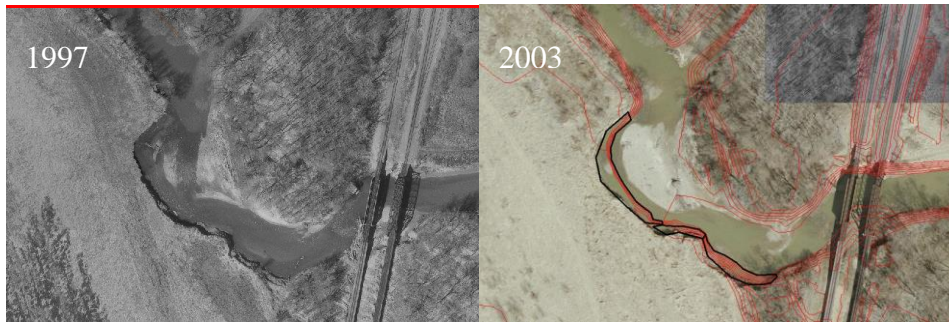
Sixty-eight locations, approximately 5 per mile, showed clear evidence of lateral channel movement with bank erosion mostly occurring on one side of the channel only. The total surface area of streambank lost, as perceived by aerial photographs, was 3 acres. The average height of the streambank eroded from the surface water level was 10 ± 1 ft. Multiplying these dimensions produces a crude estimate 1.3 million cubic feet of riparian soil lost to streambank erosion in the study area during the six year time frame. This number is likely an underestimate as the erosion occurring below the surface water and the less pronounced eroded areas (i.e. slumps) are not accounted for. An example of the 1997/2003 aerial photograph comparison can be seen in figure 10.

Figure 10 1997 and 2003 aerial photograph comparison at Site 5. The 1997 contours overlying the 2003 photo give the viewer a more accurate depiction of where land “used to be”.

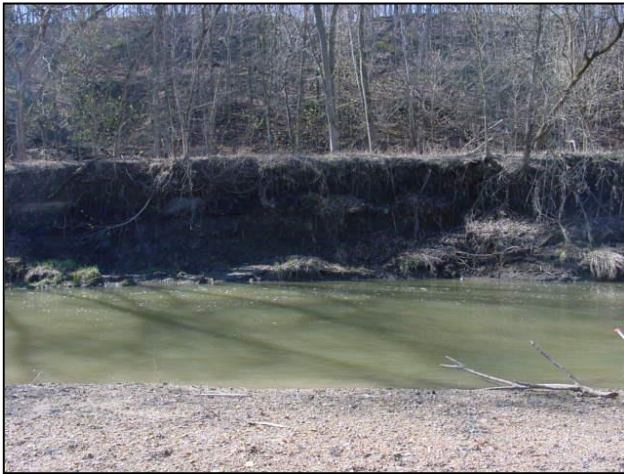
This site is located in the channelized and the upper most portion of the study area at Wildlife Prairie State Park. All the flow chart parameters indicative of **stone toe**

protection are true for this site indicating a CEM stage of III. At stage III the channel has undergone downcutting, likely due to channelization in this circumstance, and is now in the process of widening. The survey gradient for this site is slightly greater than the valley slope from the topographic map. It is possible that the channel is in a transitional state between CEM II and III; therefore, grade stabilization should also be considered.

The eroding bank is near vertical (figure 16) and while re-grading and vegetative stabilization is often utilized in conjunction with stone toe protection, the proximity to the bluff and limited accessibility to the site makes re-grading a challenge. Proper forest management including thinning invasive tree species, performing prescribed burns, and seeding would allow deep rooted vegetation to grow and improve the streambank ability to resist erosive forces.

Figure 16 Vertical bank adjacent to a forested bluff at Site 1

Summary Recommendation, Site 1: Grade stabilization, stone toe protection and forested bluff habitat management along the eroding bank.

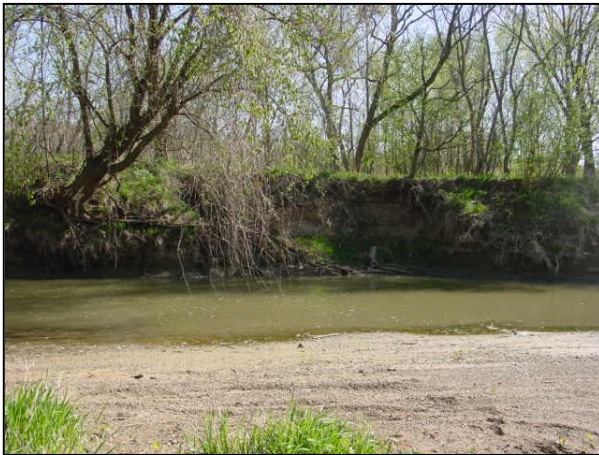
Figure 17

All parameters in the flow chart indicative of stage IV CEM and **bendway weirs and stone toe protection or stream barbs** for stabilization are true. This site is approximately 5.5 miles downstream from Site 1. In system wide instabilities, such as that seen in Kickapoo Creek, it can be expected that the evolution of the channel is more advanced in the lower reaches than the upper, particularly since channel incision (the initial stage of an adjusting channel) migrates upstream. Re-grading the bank is feasible; however, trees would likely need removal and access is limited (figure 17).

Summary Recommendation, Site 3: Place bendway weirs and stone toe protection or stream barbs along the eroding bank. Shape slope to reduce failure hazard if feasible and seed with native trees and herbaceous vegetation.

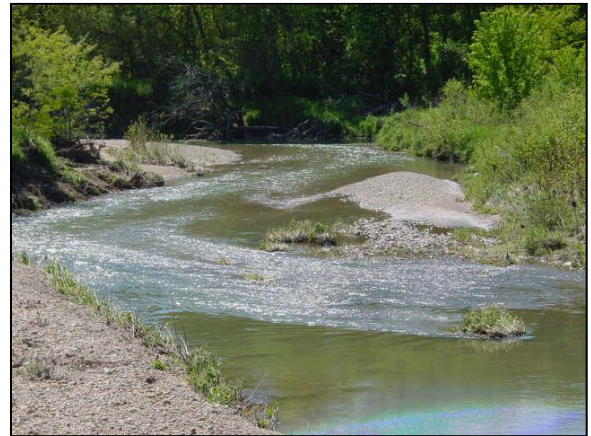
Figure 18 Weirs placed within Kickapoo Creek by the USDA/NRCS upstream of the study corridor

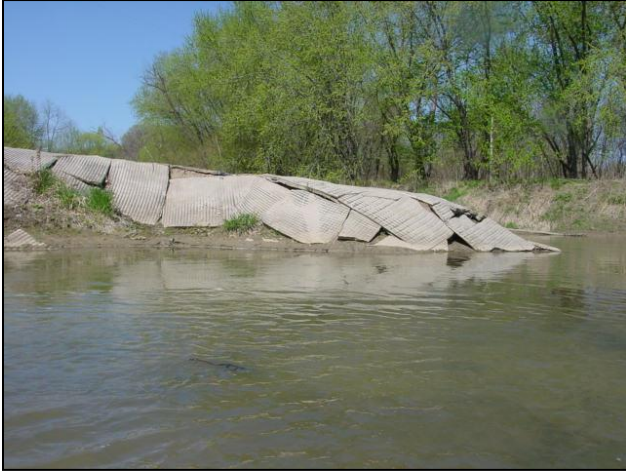
The characteristics of this site best match those listed for the **bendway weirs and stone toe protection or stream barbs** recommendation. All parameters listed for this recommendation are true; however, the bed material at the riffle is composed of silt, indicating grade instability; and the bank full width at the site is <130% of the width at the riffle, a characteristic of stage III channel evolution. These discrepancies may be related to channel failure that occurred 1,400 feet upstream where a structure redirecting the stream current was placed in the creek causing adjacent banks to erode and new sandbars to deposit (figure 19). The 1997 and 2003 aerial photographs of this site are seen in figure 20.

Figure 19 Streambank structure in the channel directly upstream of Site 4

Summary Recommendation, Site 4: Place bendway weirs and stone toe protection or stream barbs along the eroding bank at site. Shape slope to reduce failure hazard and seed with native trees and herbaceous vegetation. Investigate proper maintenance or possible removal of structure upstream to prevent further channel damage.

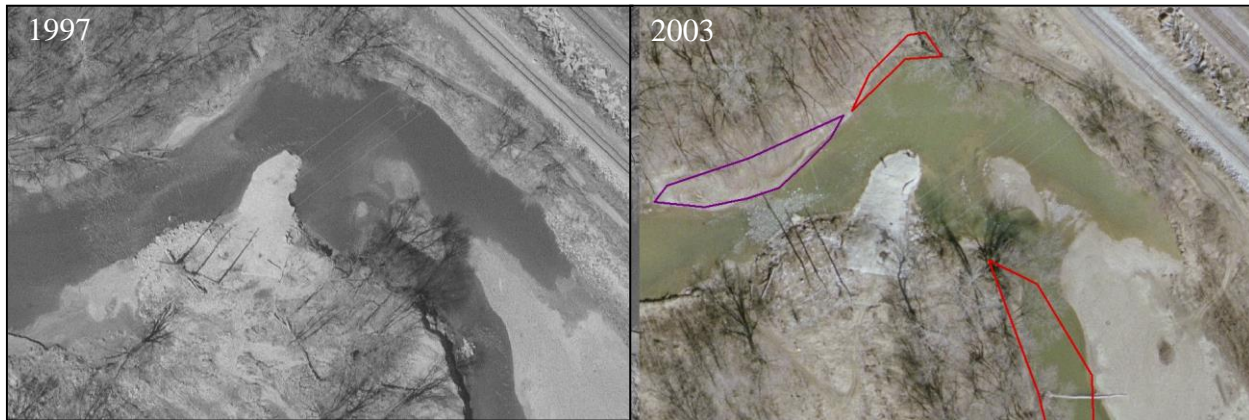
Figure 20 1997 and 2003 aerial view of Figure 19. Red polygons are areas of streambank erosion while the purple are point bar formations.
