Kickapoo Creek Stabilization Survey

June 2004

Created By: Melissa Eaton, Tri-County Regional Planning Commission
Funded By: Illinois Department of Natural Resources/ Conservation 2000 Ecosystems Program and the State of Illinois Office of Lieutenant Governor

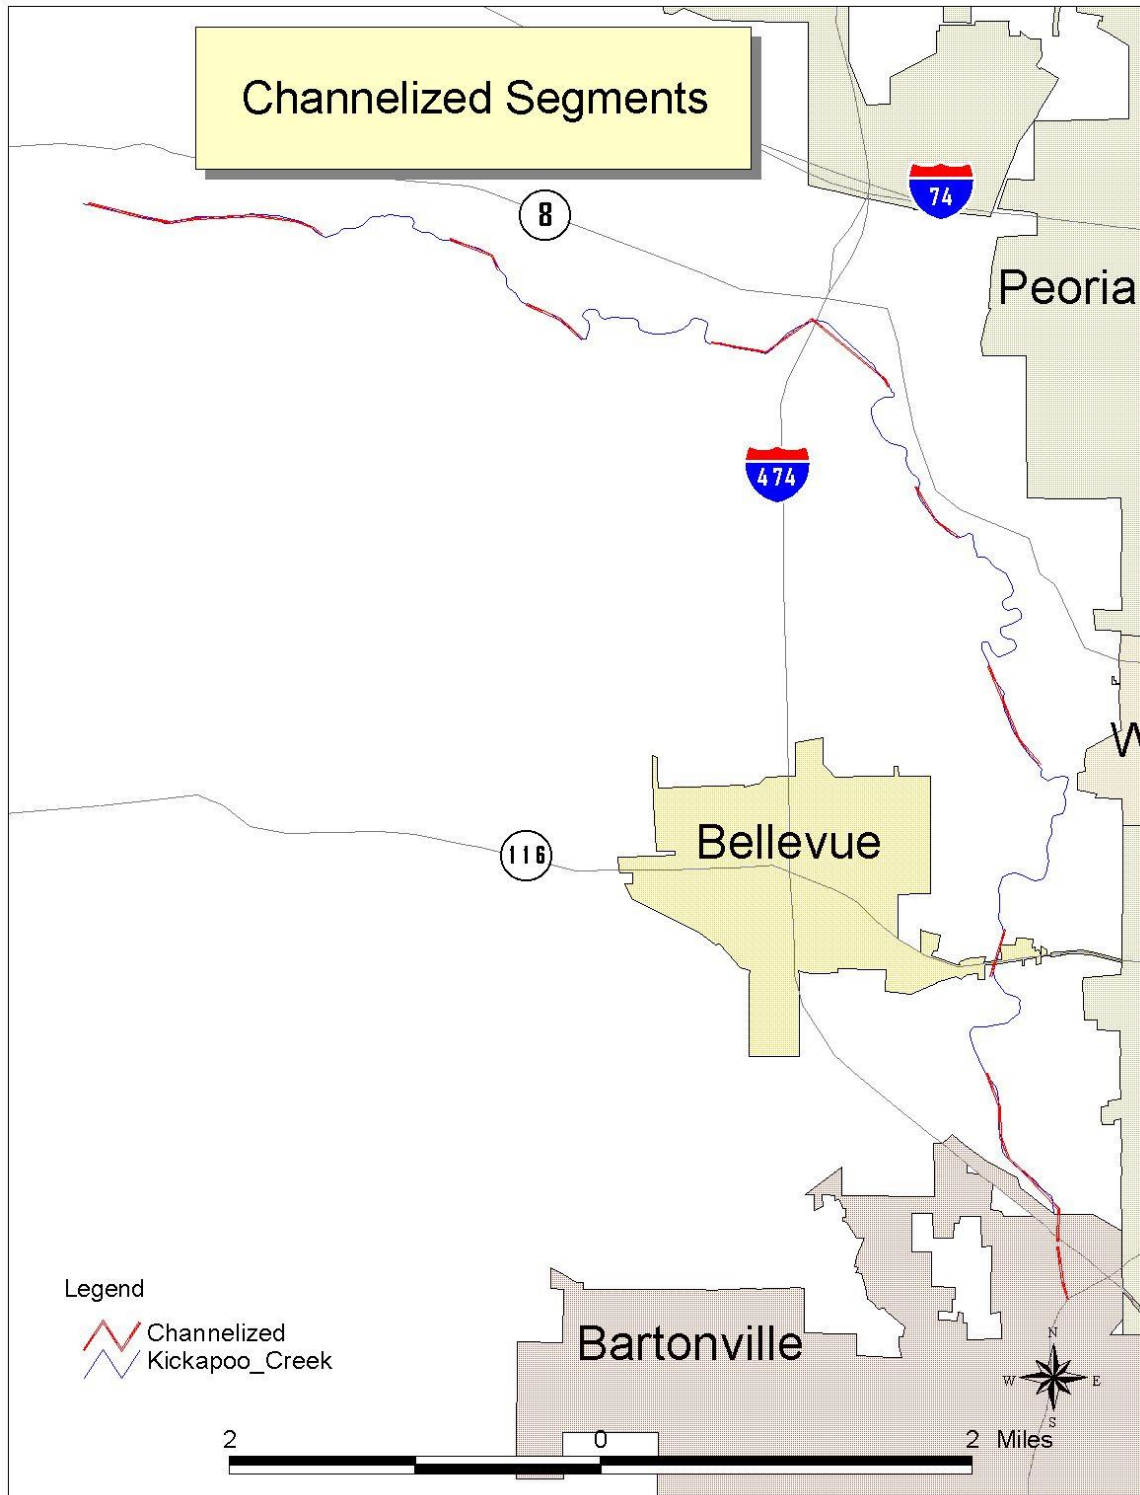
Figure 7

From analyzing year 2003 aerial photographs, it was determined that approximately 5.7 miles (12%) of stream has been channelized in the study area (figure 7). This is reflected in a low sinuosity value of 1.2 of the stream segment. Sinuosity is the ratio of stream length to valley length. Channelization occurred along farm fields, rail lines, and Kickapoo Creek Road.

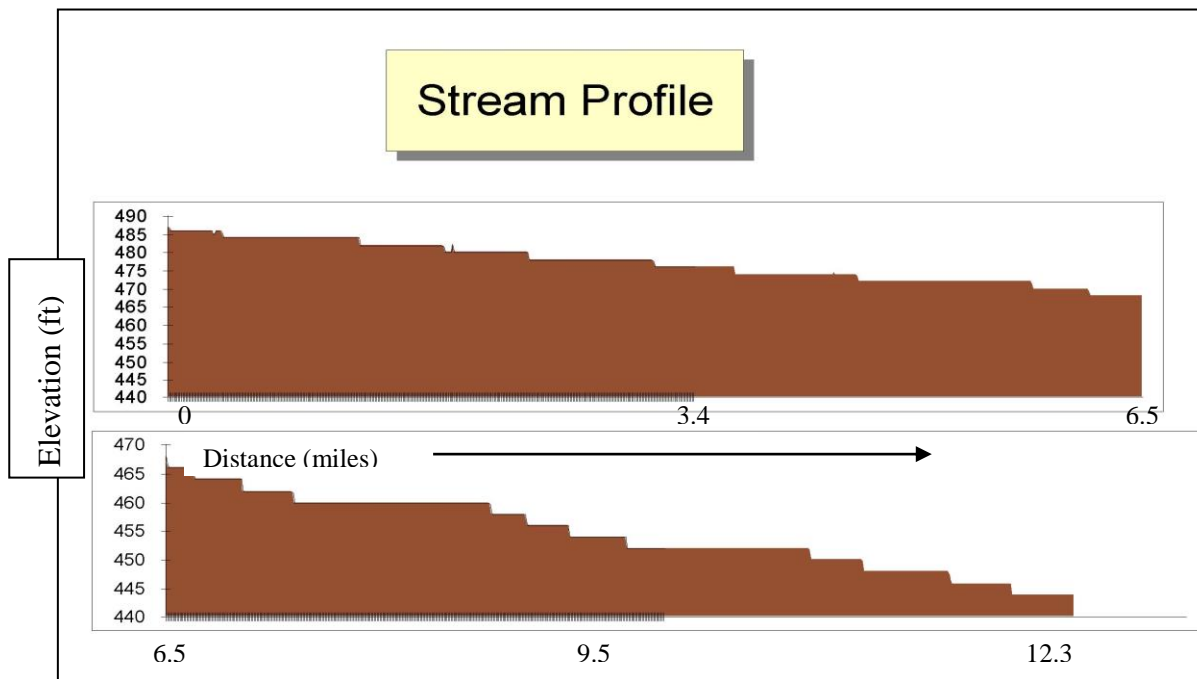
Overall gradient of the study corridor as calculated by the stream profile and 1997 2-foot contours was 0.007 (figure 11). From 0-6.5 miles into the study corridor, the drop in elevation is fairly evenly distributed; however, from mile 6.5 to the terminus the elevation drops in more clustered fashion indicating possible knick points in the stream; however, some streams in Illinois do exhibit naturally occurring steeper slopes in the lower reaches (figures 12 and 13).

Figure 11 Stream profile of Kickapoo Creek study corridor.

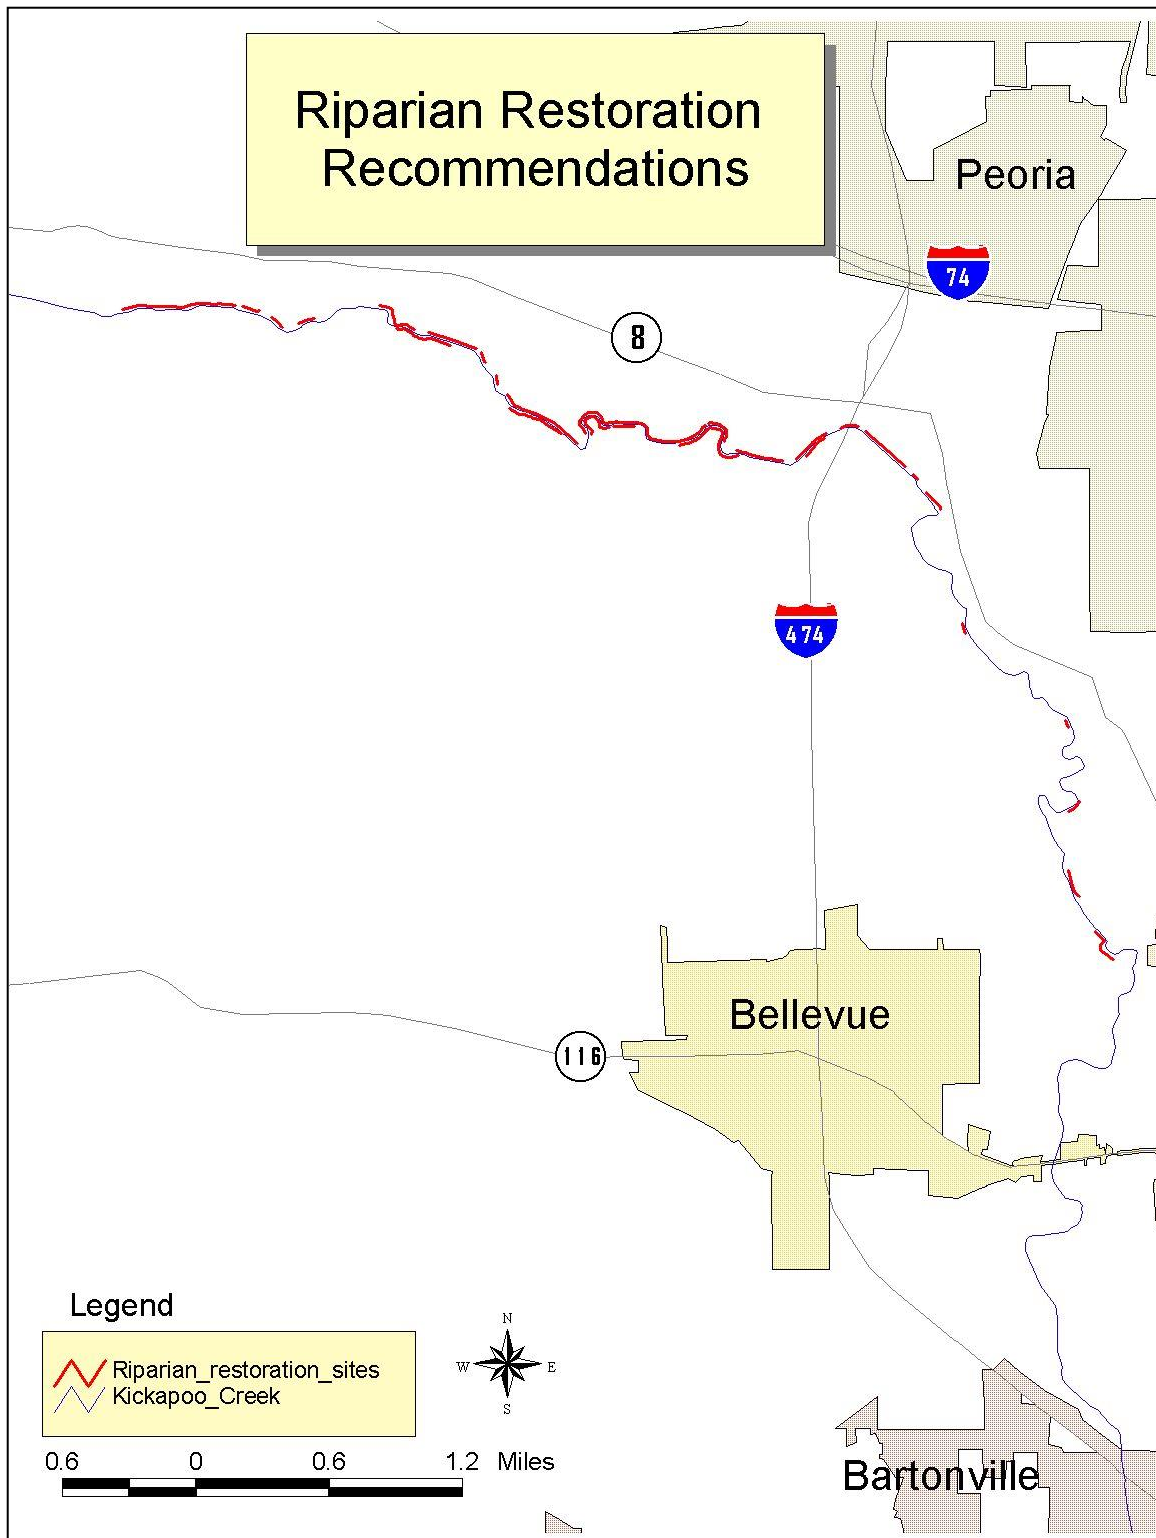
Figure 14

Riparian areas that lacked a minimum 100-foot vegetative buffer, as seen from year 2003 color aerial photographs, were marked via GIS ArcView mapping systems. Locations of those areas can be seen in figure14. A total of 5.5 miles of streambank are in need of additional vegetative buffer. The areas selected do not include those directly adjacent to roadways where restoration is not feasible.
