City experiencing more erosion after wet season

East Peoria Times-Courier

Wed Sep 02, 2009, 01:48 AM CDT

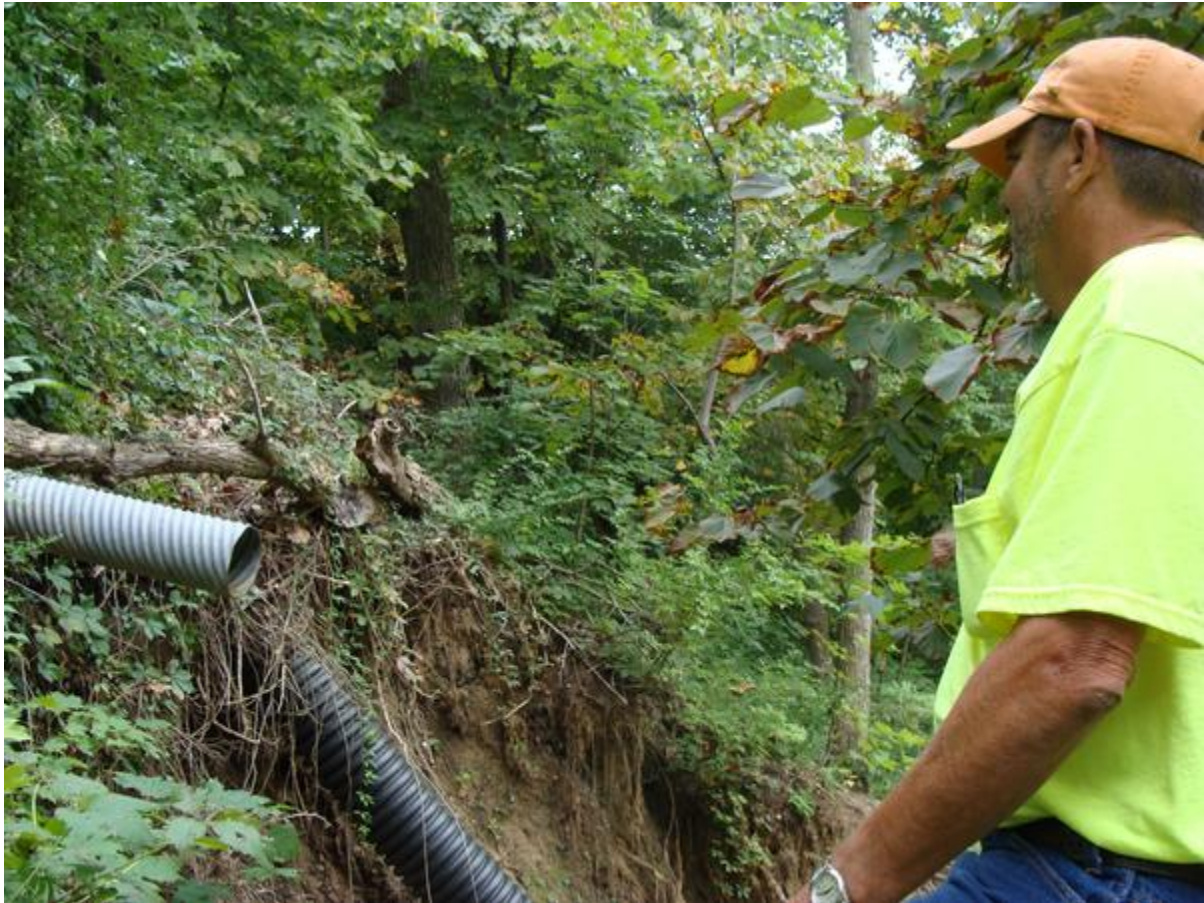
East Peoria Public Works employee Bentley Hall looks over a ravine in East Peoria where an erosion problem needs attention. Hall said the storm water run-off pipe jutting out of the side of the hill would not be allowed by today's standards.

Behind the two homes on Highview Terrace, Hall looked down the ravine where a black plastic pipe and a metal pipe jutted from the dirt. Hall said the developer installed the piping long ago.

“The idea would have been to put a pipe down to the bottom. There’s a possibility there was a pipe put in and it broke apart,” he said.

Hall guessed that over time, about 300 tons of dirt have washed away from the ravine. A tree’s roots were exposed near the pipes.

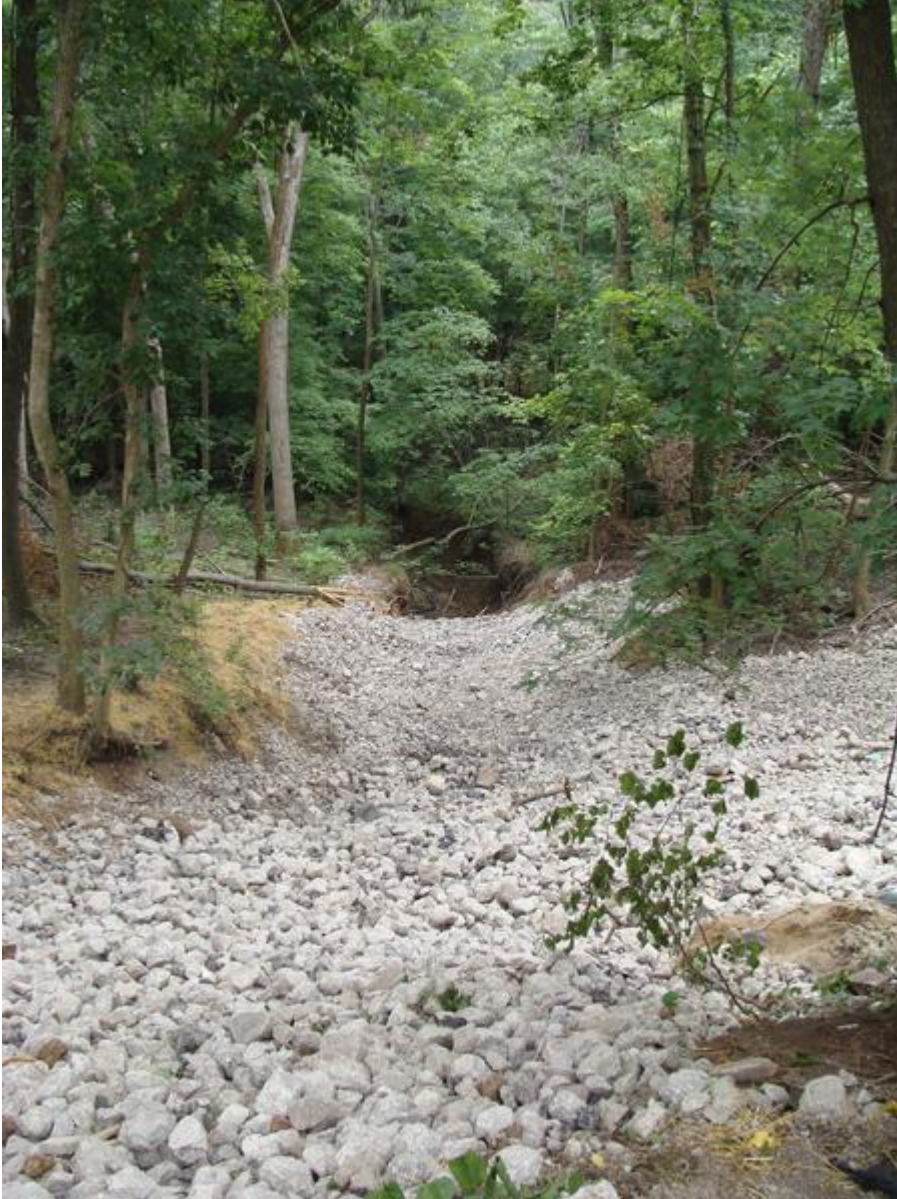
A ravine was recently filled with rock to prevent erosion.

To repair major erosion problems, the contractor has to go down the gully with equipment to find the original soil that has not been disturbed to put footings into. Wire baskets with large stones are also used for support and to slow the flow of the water.

“It holds everything they put in behind it ... and lets water run through the rocks,” Hall said. Hall said with today’s development, there is a much better system with retention and detention of water. There are also erosion control guidelines from the city and the Environmental Protection Agency.

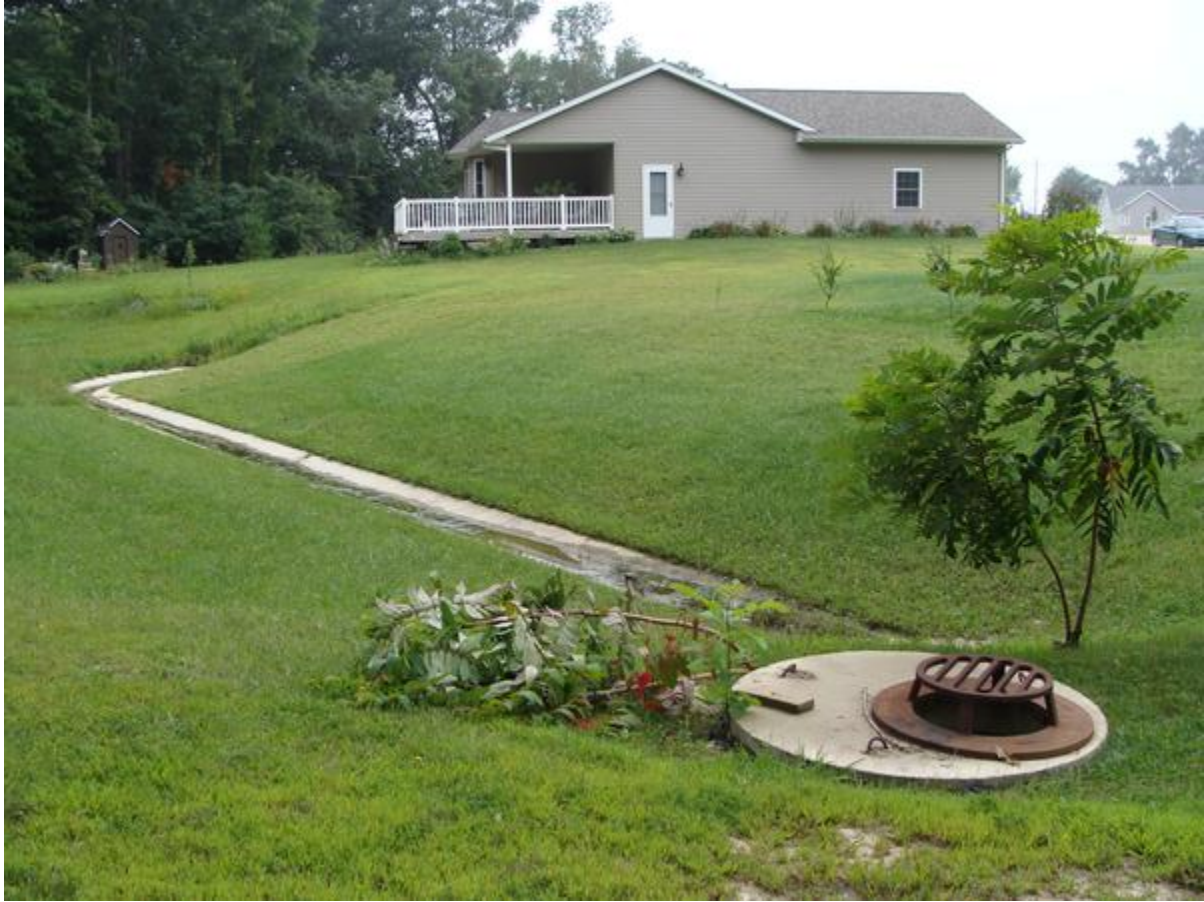
Hall said this retention pond at a new subdivision called Cottonwood Estates is the improved way to handle water run off.

At Cottonwood Estates, a new subdivision in East Peoria, Hall showed a newer retention system where the water is more controlled.

The water is contained in two retention ponds behind the homes and released slowly through pipes that narrow.
