# **The City of East Peoria Storm Water Management Plan**

November - 2025

**Patrick N. Meyer & Associates, Inc.**

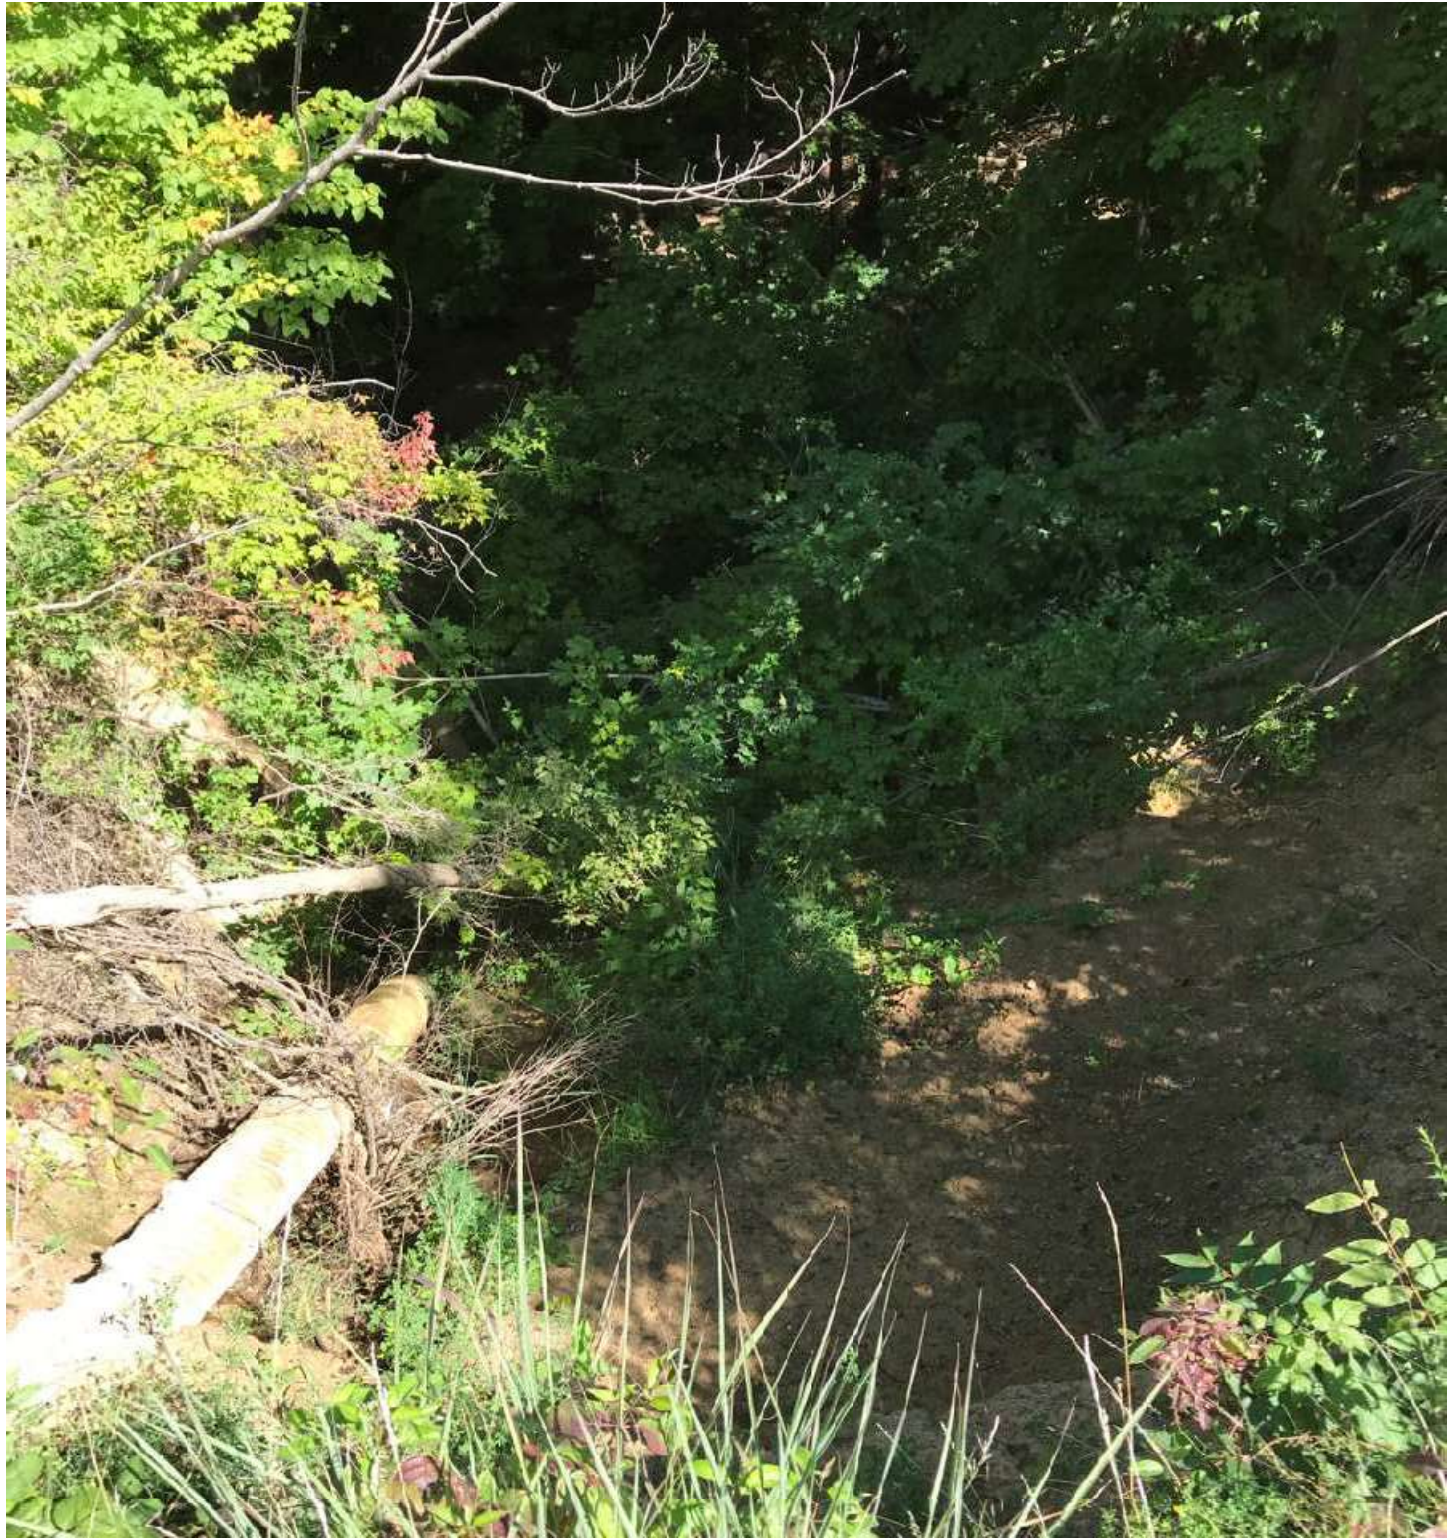
## Object ID 10-Off Centennial Dr

**COMPLETED**

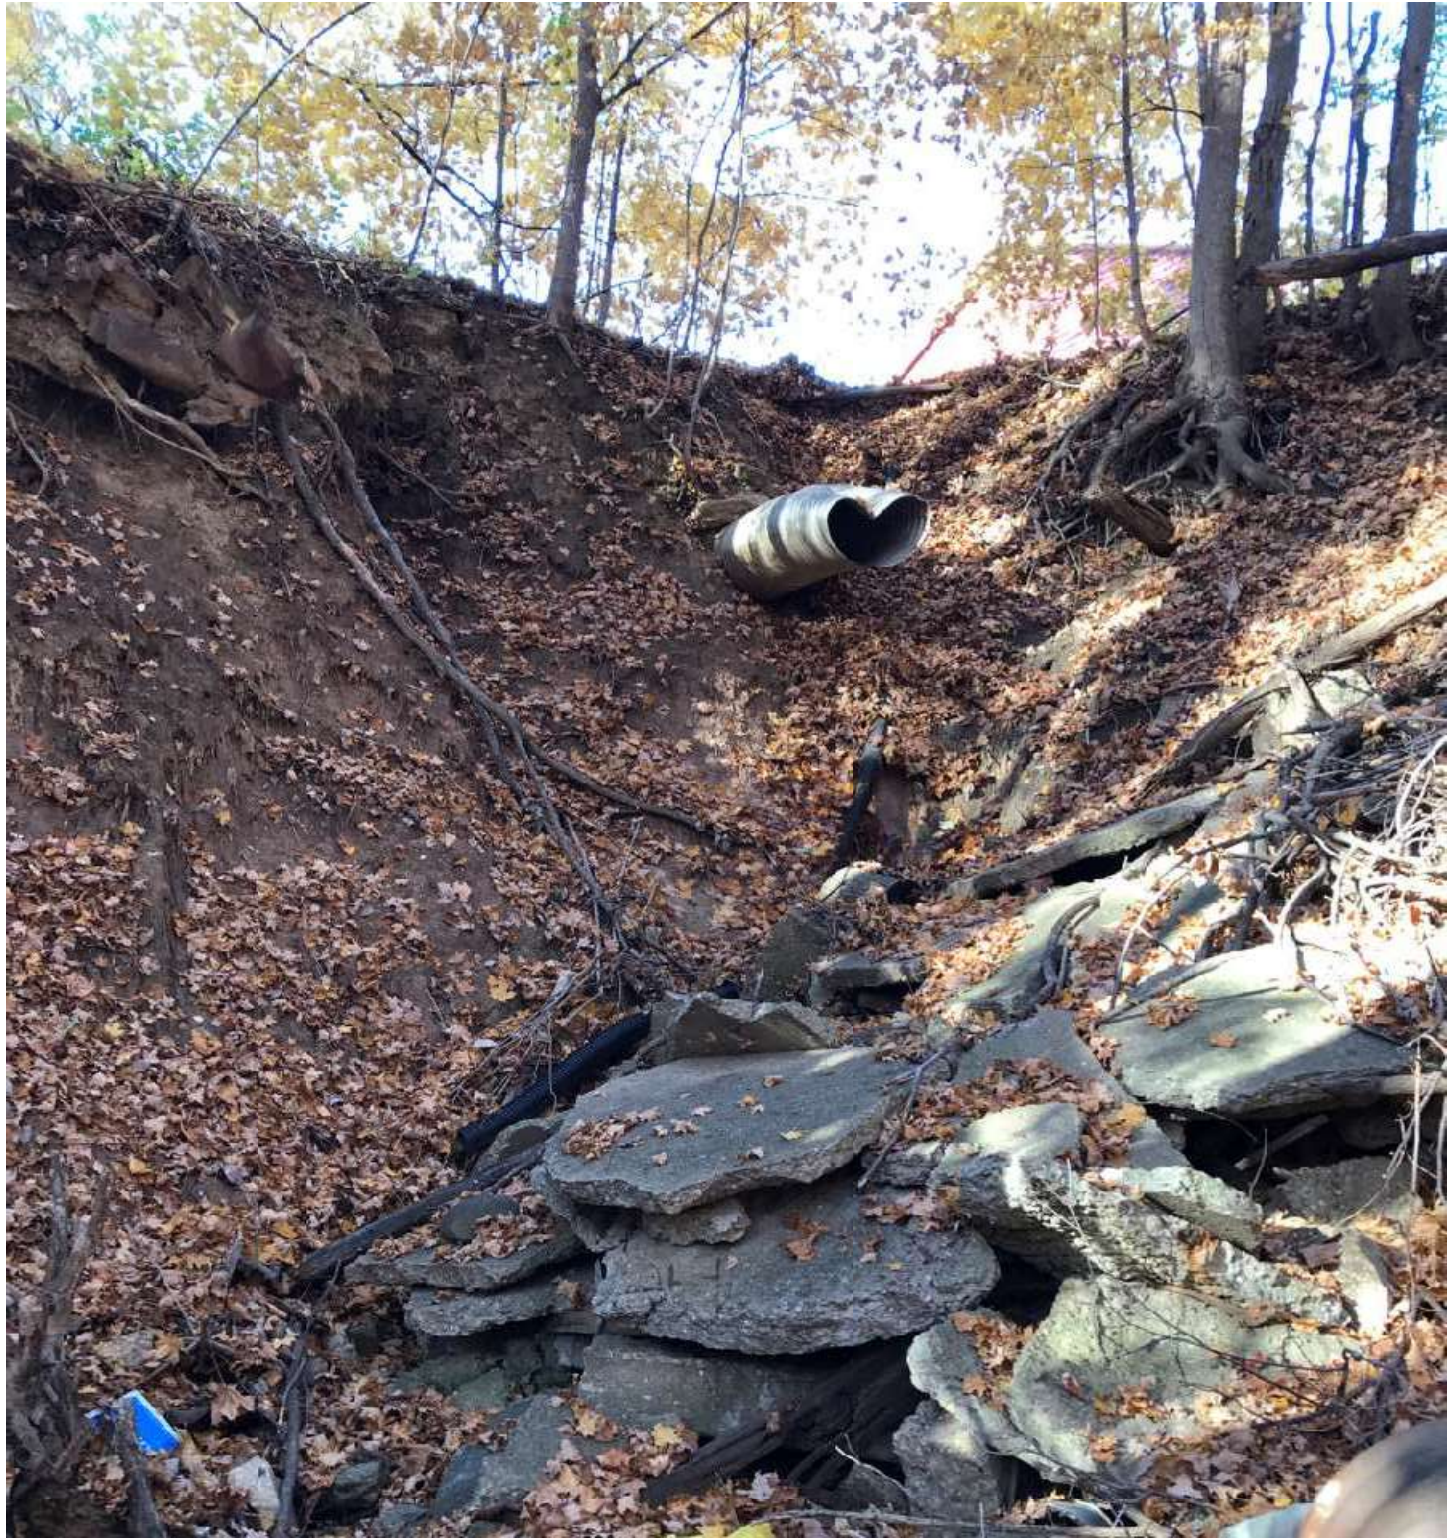
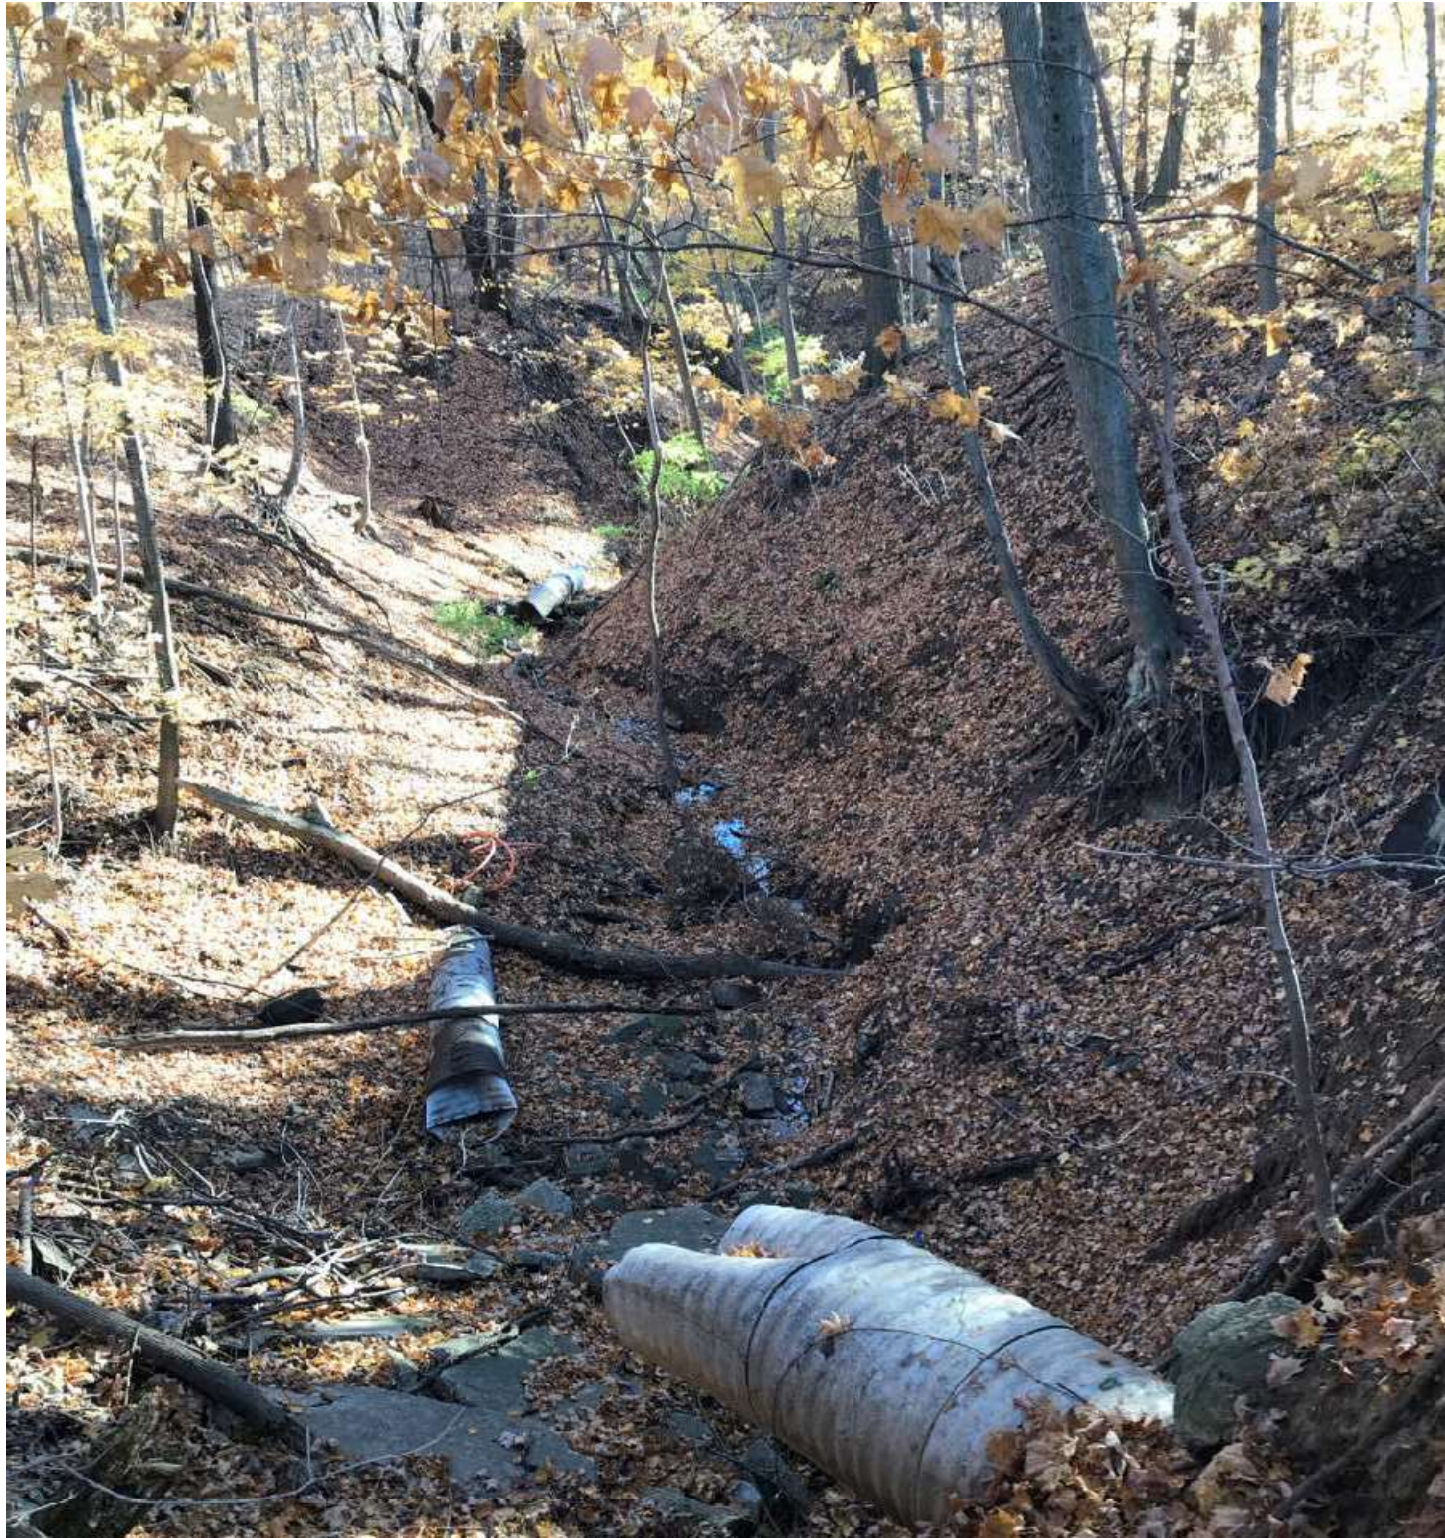
## Object ID 92-Off Illini Dr

**High  
Priority  
\$75,000**

**COMPLETED**

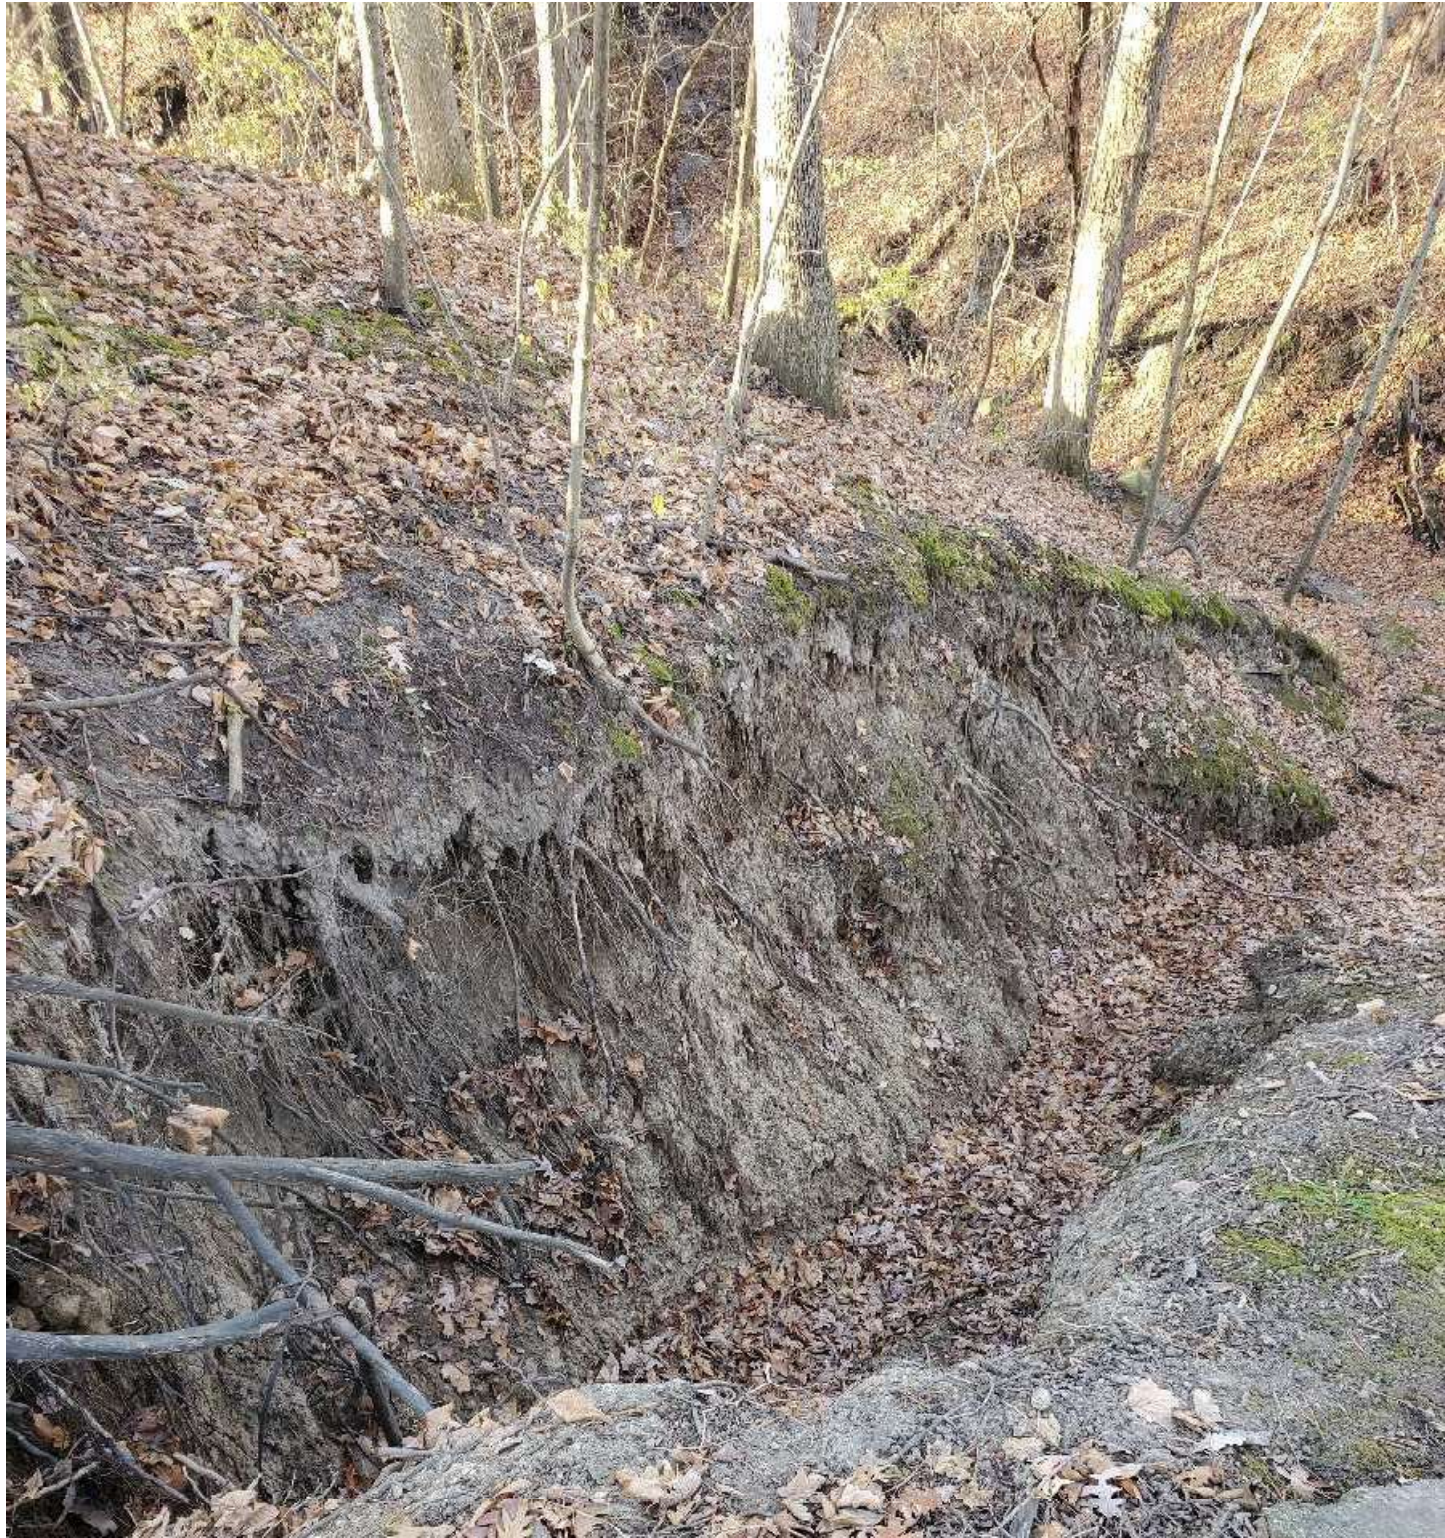
## Object ID 260-Off Maria St

**COMPLETED**

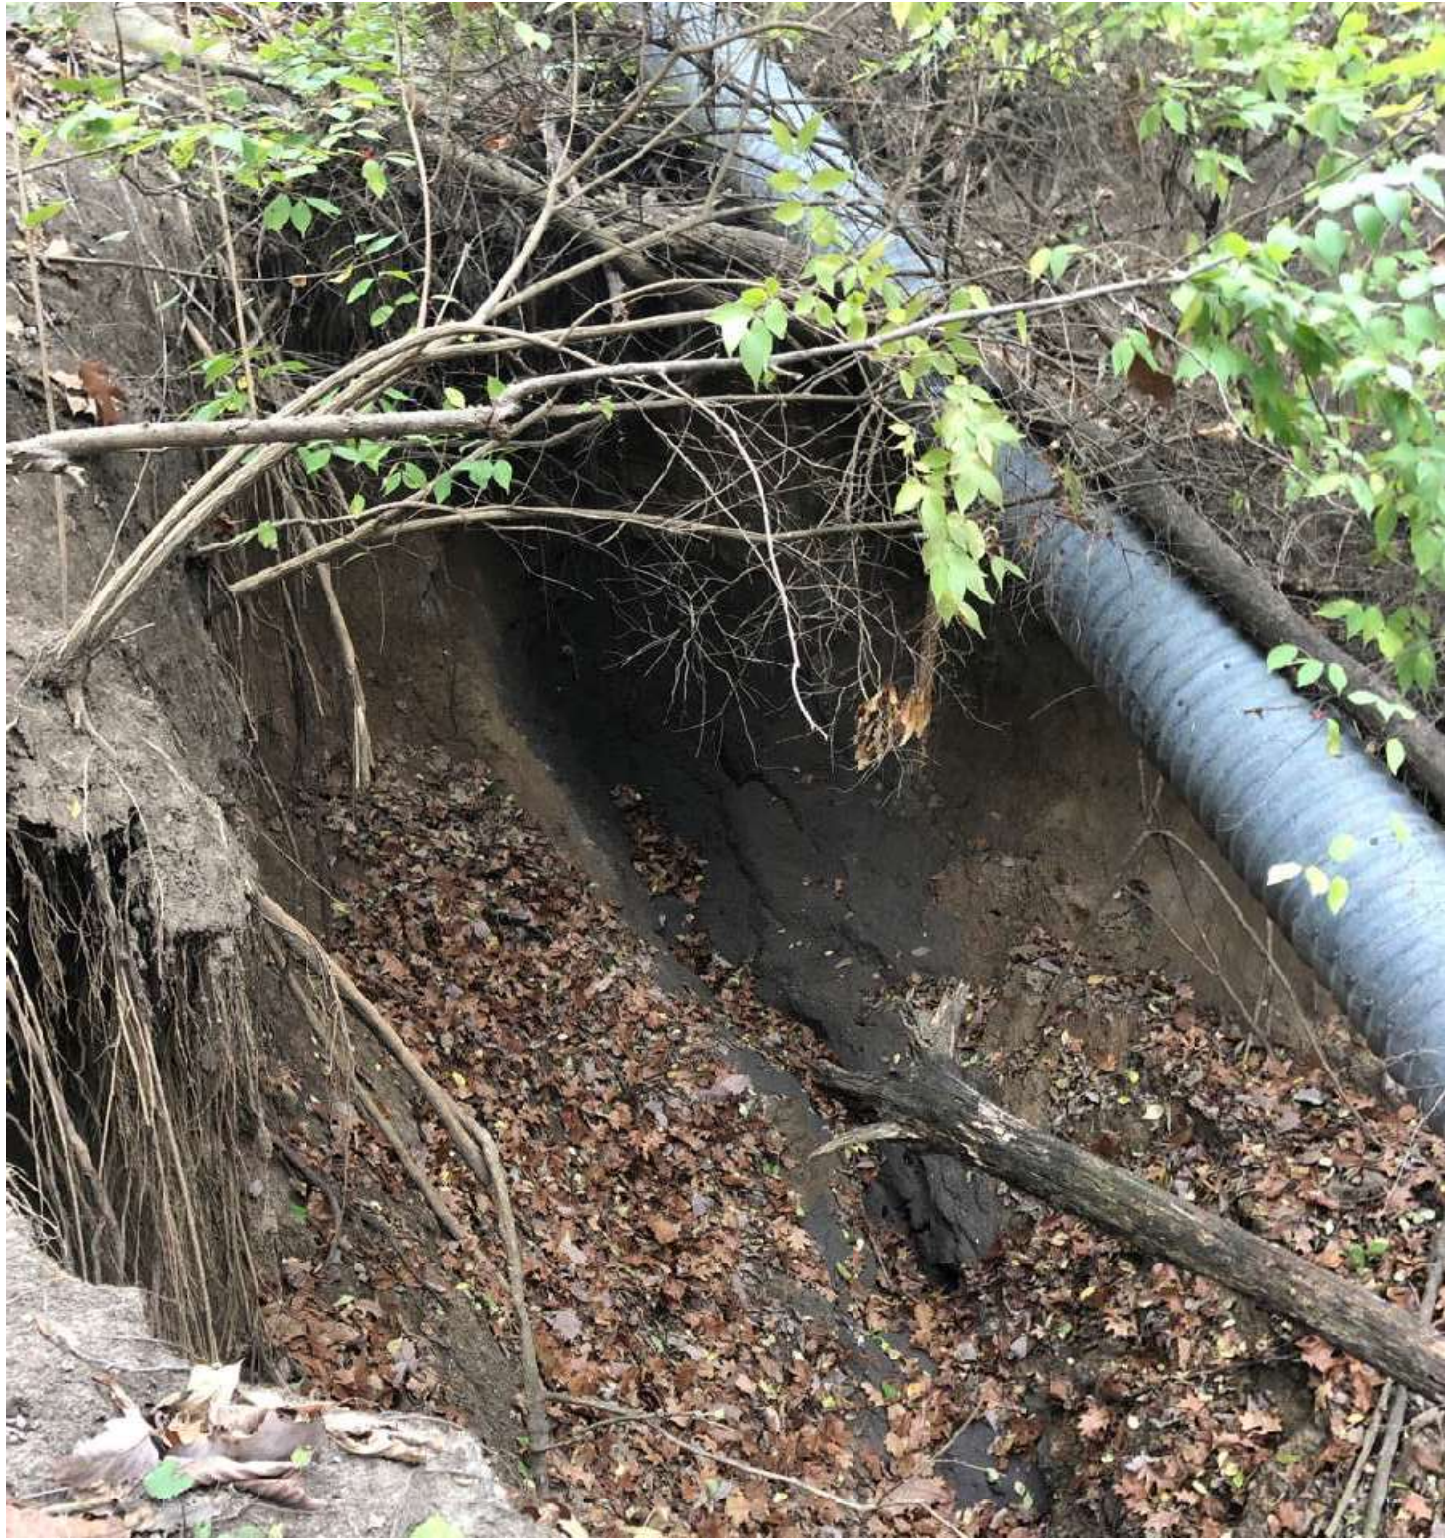
## Object ID 214-Off Springfield Rd

# COMPLETED

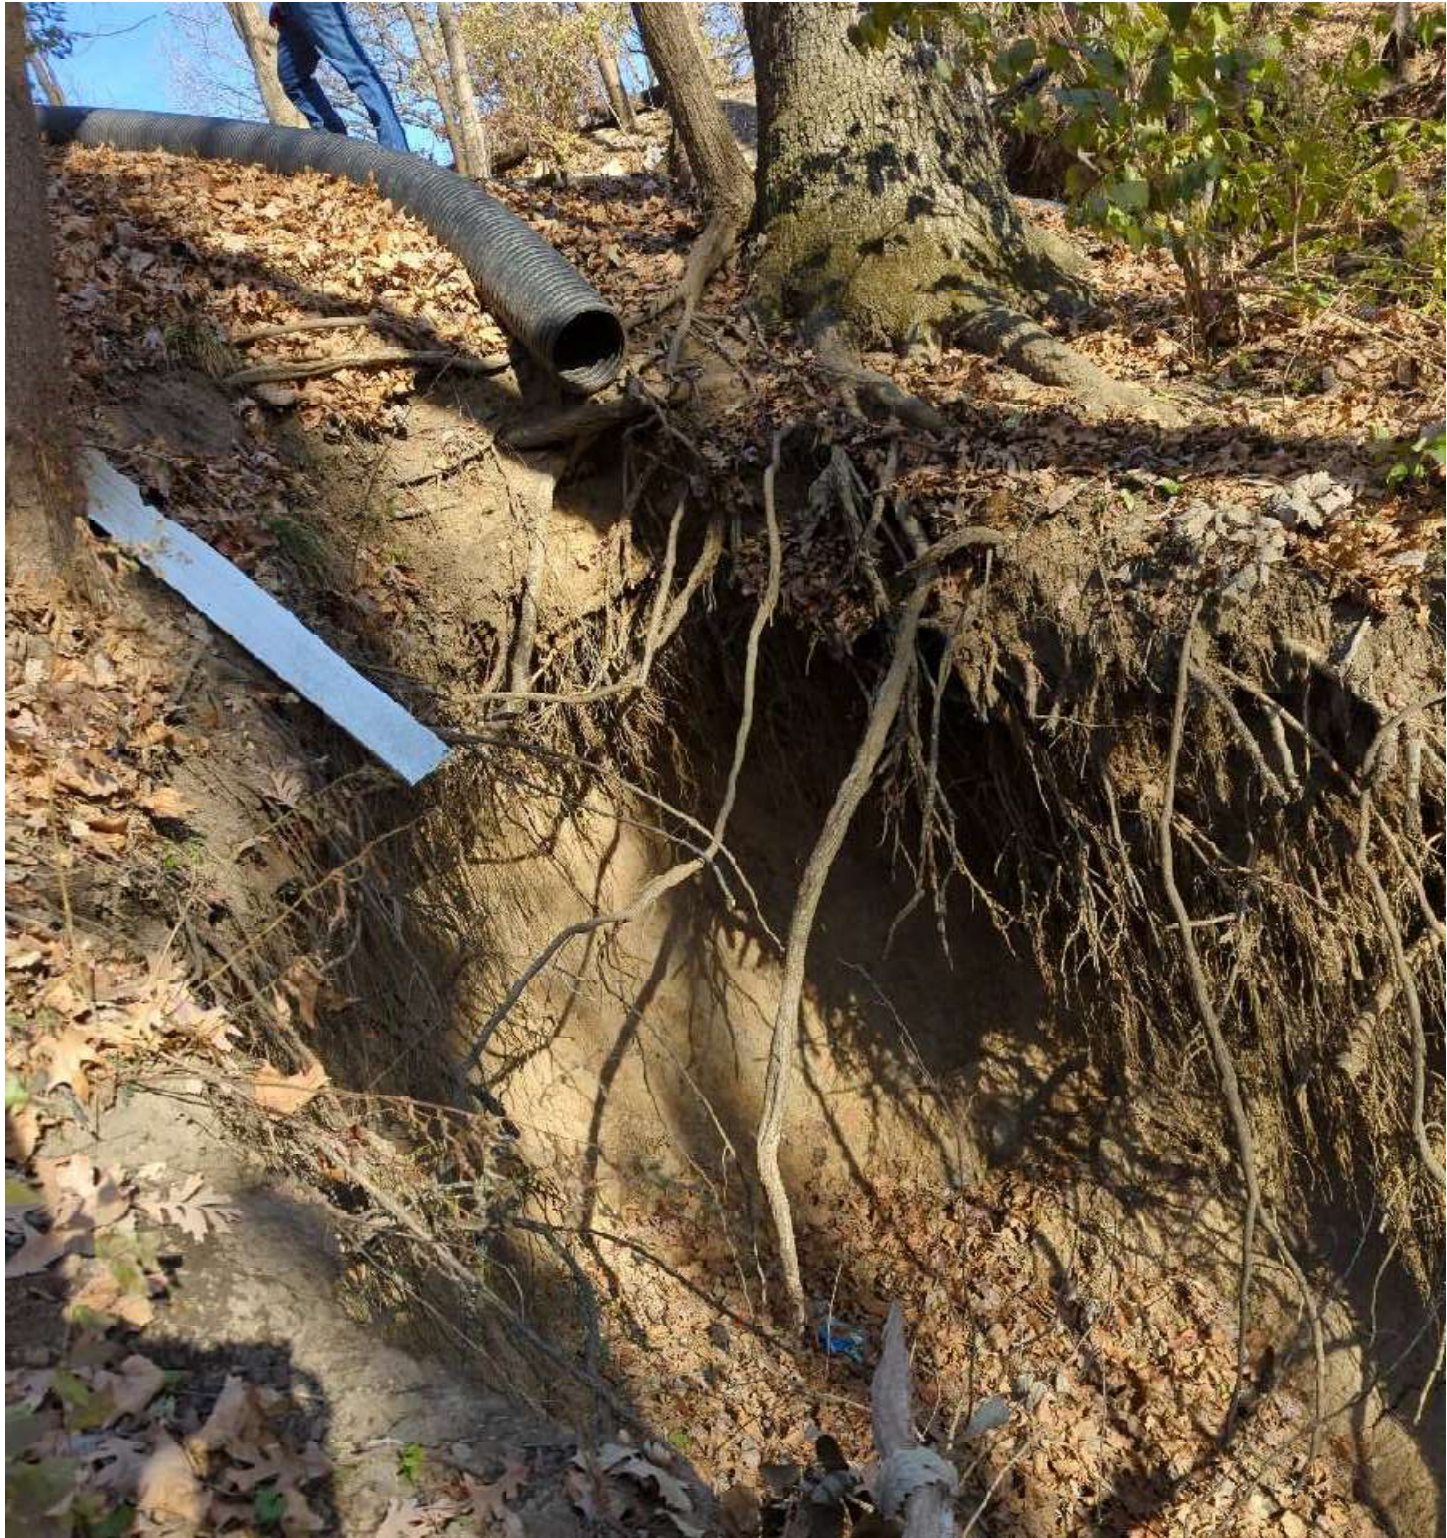
## Object ID 263-Off Maria St

**COMPLETED**

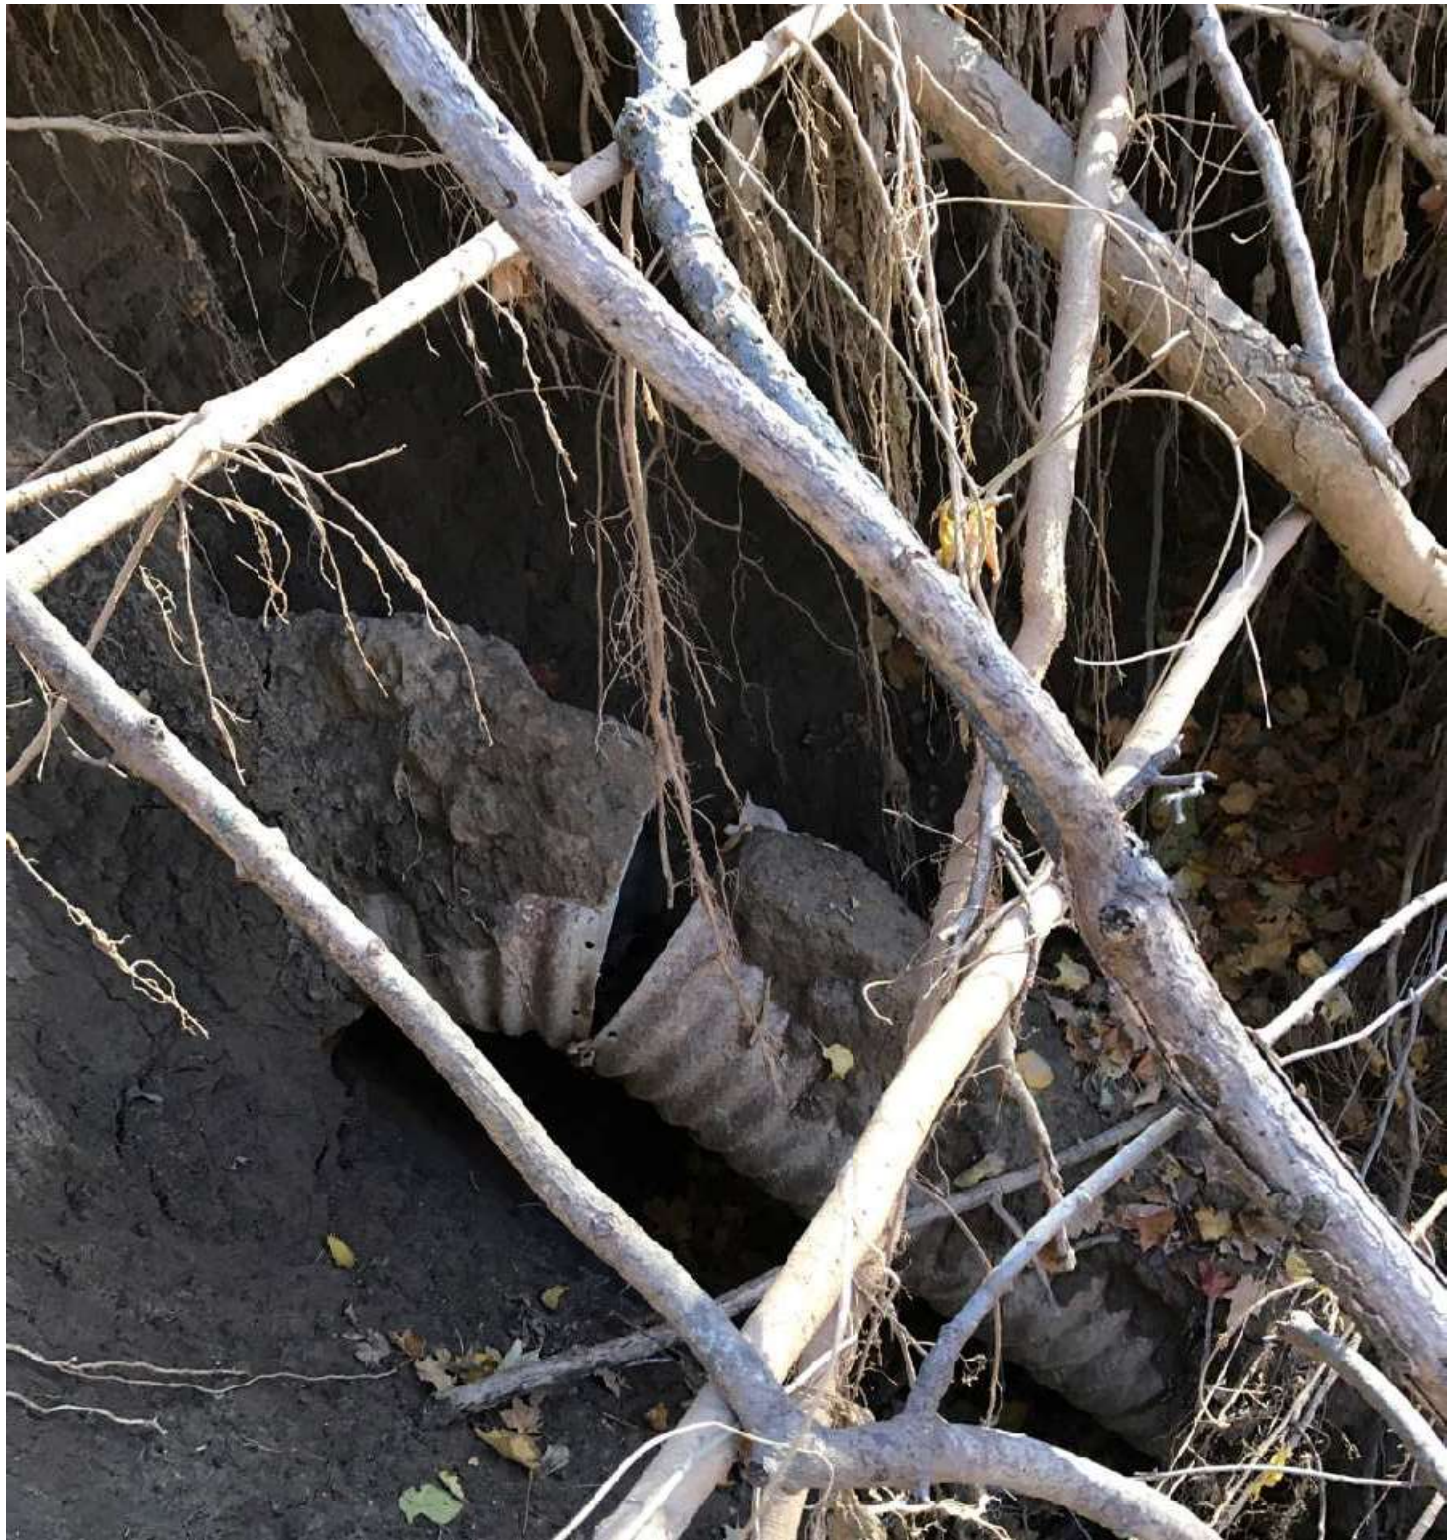
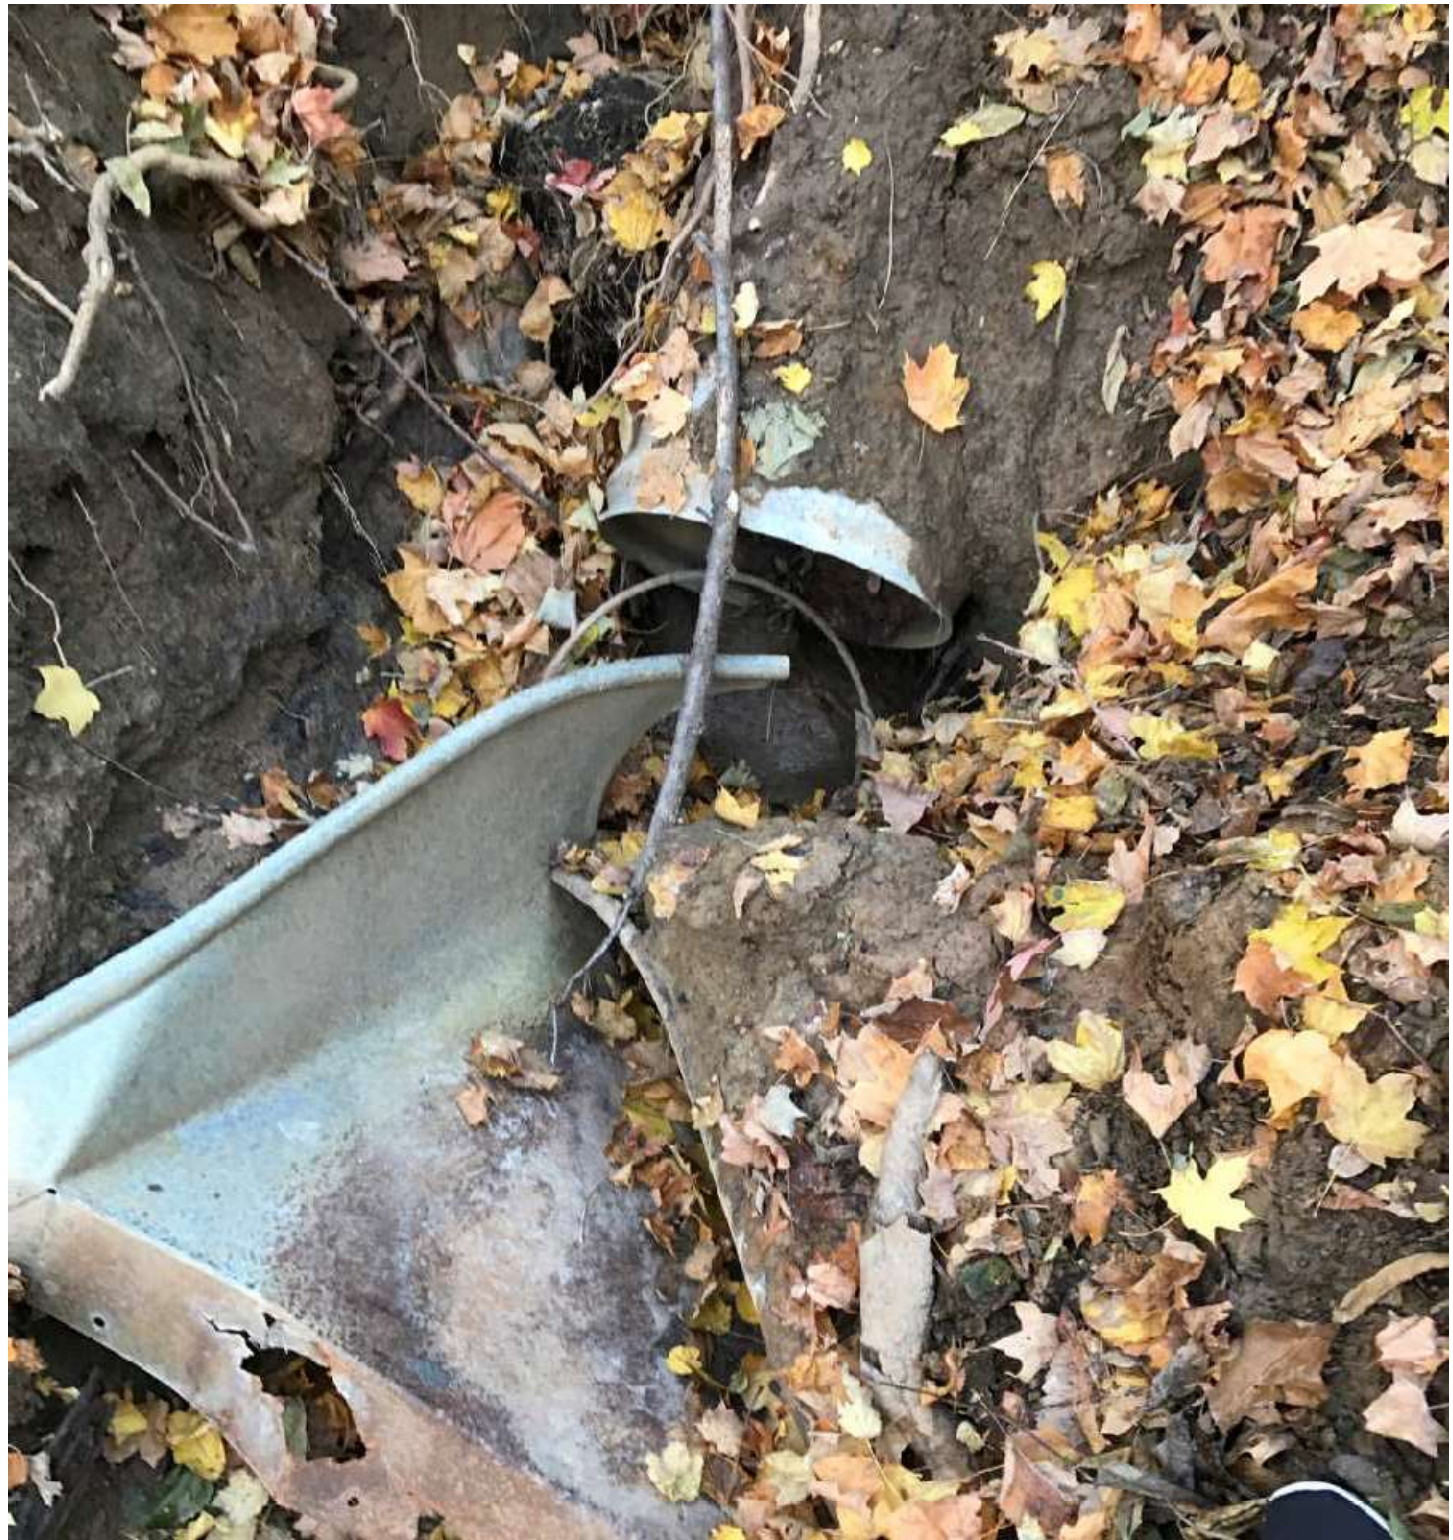
## Object ID 94-Off of Illini Dr

**High  
Priority  
\$150,000**

**COMPLETED**

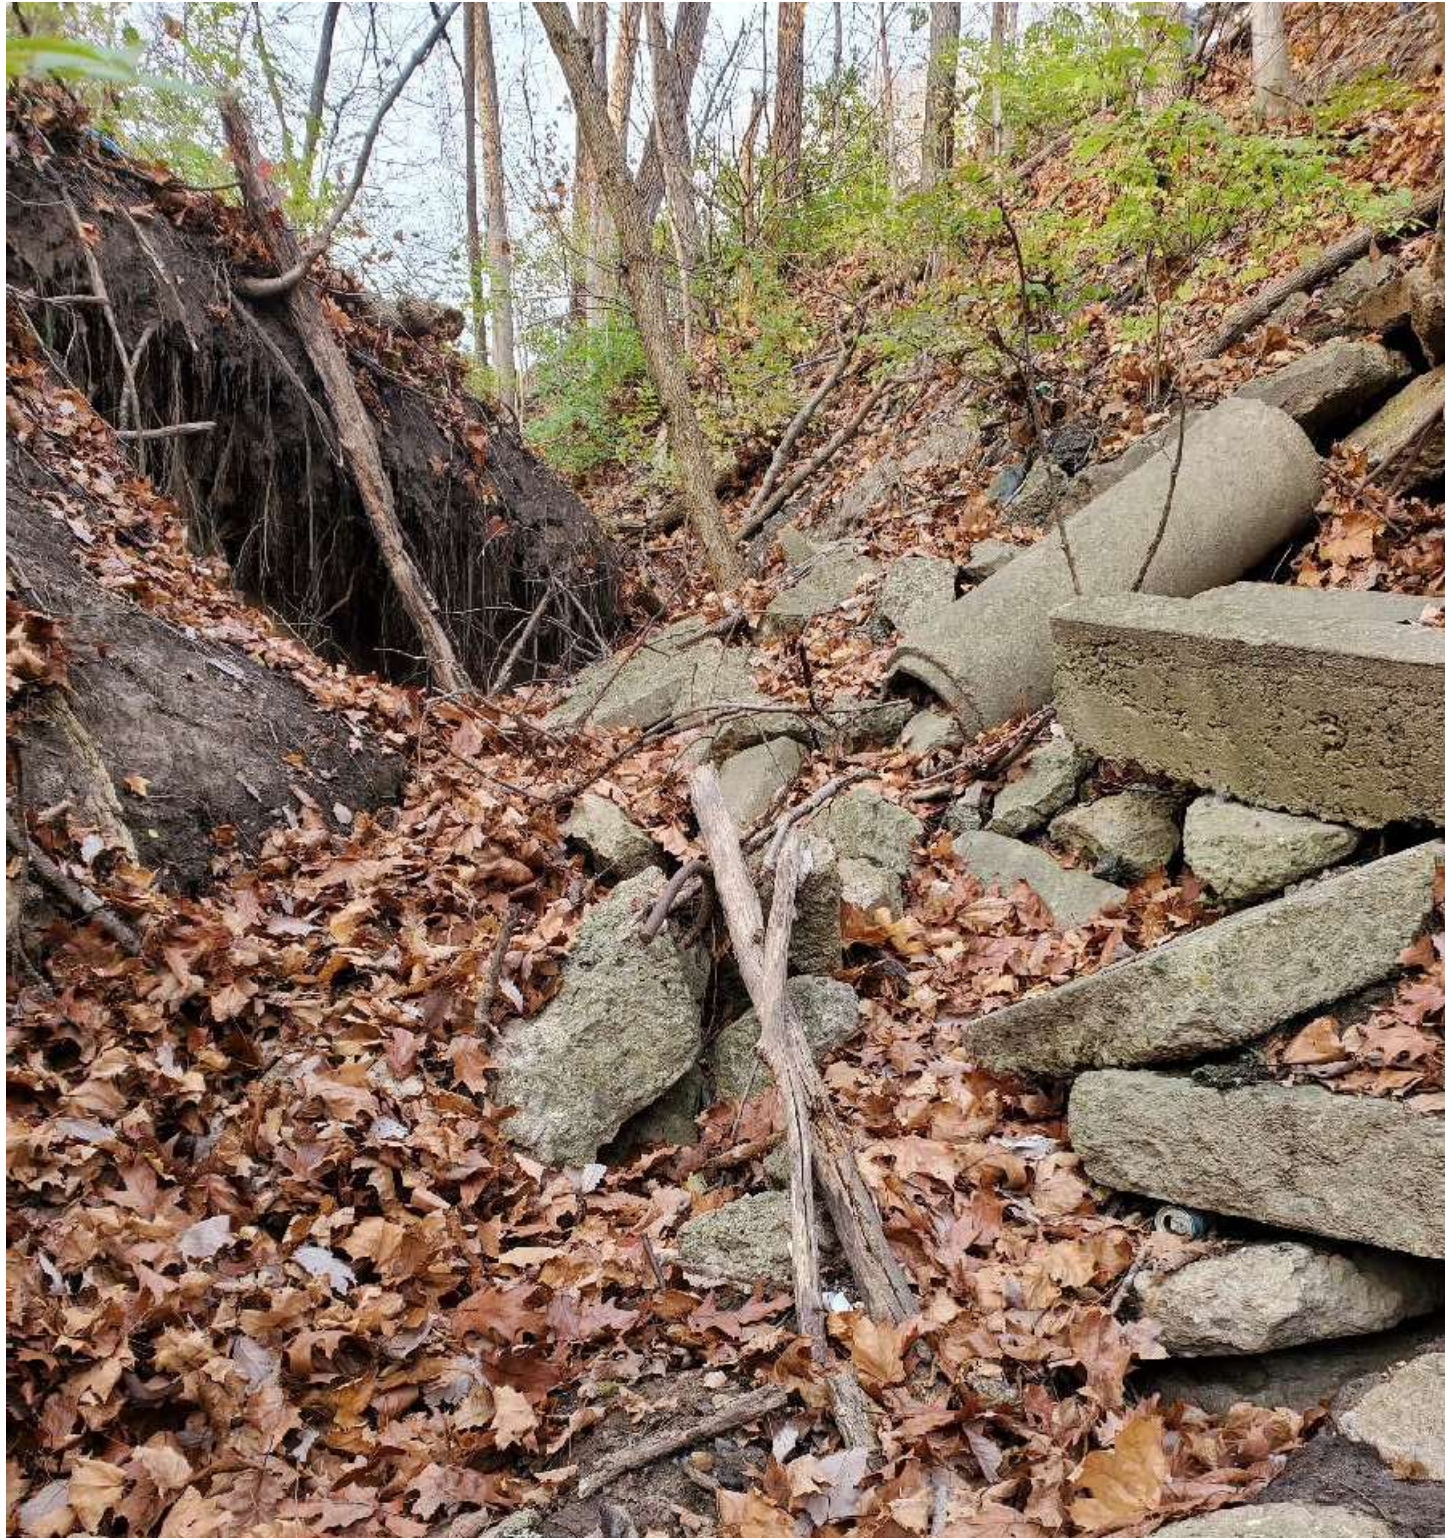
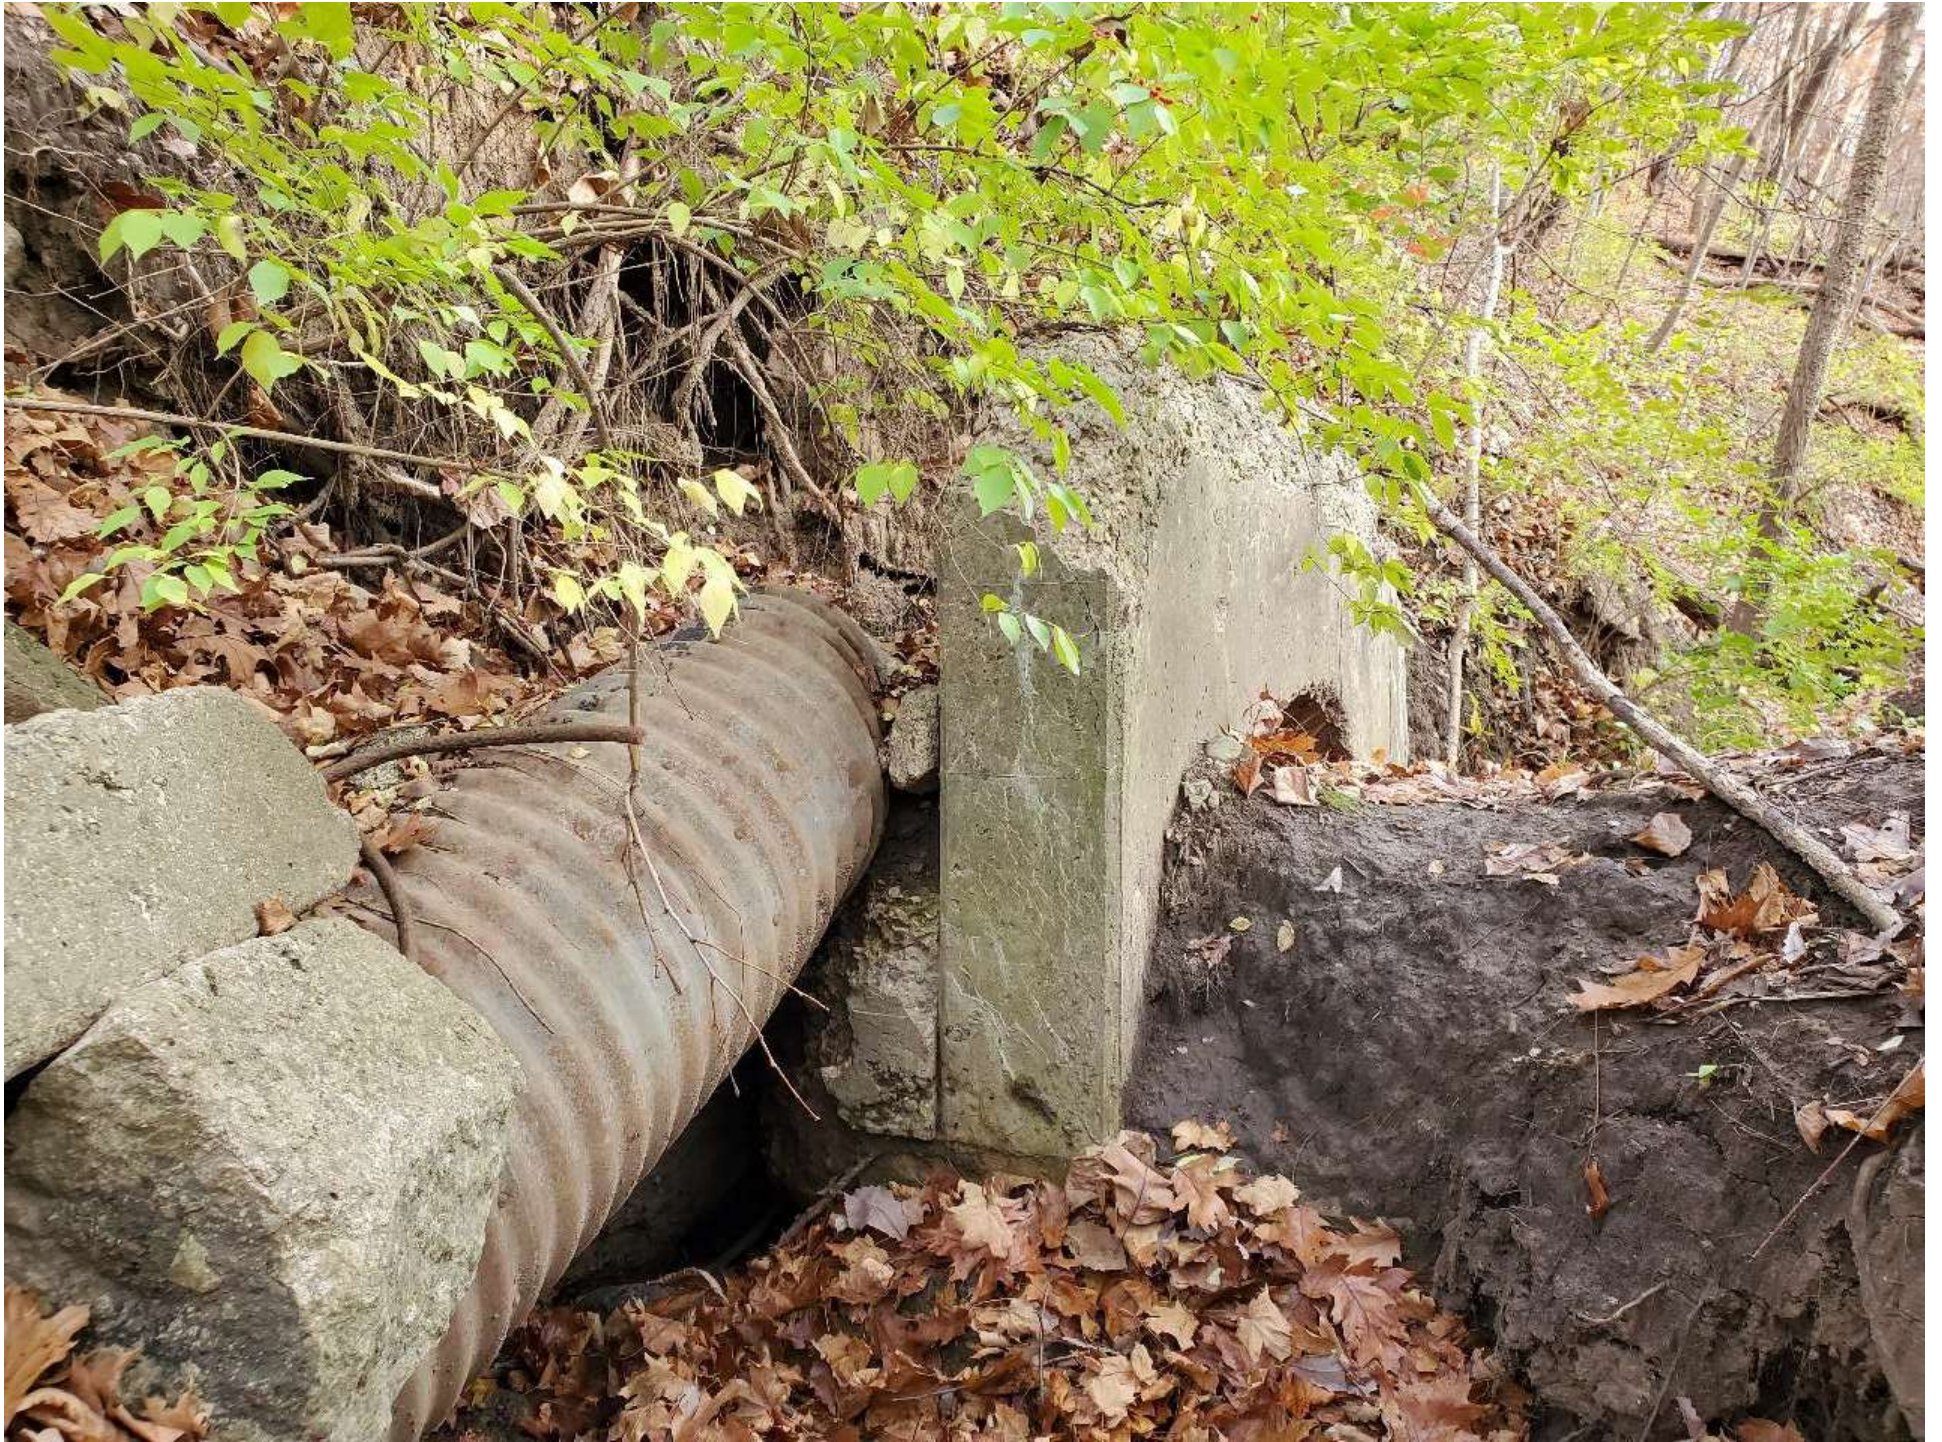
## Object ID 166-Off of Oakwood Rd

# COMPLETED
